CALIFORNIA PUBLIC UTILITIES COMMISSION
Safety and Enforcement Division
Wildfire Safety and Enforcement Branch

Short Form Investigation Report

Incident: Landon Fire

Incident Number: E20231109-01

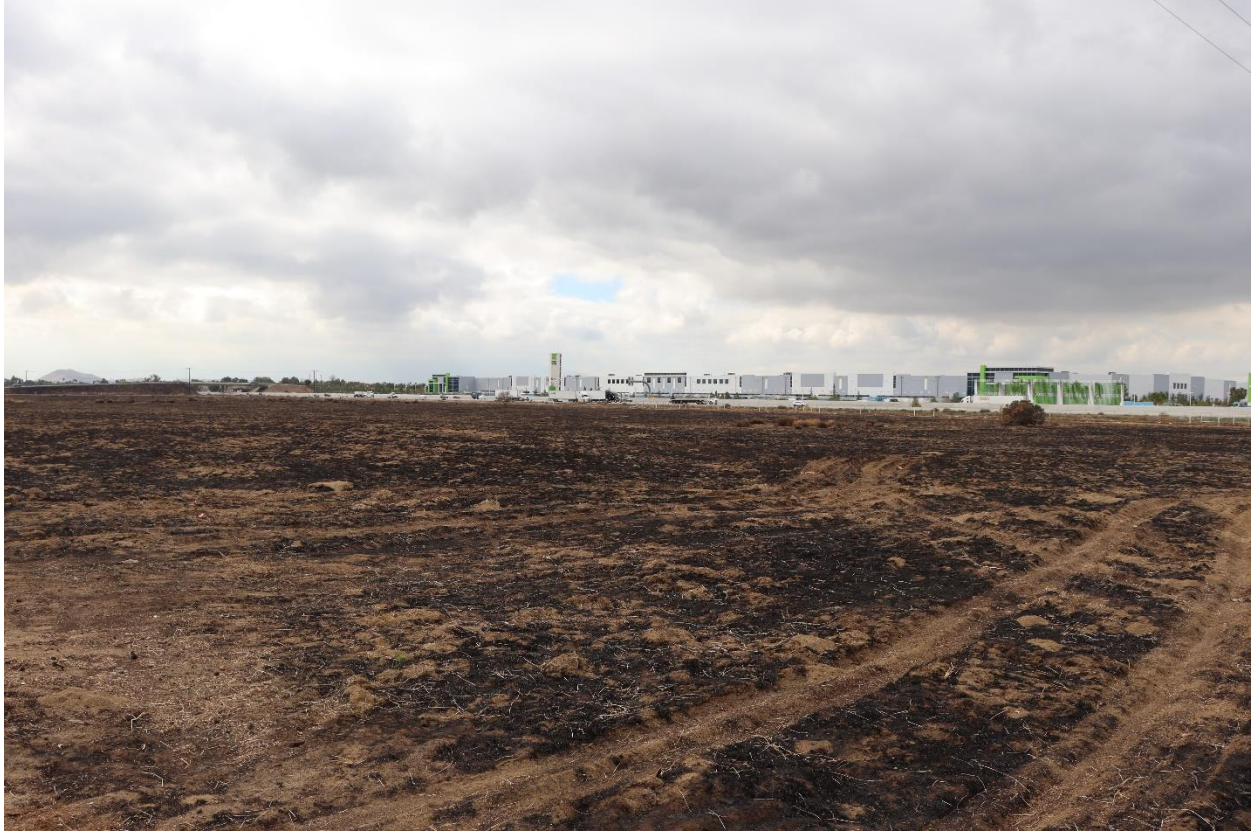
Figure 2: Burn scars visible at Incident Location during SED site visit on November 16, 2023.

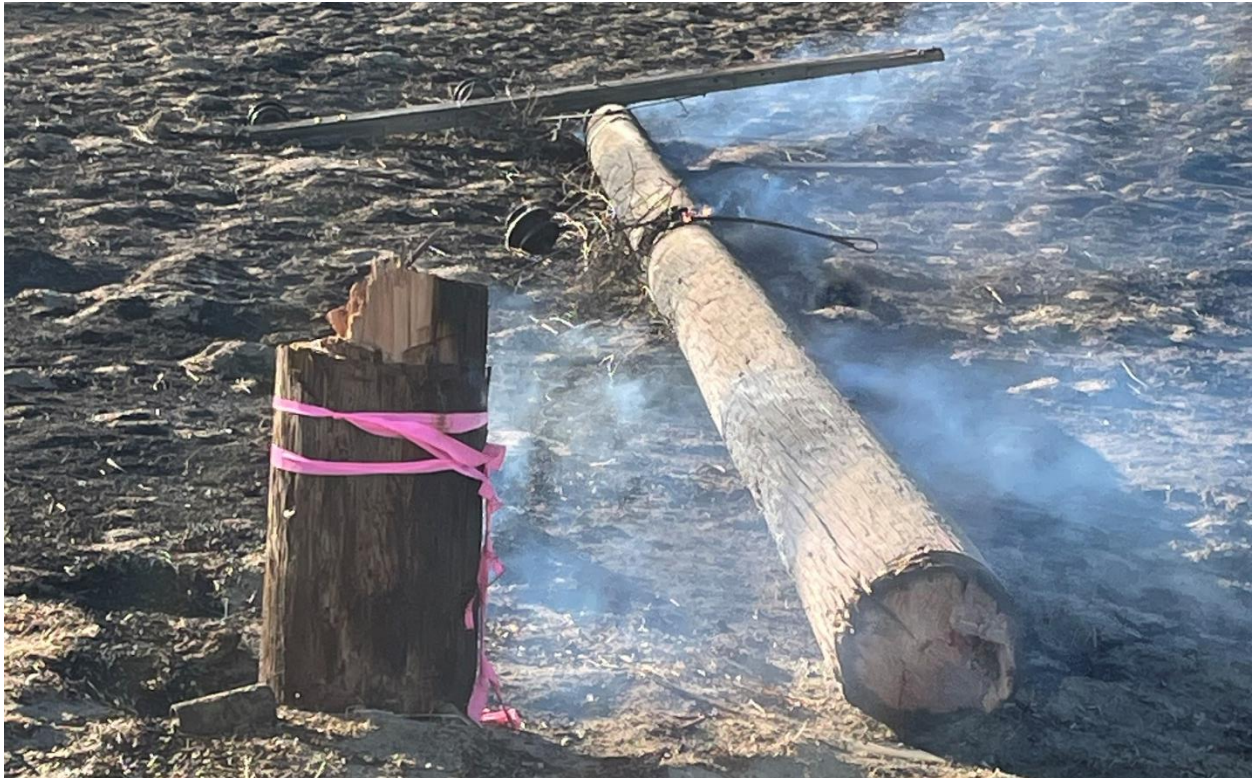
Summary: On November 9, 2023, at approximately 0553 hours, a fire ignited in an empty field south of Landon Drive in Jurupa Valley (the Incident Location) when SCE Pole No. 17174303E fell to the ground. The fire burned approximately 36 acres. The Safety and Enforcement Division (SED), Wildfire Safety and Enforcement Branch (WSEB) initiated an investigation into the incident on November 9, 2023. The California Department of Forestry and Fire Protection (CAL FIRE) informed SED on November 15, 2023, that they would not conduct an investigation into the Landon Fire because their investigator determined that the pole had been vandalized.¹ WSEB conducted a site visit on November 16, 2023, to visit the incident location and view the incident pole. WSEB received the 20-Day Report on December 12, 2023, and determined that a Data Request was not needed. WSEB determined that SCE was not at fault for the damage to their facilities. As a result, WSEB found no violations of the Commission's General Orders.

Figure 3: Pole No. 1714303E downed at Incident Location on November 9, 2023.

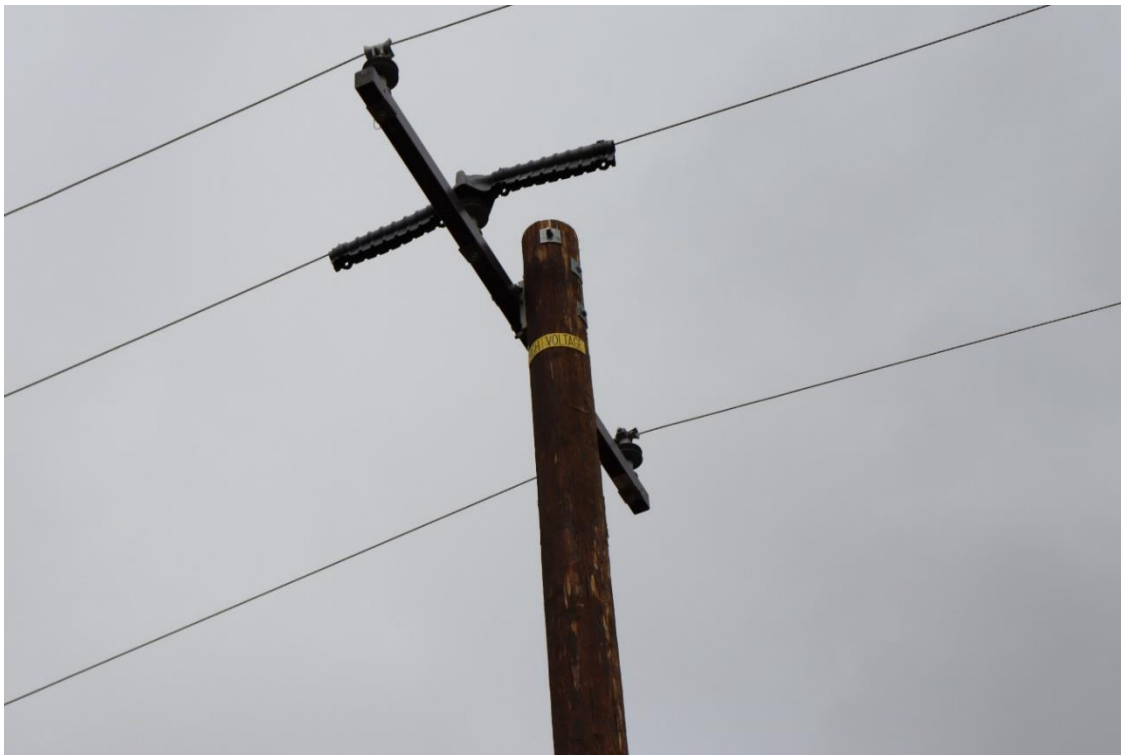
On November 16, 2023, WSEB conducted a site visit and met with SCE Senior Advisor Jose Moran at the dead-end of Landon Drive in Jurupa Valley, California. Jose Moran escorted SED to incident Pole No. 1714303E. SCE replaced the damaged pole the day of the incident after the fire was contained. **Figure 4** shows the replaced pole and equipment present at the time of the site visit. SCE showed SED a picture of the blade-like object that SCE believes was used to cut down the incident pole.

Figure 4: Replaced Pole No. 1714303E and equipment as seen by SED on November 16, 2023.

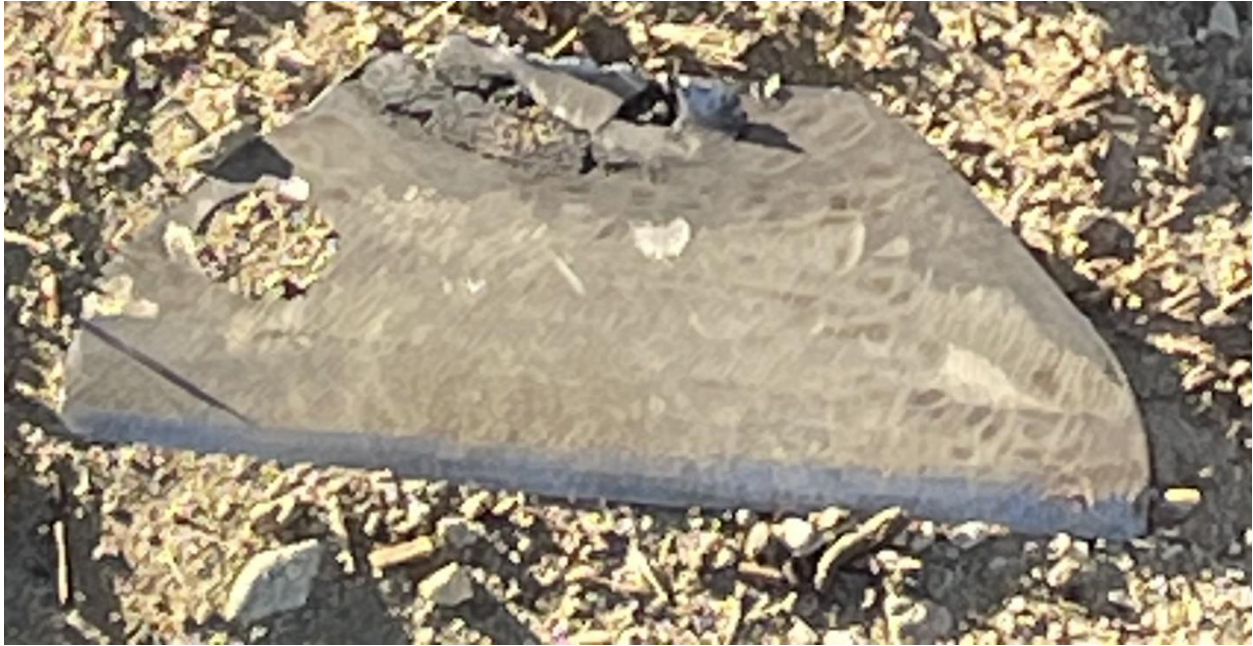
Figure 5: Blade-like object photographed by SCE personnel on November 9, 2023, next to the fallen pole.

SED analyzed evidence and determined that SCE is not responsible for the damage that caused Pole No. 1714303E to fall and ignite the Landon Fire due to the presence of the blade-like object at the incident location and characteristics of the cut. SED agrees with CAL FIRE that the pole was vandalized.

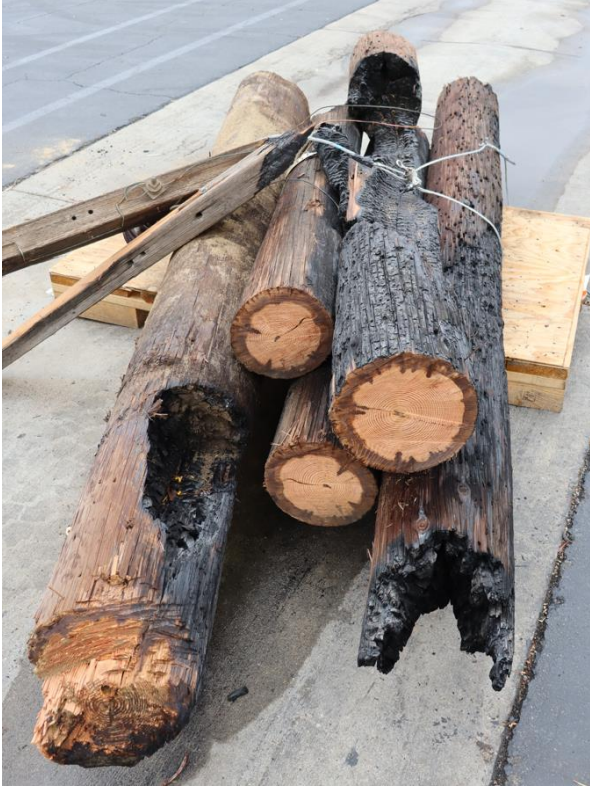
SED then traveled to the SCE Service Center located at 7951 Redwood Avenue in Fontana, California. SCE escorted SED to the yard and viewed the damaged pole. SCE had cut the damaged pole for easier transportation from the Incident Location, but the cuts made for transportation were cleanly cut and evident. SED investigators were able to observe the portion of the pole that had been most likely cut by the blade-like object photographed at the Incident Location. The damaged portion of the pole was clearly distinct from the cuts made for transportation because the pole was not cut cleanly through. This damaged portion of the pole was approximately 30 inches above ground level, as measured by SED.

Figure 6: Pole No. 1714303E cut into sections for transportation and stored at the SCE yard.

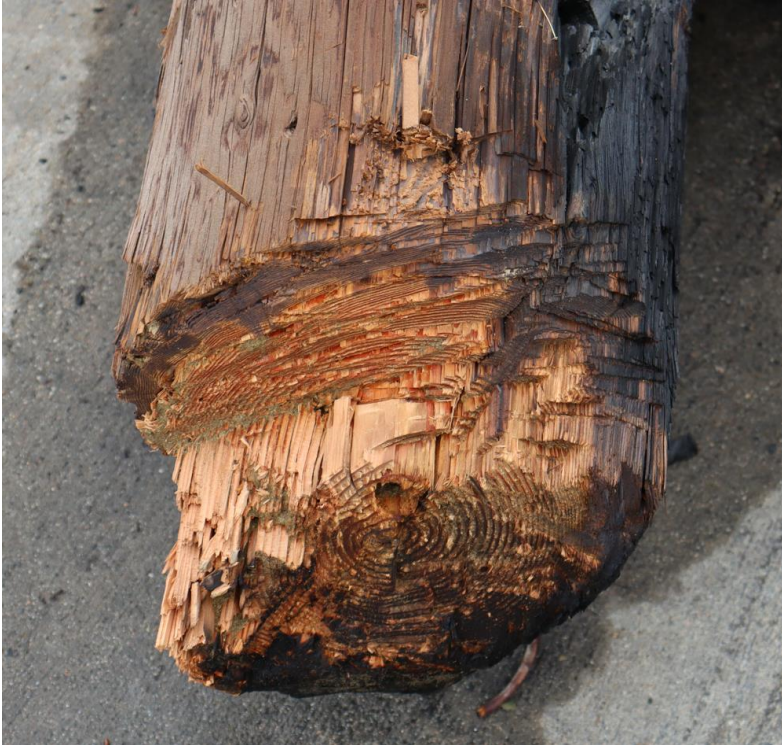
Figure 7: Bottom half of Pole No. 1714303E showing where the pole was most likely cut by the blade-like object.

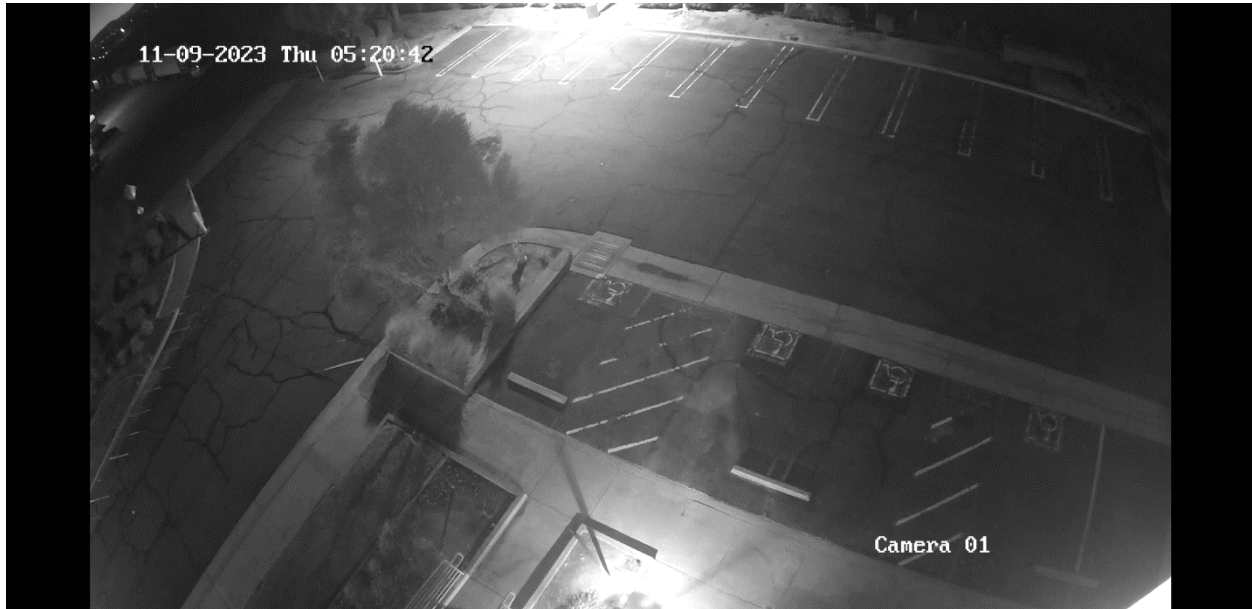
On December 1, 2023, SED received security footage from a nearby business, which SCE Senior Advisor Jose Moran had recommended SED contact. SED investigators reviewed the security footage and were not able to conclusively determine if an individual vandalized Pole No. 1714303E, due to the angle of the camera not showing the field adjacent to Landon Drive. SED concluded that the pole was downed around approximately 0520 hours due to observing three flashes on the security footage followed by power going out to nearby streetlights.

Figure 8: Security footage of Levecke parking lot with streetlight before suspected fire ignition.

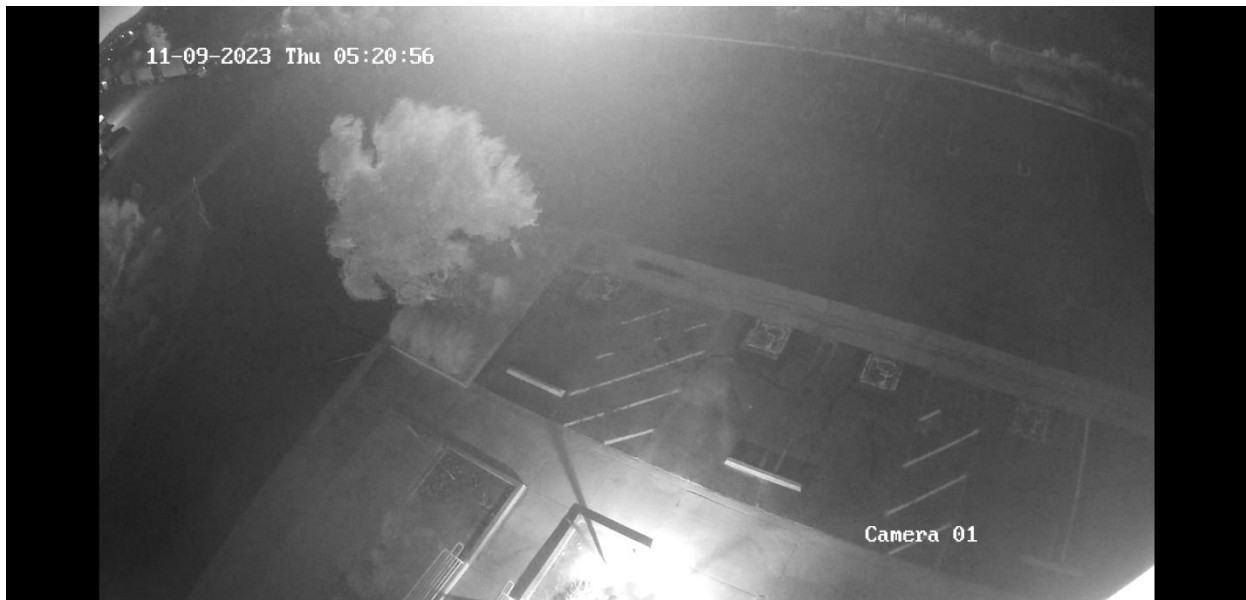
Figure 9: Security footage showing parking lot after ignition and power being lost to streetlight.
