**SUBJECT: Electric Audit of SDG&E Eastern District File No. EA2024-1122**

A General Order 165 Electric Distribution Audit/Inspection of SDG&E's Eastern Construction and Operation District (conducted by SED Engineers Kyle King) was held from February 26, 2024, to March 1, 2024. During the field inspection your staff identified a total of seven SDG&E overhead findings and one SDG&E underground finding.

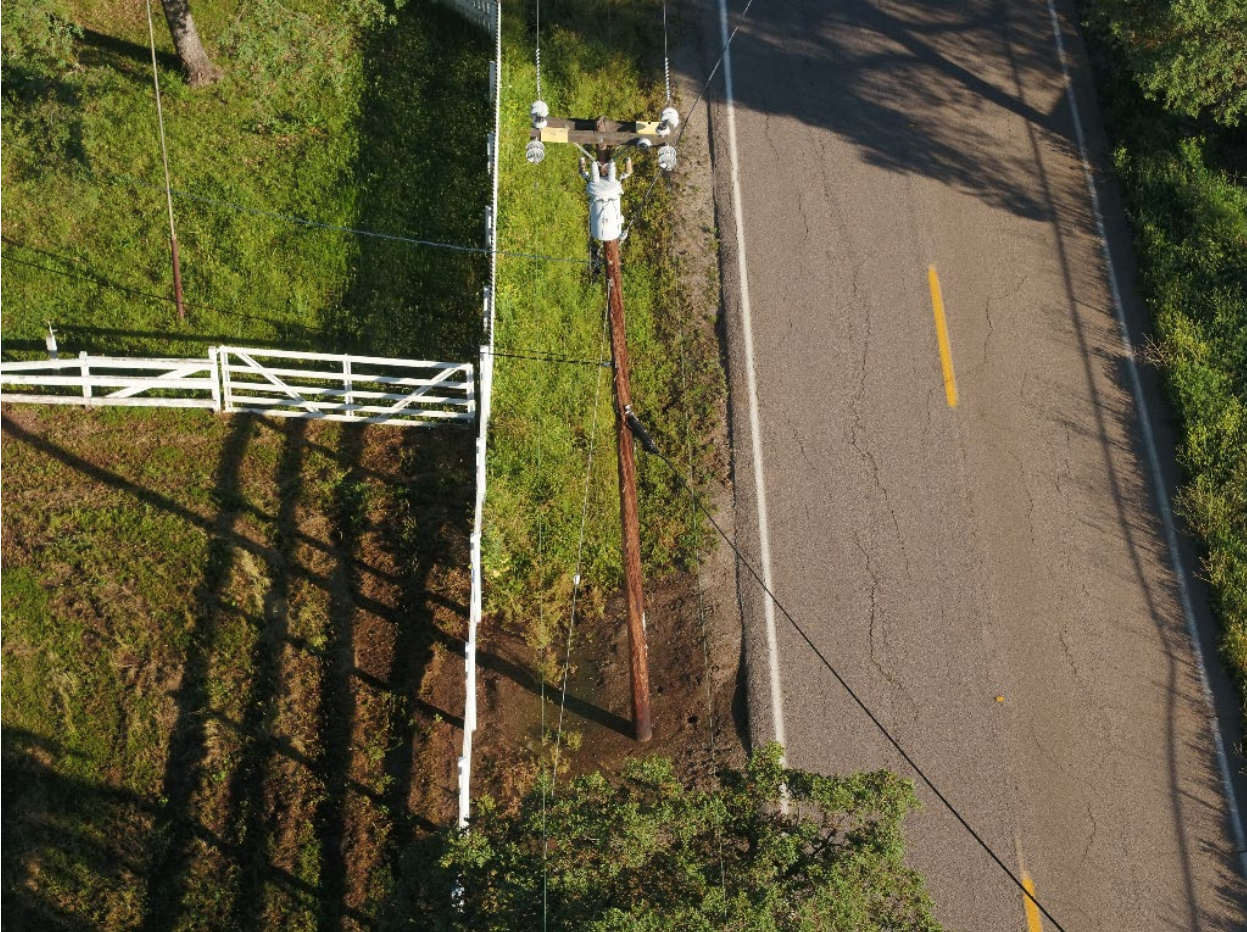
P177400: June 2023 *inspection photo* showing the CIP safety hazard wasn't present.

In response, SDG&E asserts that during SDG&E's latest inspection on June 9, 2023, the CIP safety hazard wasn't present. To resolve this issue, we have included the photo from the latest inspection showing the communications service drop was not touching the fence as Attachment A.

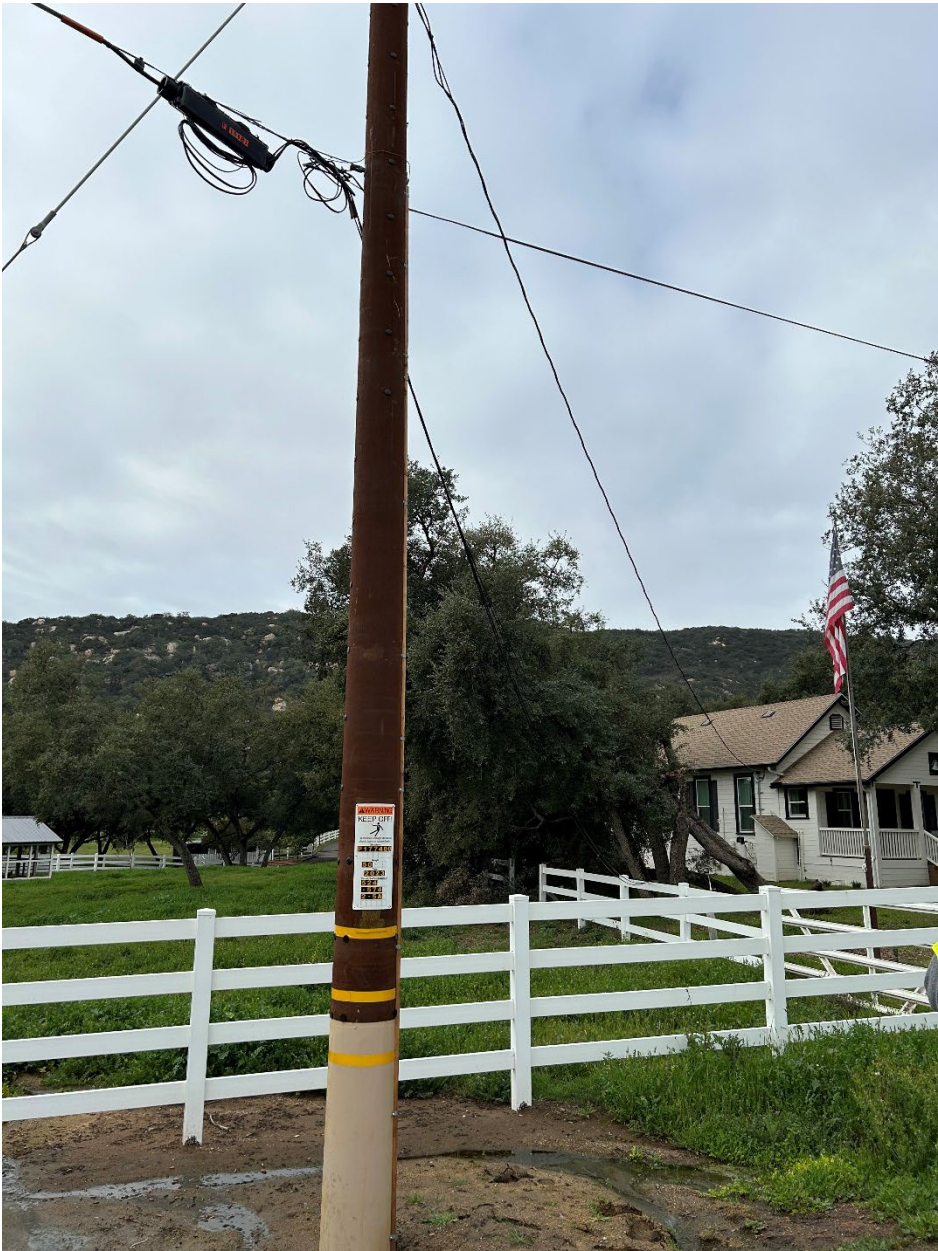
Violation 1 concludes that during SDG&E's latest inspection, SDG&E did not document and report to the responsible third party that due to a fallen tree, a communications service drop supported on P177400 was pulled towards the ground and touching a fence.

P177400: February 2024 *audit photo* showing the CIP safety hazard identified during CPUC audit.

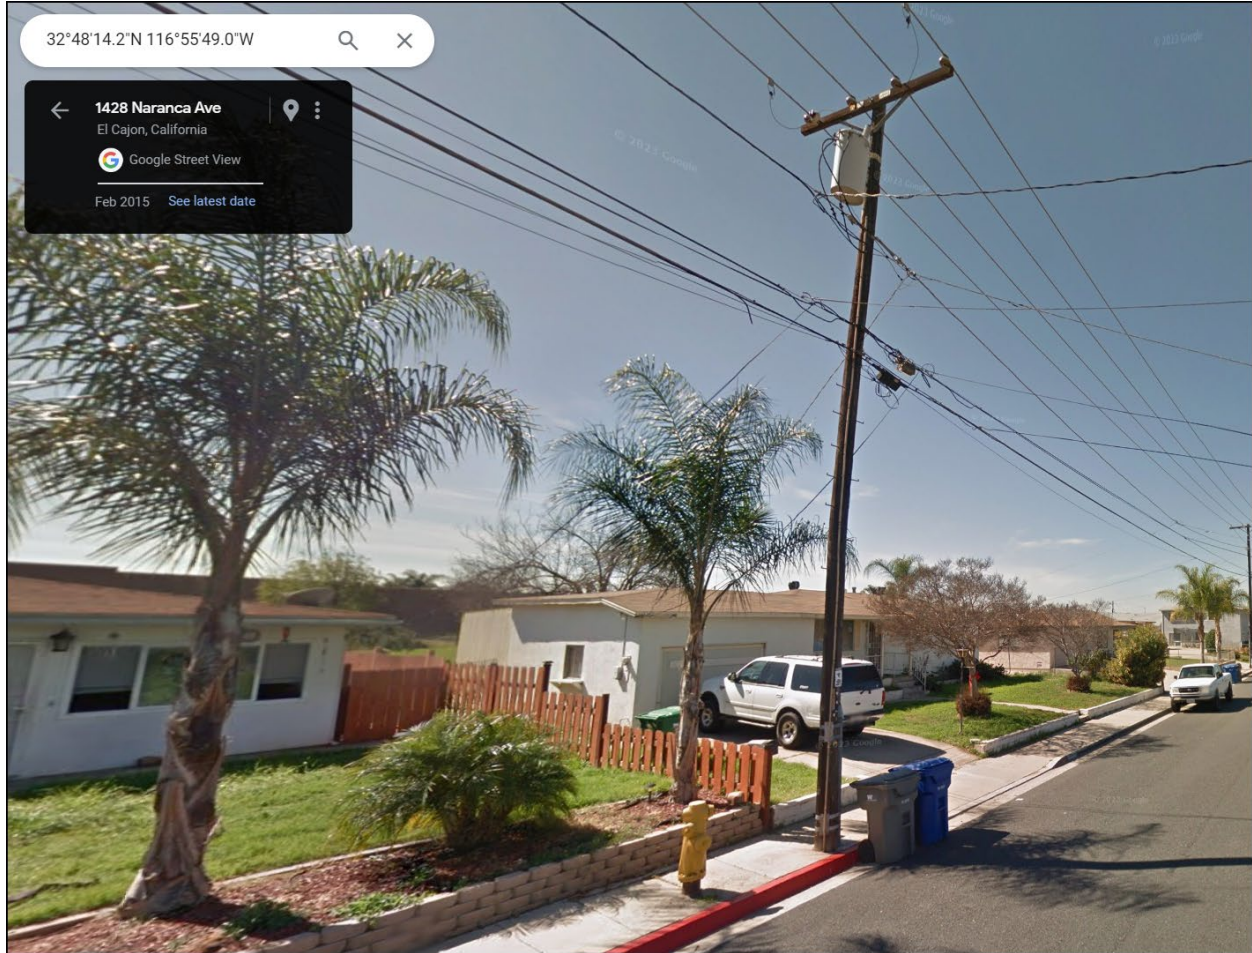
Feb 2015 Google image showing two service drops (SDG&E and CIP) with no clearance issue.

In response, SDG&E asserts that SDG&E's service drop attachment point hasn't changed over the years. The clearance violation was created when new communications service drop and communications dish was attached on roof. To resolve this issue, we have included Google photos from before and after of the new communications service drop and communications dish attachments as Attachment B.

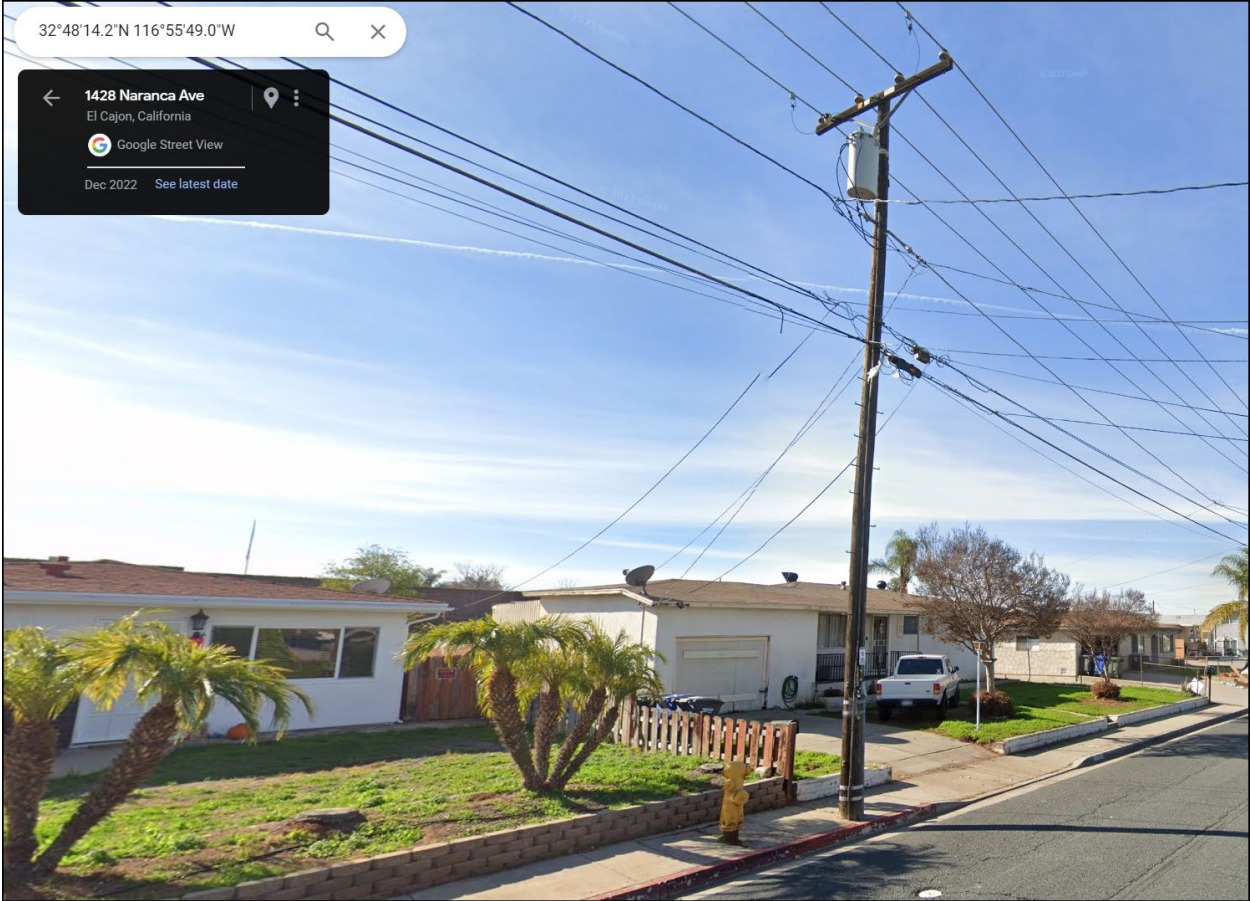
Violation 2 concludes that an SDG&E service drop on Pole number JP370364, was detached from its attachment point on a roof eave. This caused the SDG&E service drop to become entangled with a communications service drop at the roof. As a result, the clearance between the SDG&E service drop and the communications service drop was less than 12 inches within 15 feet of the point of attachment.

Dec 2022 Google image showing three service drops (SDG&E and two CIPs) with clearance issue. SDG&E's service drop attachment point didn't move.
