**CALIFORNIA PUBLIC UTILITIES COMMISSION**  
**Safety and Enforcement Division**  
**Wildfire Safety and Enforcement Branch**

**Incident Investigation Report**

**Incident Number:** E20220819-01 (Ridge Fire)

**Regulated Utility Facilities Involved:** Jarvis 12kV Distribution Circuit

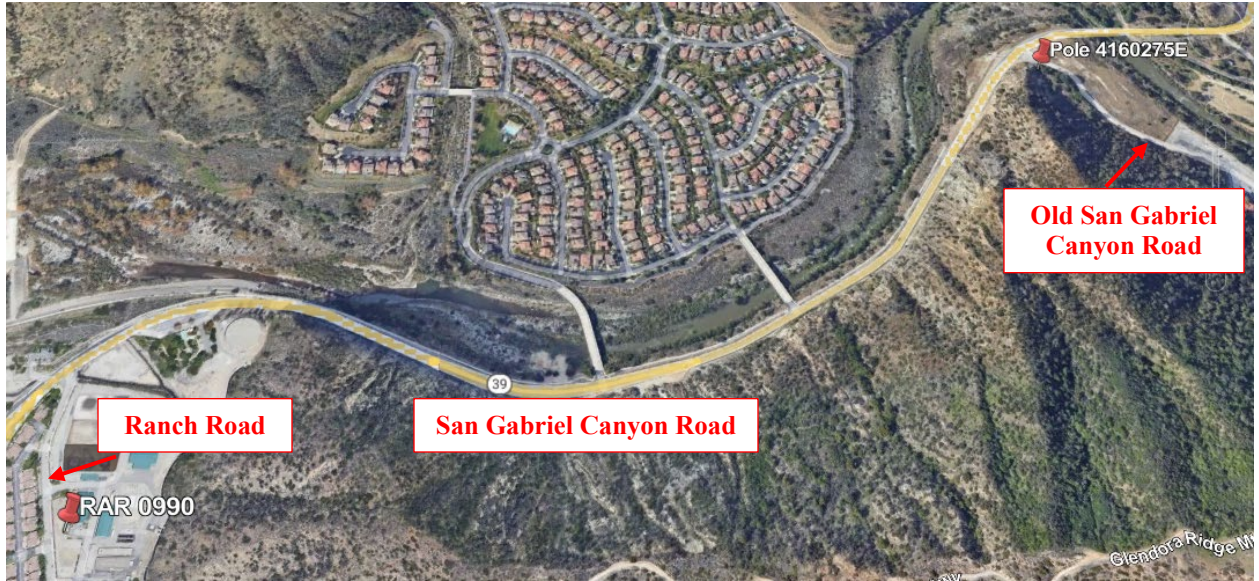
**Figure 4.** Map showing the location of RAR 0990 with respect to Pole 4160275E.
