# San Jose Incident Investigation Report

SAFETY AND ENFORCEMENT DIVISION  
GAS SAFETY AND RELIABILITY BRANCH

Final Report

<b>Report Date:</b>	May 23, 2024
<b>Investigators:</b>	Hengyao Chen
<b>Incident Number:</b>	G20230608-3539
<b>Date incident reported to CPUC</b>	June 8, 2023
<b>Utility:</b>	Pacific Gas and Electric Company (PG&E)
<b>Date and Time of the Incident:</b>	June 8, 2023 at 0300 hours
<b>Location of the Incident:</b>	██████ Alum Rock Ave San Jose, CA, Santa Clara County

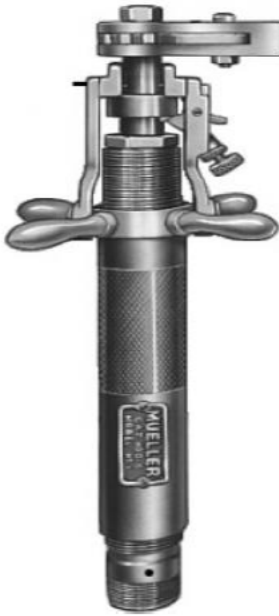
*Inspection of D-5 Machine: Inspected all components, no issues found.*

**Mueller D-5 Machine** – for drilling and stoppering operations under pressure.
