**Pacific Gas and
Electric Company®**

Response to CPUC 2020 audit inspection findings report of PG&E's Cupertino
Substation Headquarters

**CPUC AUDIT FINDINGS OF PG&E CUPERTINO
SUBSTATION HEADQUARTERS
JULY 6-10, 2020**

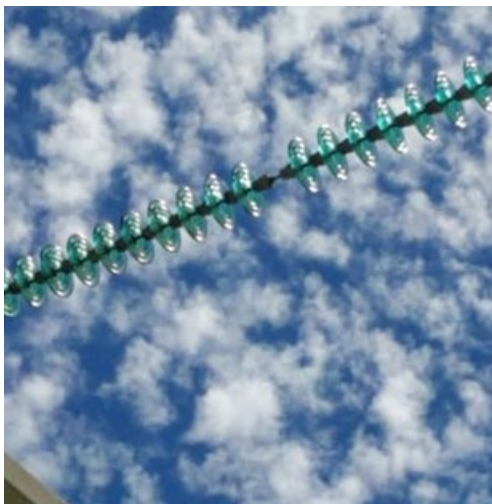
13.5. There is a disc missing from a green insulator string.

PG&E Response: As responded in CPUC Data Request #2 (CPUC Reference Number: SA2020-870), in response to Question 1.k.iii., after an evaluation was performed of the string insulators identified on the 230kV Bus during the station audit at Hicks Substation, PG&E agrees that one bell insulator is missing on one of the three strings. There is adequate insulation creepage to prevent flashover with only one of the 24 string bell insulators missing. This work will be bundled as part of the ongoing 230kV Bus capital upgrade project to be completed by 1/21/2021. The Capital Order this work is being performed under is 74004825.

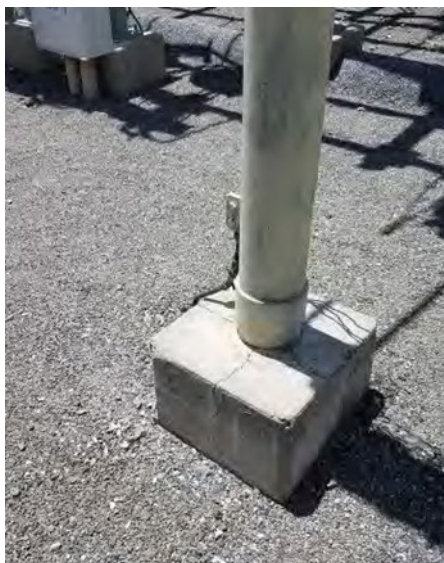
14.1. There is a crack in the concrete foundation by bus 1114/5B.

PG&E Response: Notification 119571994 was created for Substation Civil Engineering

to evaluate the cracked foundation observed at Saratoga Substation near the bus foundation for CB 1114. The assessments completed on 8/26/2020 recommended repair. This work is currently under bid with an approved civil contractor to be completed before the end of Q1 2021.

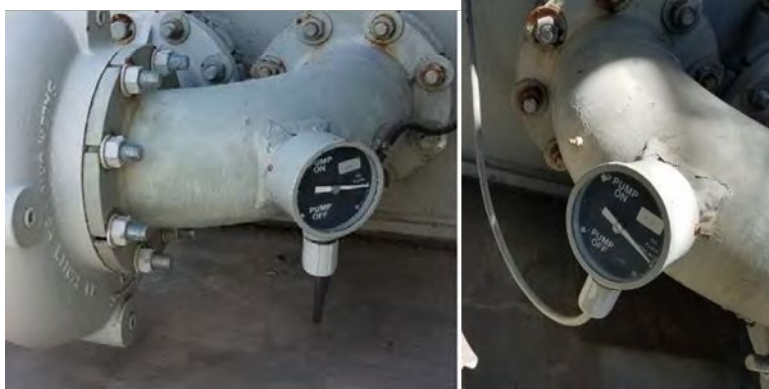
14.2. Transformer #2 has two non-functioning flow indicators at its oil pumps.

PG&E Response: The main tank oil circulating pumps on Saratoga Transformer #2 are operational as validated during the field audit with CPUC representatives on site. Notification 119571884 was created to repair or replace both oil flow indicators that are reflecting incorrectly. Both flow indicators were replaced. This work was completed on 8/12/2020.
