**CPUC SUBSTATION AUDIT FINDINGS REPORT RESPONSE**  
**PG&E Cupertino Headquarters**  
**January 27 – 31, 2025**

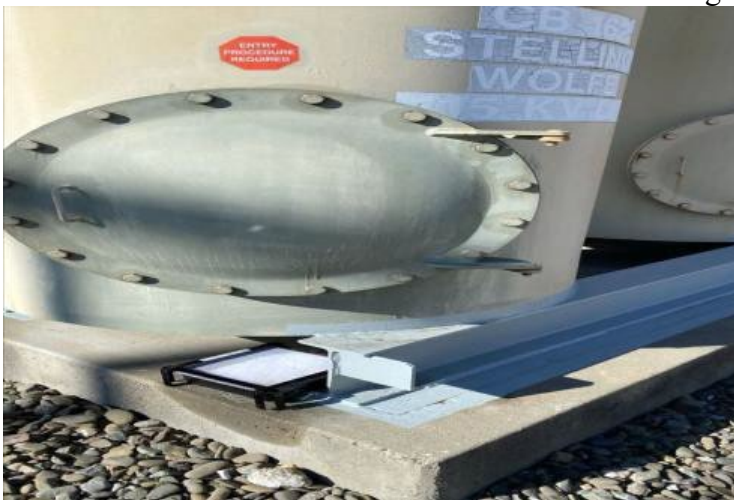
1.1 Circuit Breaker 162 had an Oil Leak. Existing LC Tag#130788506.

We agree an oil leak was present on breaker 162 at Wolfe Substation. This nonconformance has a pre-existing LC notification, 130788506, that was established in our system of record, SAP, prior to the field audit. We do not agree that this finding qualifies as a violation of GO 174, Rule 12 since this LC notification is being worked in accordance with our maintenance procedures and is not past due.

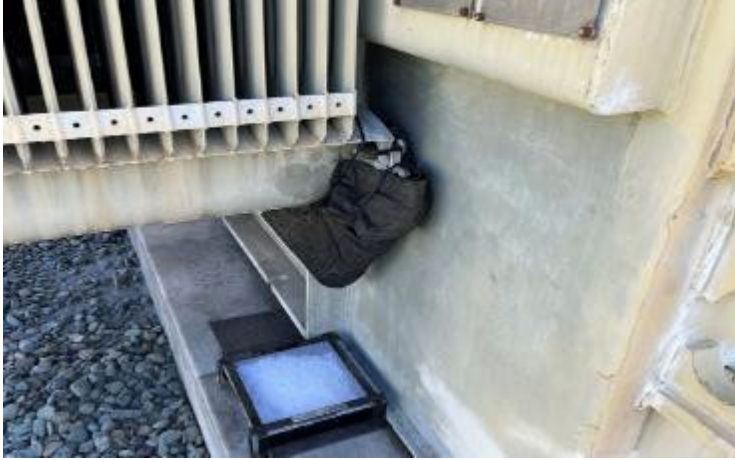
1.2 Transformer Bank 2 had an Oil Leak at Radiator Flange. Existing LC Tag#130788501.

We agree that an oil leak was present on Bank 2 radiator flange at Wolfe Substation. This nonconformance had a pre-existing LC notification, 130788501, that was established in our system of record, SAP, prior to the field audit. We do not agree that this finding qualifies as a violation of GO 174, Rule 12 since this LC notification was being worked in accordance with our maintenance procedures and was completed on April 21, 2025.

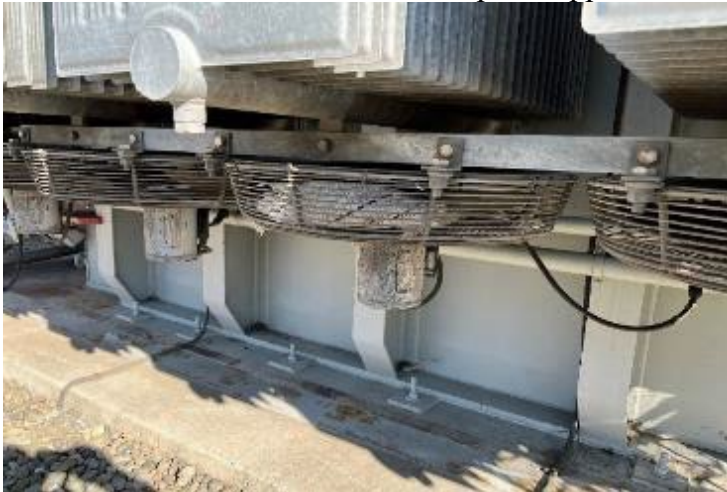
1.3 Transformer Bank 2 had Paper Trapped Inside Fan. Fixed in Field.

The cited violation pertains to Transformer Bank 1, not Transformer Bank 2. We agree with the finding of paper in the high side fan of Transformer Bank 1 at Wolfe Substation. This issue was corrected onsite by PG&E QEW on the day of the field audit.

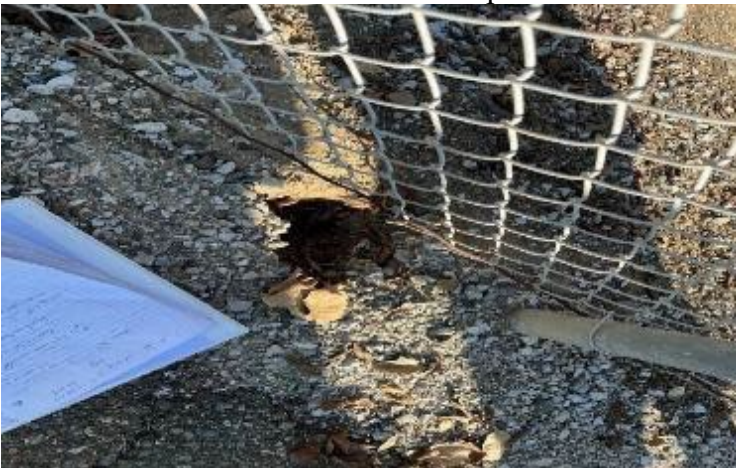
1.5 The Perimeter Fence had Gap Greater than 6 Inches Depth. PG&E Fixed in Field.

We agree with the finding of a squirrel hole under the perimeter fence at Wolfe Substation. This issue was corrected onsite by PG&E QEW on the day of the field audit.

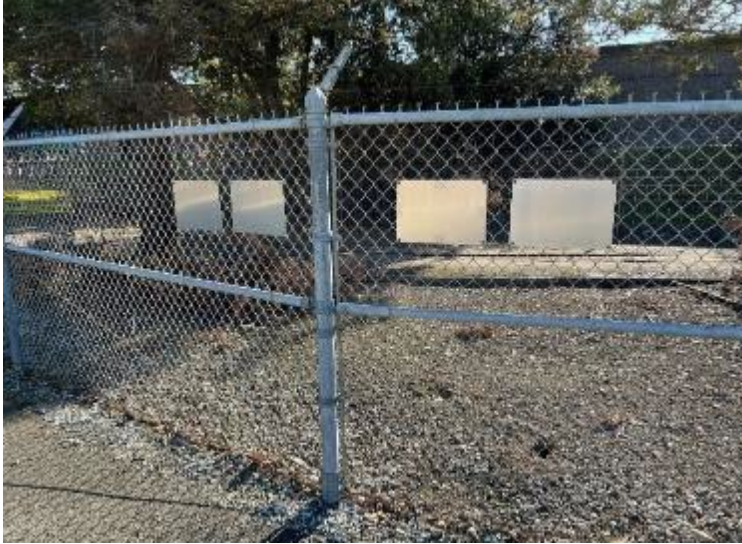
1.6 The Perimeter Fence had Several Sets of Warning Signs Posted Inside Fence.

We agree that signage was posted inside the fence at Wolfe Substation. This nonconformance had a pre-existing LC notification, 130788877, that was established in our system of record, SAP, prior to the field audit. We do not agree that this finding qualifies as a violation of GO 174, Rule 12 since this LC notification was worked in accordance with our maintenance procedures and completed timely on February 19, 2025.

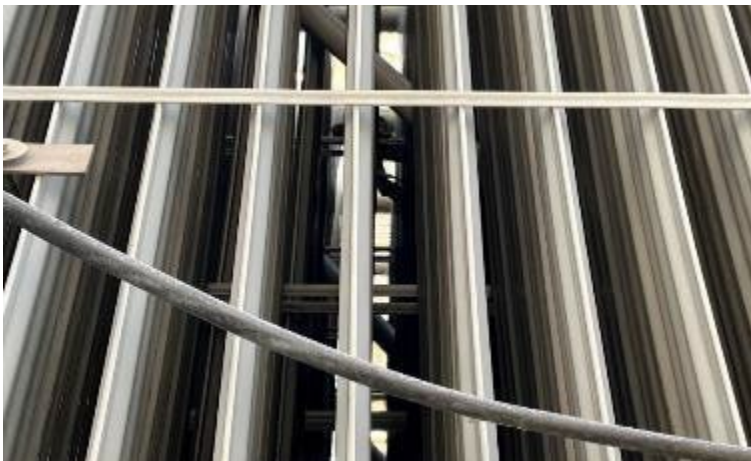
2.1 Transformer Bank 3 Had Branch Inside Radiator.

We agree with the finding of a branch inside the radiator of Transformer Bank 3 at Saratoga Substation. We created LC notification, 131181252, added it to the workplan and will be completed based on current work prioritization and material availability.

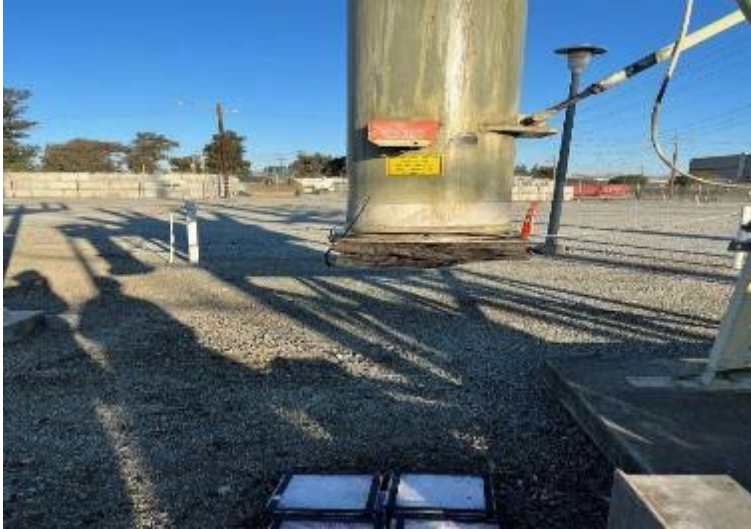
3.1 Circuit Breaker 112 has an Oil leak on Hydraulic Line. Existing LC Tag#130109005.

We agree an oil leak was present at Circuit Breaker 112 at Llagas Substation. This nonconformance has a pre-existing LC notification, 130109005, that was established in our system of record, SAP, prior to the field audit. We do not agree that this finding qualifies as a violation of GO 174, Rule 12 since this LC notification is being worked in accordance with our maintenance procedures and is not past due.

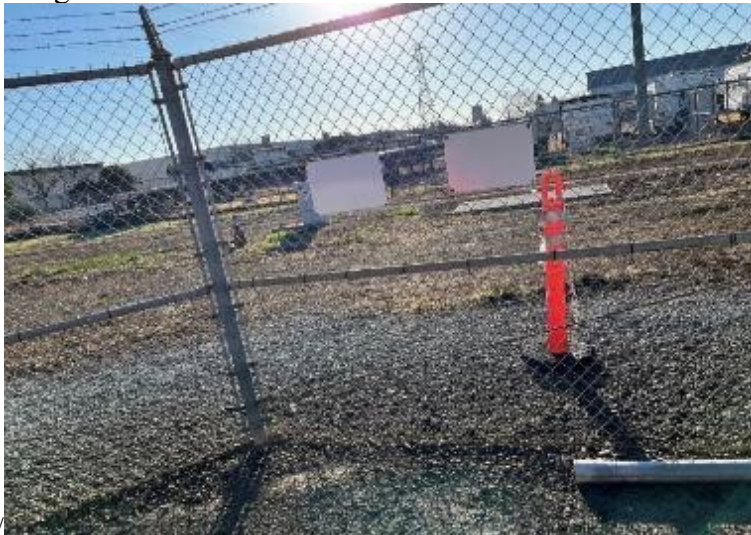
3.2 The Perimeter Fence had Warning Signs Posted Inside Fence. Existing LC Tag#130108978.

We agree that signage was posted inside the fence at Llagas Substation. This nonconformance has a pre-existing LC notification 130108978, that was established in our system of record, SAP, prior to the field audit. We do not agree that this finding qualifies as a violation of GO 174, Rule 12 since this LC notification is being worked in accordance with our maintenance procedures and is not past due.

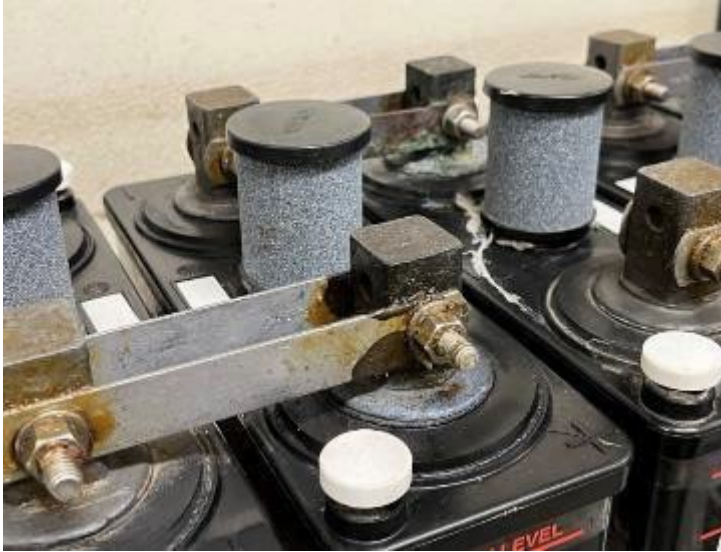
4.1 Battery had Corrosion. Existing LC Tag#129517567.

We agree that a battery had corrosion at Morgan Hill Substation. This nonconformance had a pre-existing LC notification, 129517567, that was established in our system of record, SAP, prior to the field audit. We do not agree that this finding qualifies as a violation of GO 174, Rule 12 since this LC notification was worked in accordance with our maintenance procedures and completed on February 18, 2025.

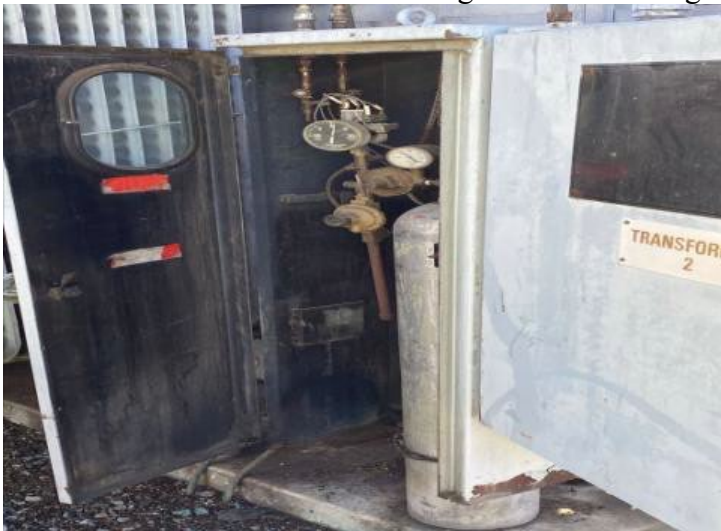
4.2 Transformer Bank 2 Nitrogen Bottle Missing Second Strap. PG&E Fixed in Field.

We agree that the nitrogen bottle in Transformer Bank 2 is missing the second strap at Morgan Hill Substation. This nonconformance had a pre-existing LC notification, 129522611, that was established in our system of record, SAP, prior to the field audit. We do not agree that this finding qualifies as a violation of GO 174, Rule 12 since this LC notification was being worked in accordance with our maintenance procedures. However, this was corrected onsite by PG&E QEW on the day of the field audit.

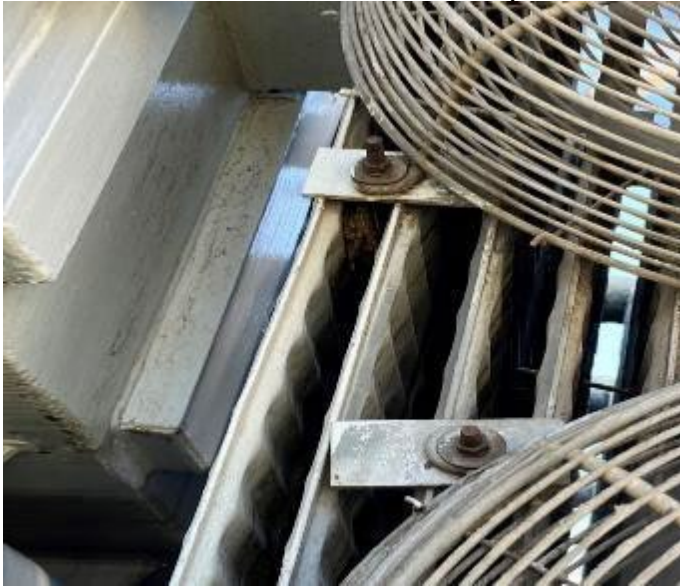
4.3 Transformer Bank 2 Had Wasp Nest. PG&E Fixed in Field.

We agree with the finding of a wasp nest found in Transformer Bank 2 at Morgan Hill Substation. This issue was corrected onsite by PG&E QEW on the day of the field audit.

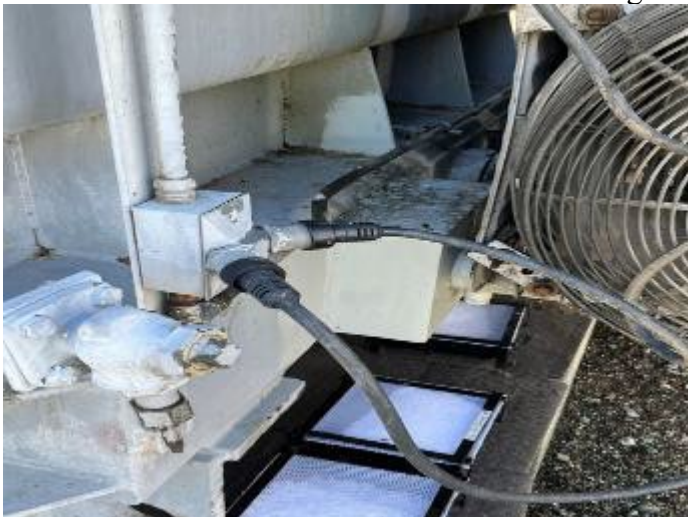
4.4 Transformer Bank 2 Had Oil Leak Mitigation. Existing LC Tag#130774181.

We agree that Transformer Bank 2 had an oil leak at Morgan Hill Substation. This nonconformance has a pre-existing LC notification, 130774181, that was established in our system of record, SAP, prior to the field audit. We do not agree that this finding qualifies as a violation of GO 174, Rule 12 since this LC notification is being worked in accordance with our maintenance procedures and is not past due.

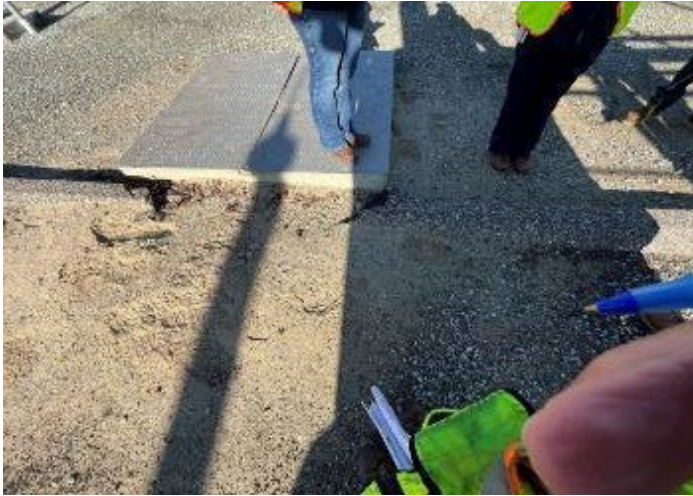
4.5 Circuit Breaker 172 had Oil Protection Berm Breach. Existing LC Tag#124924236.

We agree that Circuit Breaker 172 had an oil protection berm breach at Morgan Hill Substation. This nonconformance has a pre-existing LC notification, 124924236, that was established in our system of record, SAP, prior to the field audit. We do not agree that this finding qualifies as a violation of GO 174, Rule 12 since this LC notification is being worked in accordance with our maintenance procedures and is not past due.

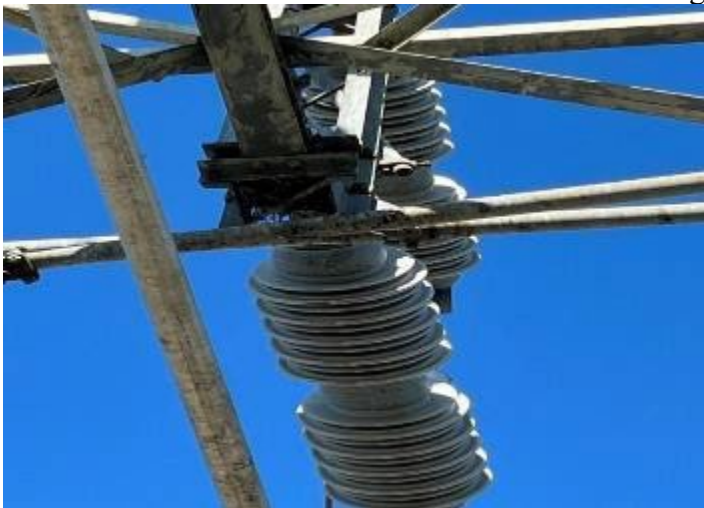
4.6 Circuit Breaker 182 had Birds Nest. Existing LC Tag#129522212.

The cited violation references Circuit Breaker 182, however, this is the 115kV Bus F C-Phase CCVT. Nonetheless, we agree a bird's nest was present on the 115kV Bus F C-Phase CCVT at Morgan Hill Substation. This nonconformance had a pre-existing LC notification, 129522212, that was established in our system of record, SAP, prior to the field audit. We do not agree that this finding qualifies as a violation of GO 174, Rule 12 since this LC notification was being worked in accordance with our maintenance procedures and was not past due. However, the bird's nest was removed on February 8, 2025.

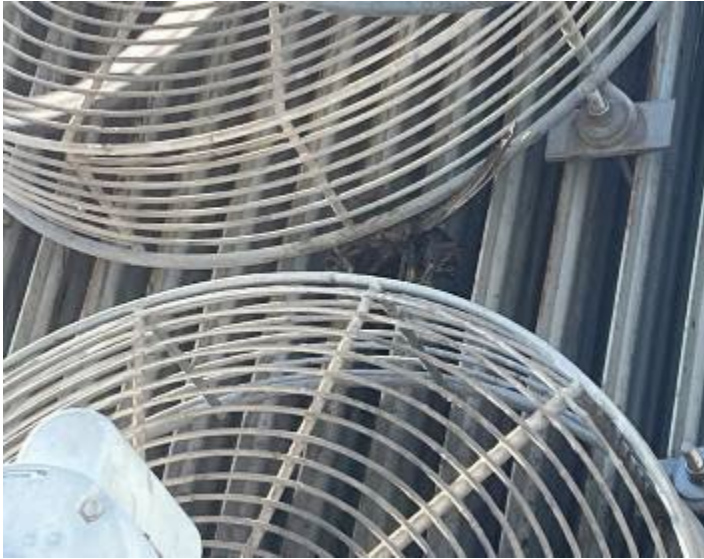
4.7 Transformer Bank 1 Had Bird Nest. PG&E Fixed in Field.

We agree with the finding of a bird's nest on Transformer Bank 1 at Morgan Hill Substation. This issue was corrected onsite by PG&E QEW on the day of the field audit.

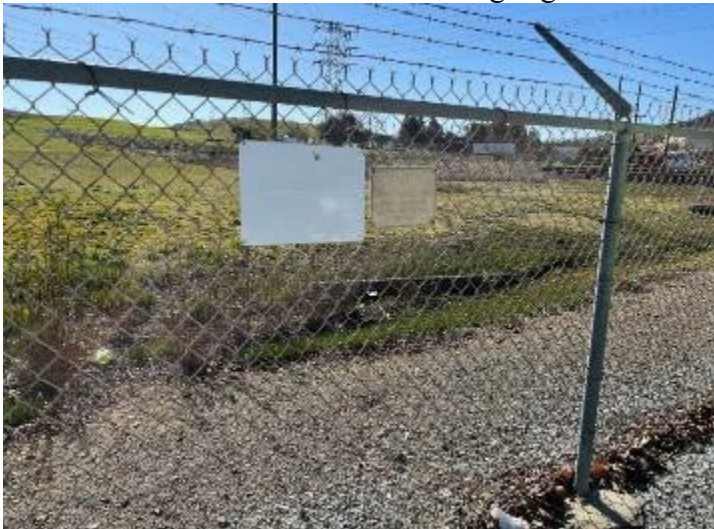
4.8 Perimeter Fence had Warning Signs Posted Inside Fence. Existing LC Tag#130108978.

The cited violation pertains to Llagas Substation, not Morgan Hill Substation. The correct LC notification for the referenced violation is LC notification 129517975. Nonetheless, we agree with the finding that the perimeter fence had warning signs posted inside the fence at Morgan Hill Substation. This nonconformance had a pre-existing LC notification, 129517975, that was established in our system of record, SAP, prior to the field audit. We do not agree that this finding qualifies as a violation of GO 174, Rule 12 since this LC notification was being worked in accordance with our maintenance procedures and was not past due. However, the signage was corrected on February 24, 2025.

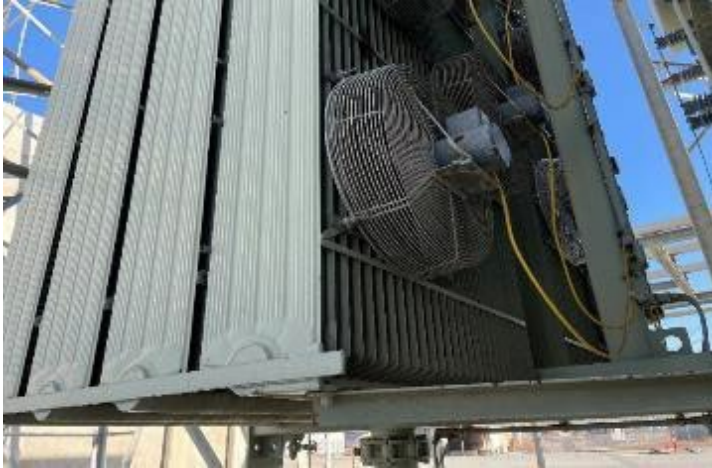
### 5.1 Transformer Bank 11 Phase C Two Fans Not Working Existing LC Tag#128582602.

We agree that two fans on Transformer Bank 11 C-Phase were not working at Metcalf Substation. This nonconformance has a pre-existing LC notification, 128582602, that was established in our system of record, SAP, prior to the field audit. We do not agree that this finding qualifies as a violation of GO 174, Rule 12 since this LC notification is being worked in accordance with our maintenance procedures and is not past due.

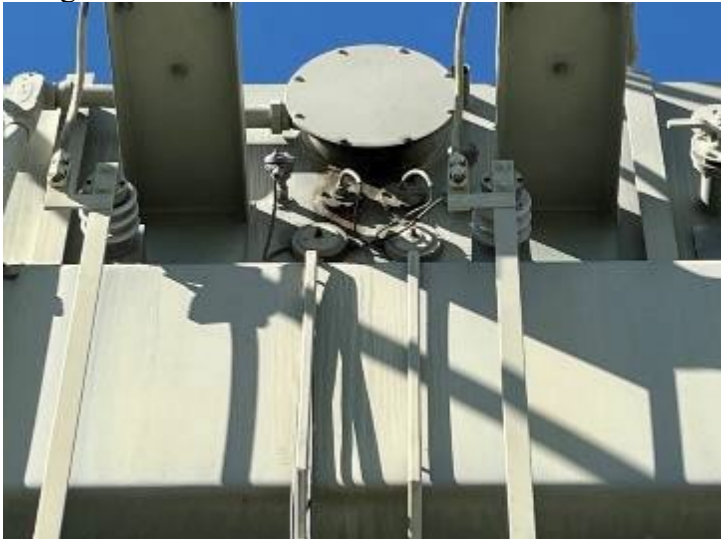
### 5.2 Transformer Bank 11 Phase C Oil Leak Mitigation Upper Manway Existing LC Tag#129715835.

We agree that Transformer Bank 11 C-Phase has an oil leak mitigation on the upper manway at Metcalf Substation. This nonconformance has a pre-existing LC notification, 129715835, that was established in our system of record, SAP, prior to the field audit. We do not agree that this finding qualifies as a violation of GO 174, Rule 12 since this LC notification is being worked in accordance with our maintenance procedures.

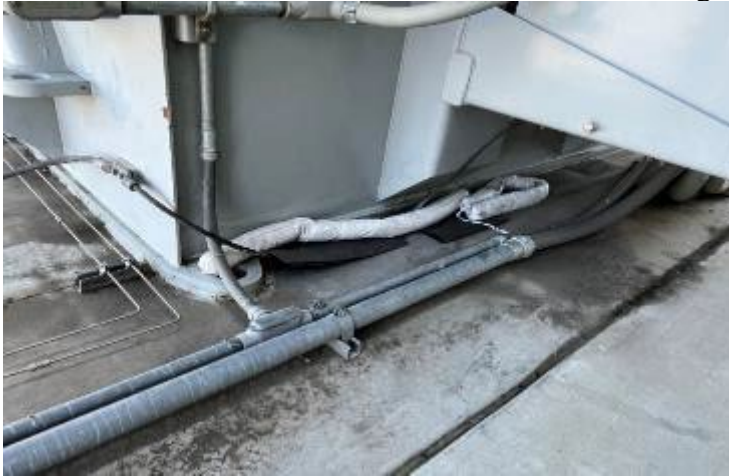
5.3 Transformer Bank 12 Phase A Oil Leak Mitigation Existing LC Tag#130780077.

The cited violation pertains to San Mateo Substation, not Metcalf Substation. The correct LC notification is 130783098 for the referenced violation. Nonetheless, we agree with the finding that Transformer Bank 12 A-Phase has an oil leak mitigation at Metcalf Substation. This nonconformance had a pre-existing LC notification, 130783098, that was established in our system of record, SAP, prior to the field audit. We do not agree that this finding qualifies as a violation of GO 174, Rule 12 since this LC notification was being worked in accordance with our maintenance procedures and was not past due. However, this work was completed on April 23, 2025.

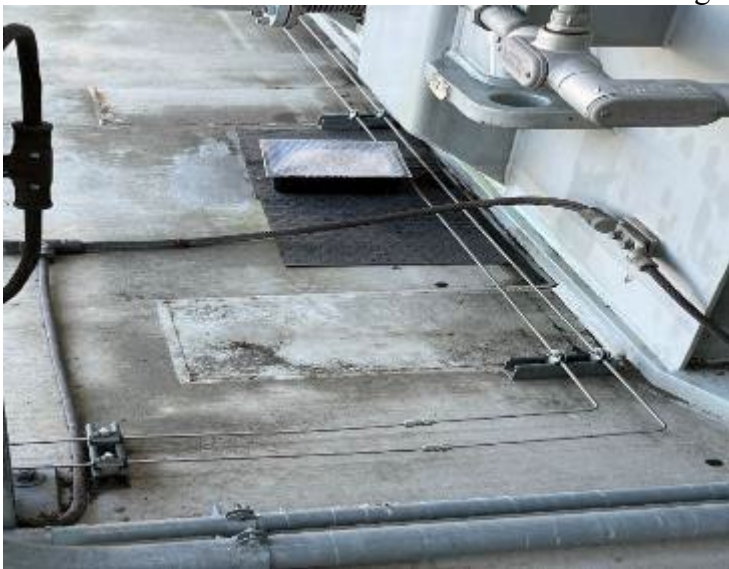
5.4 Transformer Bank 12 Phase B Oil Leak Mitigation Existing LC Tag#130783098.

We agree with the finding that Transformer Bank 12 B-Phase B has an oil leak at Metcalf Substation. This nonconformance had a pre-existing LC notification, 130783098, that was established in our system of record, SAP, prior to the field audit. We do not agree that this finding qualifies as a violation of GO 174, Rule 12 since this LC notification was being worked in accordance with our maintenance procedures and was not past due and was completed on April 23, 2025.

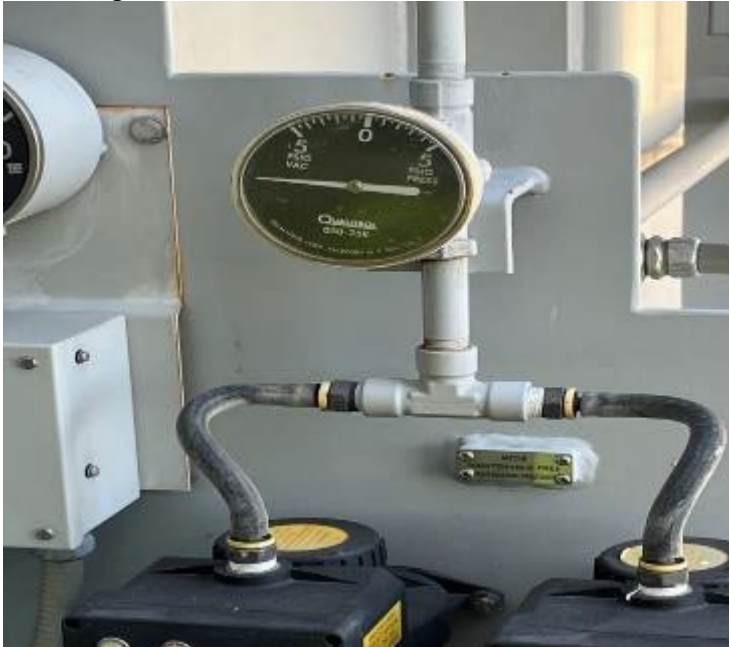
5.5 Transformer Bank 12 Phase B Conservator Tank Pressure Gauge Malfunction. Existing LC Tag#129692396 PG&E Fixed in Field.

We agree with the finding that Transformer Bank 12 B-Phase conservator tank pressure gauge had a malfunction at Metcalf Substation. This nonconformance had a pre-existing LC notification, 129692396, that was established in our system of record, SAP, prior to the field audit. We do not agree that this finding qualifies as a violation of GO 174, Rule 12 since this LC notification was scheduled to be worked in accordance with our maintenance procedures and was corrected onsite by PG&E QEW on the day of the field audit.

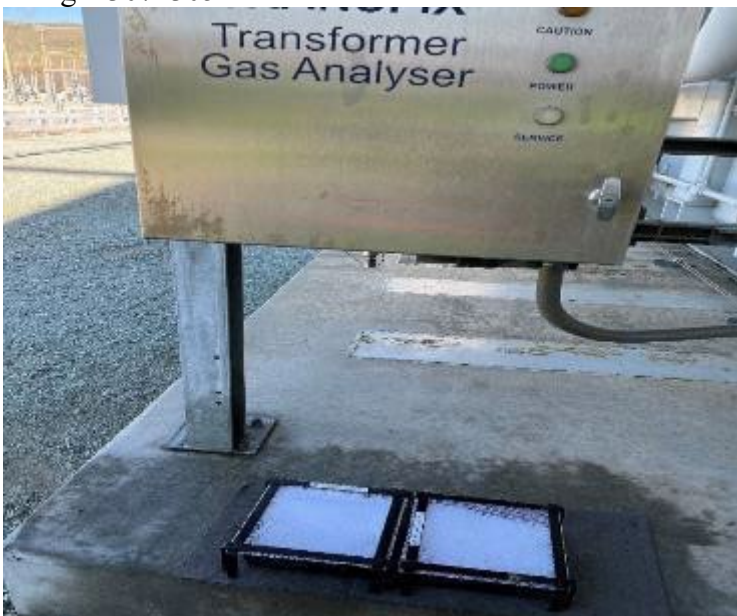
5.6 Transformer Bank 13 Phase B Oil Leak Mitigation Kelman Gas Analyzer Existing LC Tag#130713051.

We agree that Transformer Bank 13 B-Phase had an oil leak mitigation on the Kelman gas analyzer at Metcalf Substation. This nonconformance had a pre-existing LC notification, 130713051, that was established in our system of record, SAP, prior to the field audit. We do not agree that this finding qualifies as a violation of GO 174, Rule 12 since this LC notification was being worked on in accordance with our maintenance procedures and was not past due. This LC notification was completed on April 23, 2025.

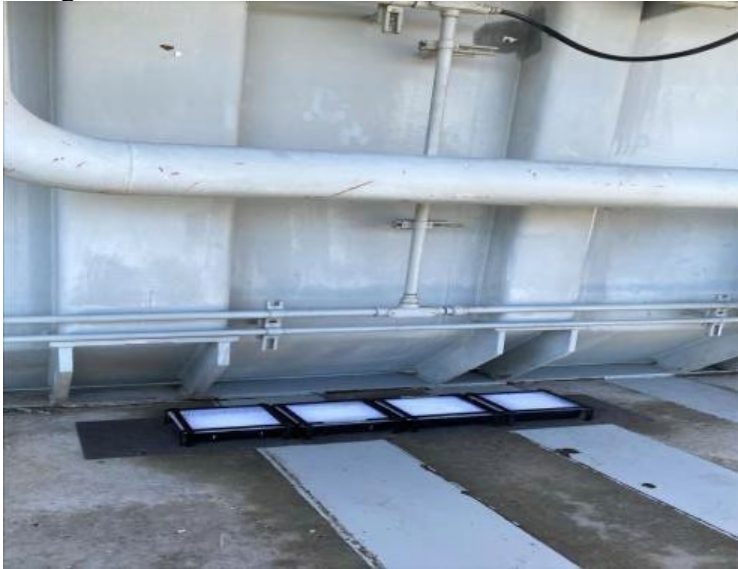
5.7 Transformer Bank 13 Phase B Oil Leak Mitigation Pump Flange Existing LC  
Tag#130783076.

We agree that Transformer Bank 13 B-Phase had an oil leak at Metcalf Substation. This nonconformance had a pre-existing notification, 130783076, that was established in our system of record SAP, prior to the field audit. We do not agree that this finding qualifies as a violation of GO 174, Rule 12 since this LC notification was worked in accordance with our maintenance procedures and was completed on April 23, 2025.

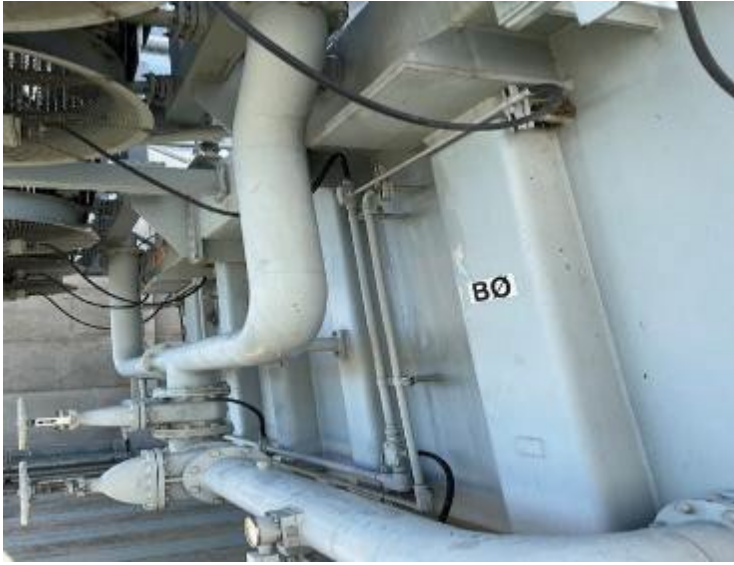
5.8 Transformer Bank 13 Phase B Birds Nest Radiator Fan Power Cord.

We agree that a bird's nest was found near Transformer Bank 13 B-Phase radiator fan power cord at Metcalf Substation. However, we do not agree that this finding qualifies as a violation of GO 174, Rule 12 as the location of this bird's nest does not pose a safety or reliability risk.

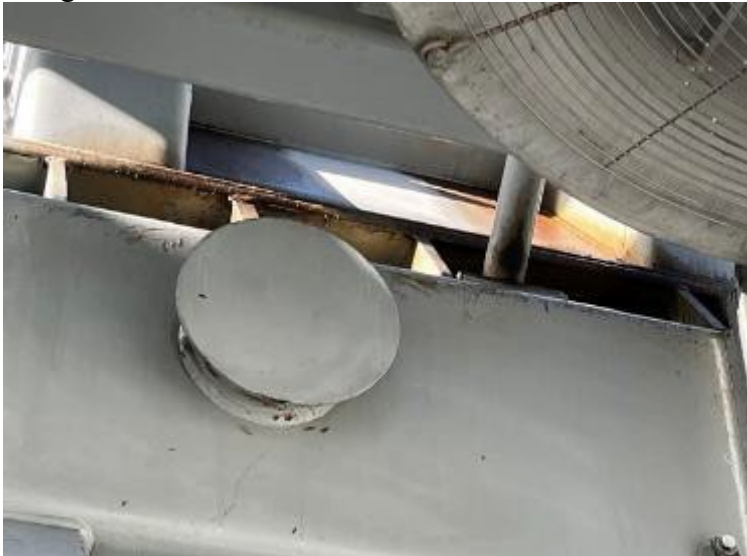
5.9 Transformer Bank 13 Phase C Oil Leak Mitigation Upper Flange Existing LC Tag#130783071.

The previously provided LC notification, 130783071, was cancelled as it was a duplicate of LC notification 130783097. We agree that Transformer Bank 13 C-Phase had an oil leak on the upper flange at Metcalf Substation. This nonconformance had a pre-existing LC notification, 130783097, that was established in our system of record, SAP, prior to the field audit. We do not agree that this finding qualifies as a violation of GO 174, Rule 12 since this LC notification was being worked in accordance with our maintenance procedures and not past due. This LC notification was completed on April 23, 2025.

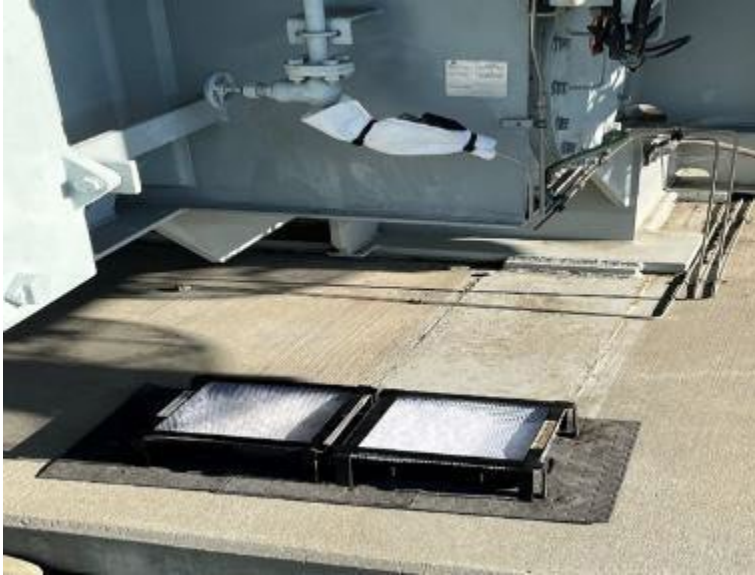
5.10 Transformer Bank 4 Oil Leak Mitigation Existing LC Tag#130116644.

We agree that Transformer Bank 4 has an oil leak mitigation at Metcalf Substation. This nonconformance has a pre-existing LC notification, 130116644, that was established in our system of record, SAP, prior to the field audit. We do not agree that this finding qualifies as a violation of GO 174, Rule 12 since this LC notification is being worked in accordance with our maintenance procedures.

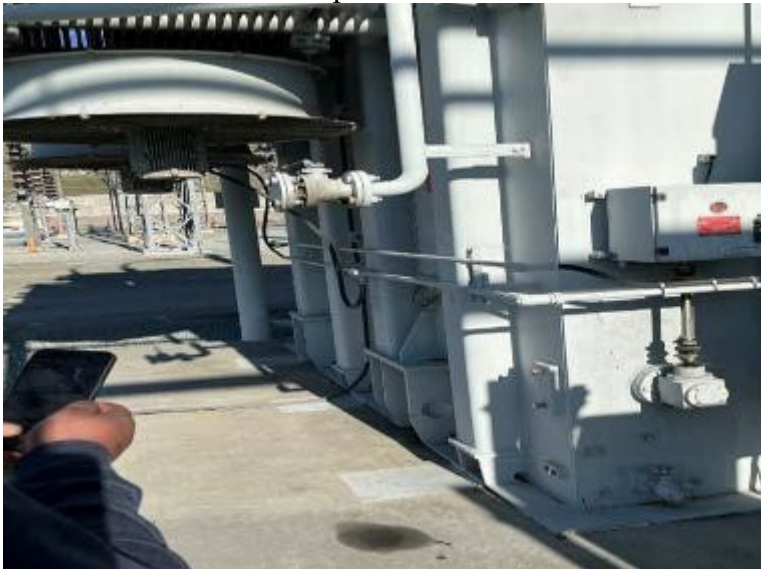
5.11 Transfer Bank Spare Oil Leak at Oil Filter Conservator Connection. PG&E Fixed in Field.

We agree with the finding of Transformer Bank Spare oil leak at the oil filter conservator connection at Metcalf Substation. This issue was corrected onsite by PG&E QEW on the day of the field audit.

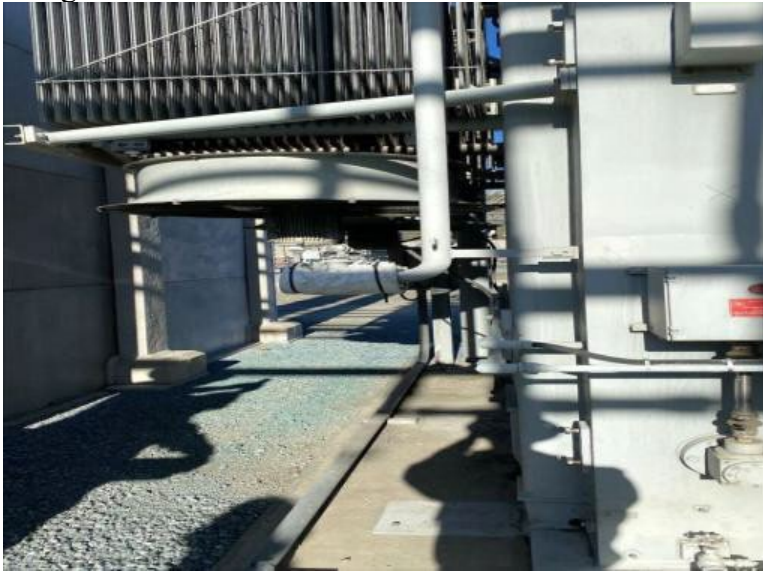
5.12 Transfer Bank 1A Oil Leak Mitigation at Conservator Drain Valve Existing LC Tag#130713052.

We agree that Transformer Bank 1A has an oil leak mitigation at the conservator drain at Metcalf Substation. This nonconformance has a pre-existing LC notification, 130713052, that was established in our system of record, SAP, prior to the field audit. We do not agree that this finding qualifies as a violation of GO 174, Rule 12 since this LC notification is being worked in accordance with our maintenance procedures and is not past due.

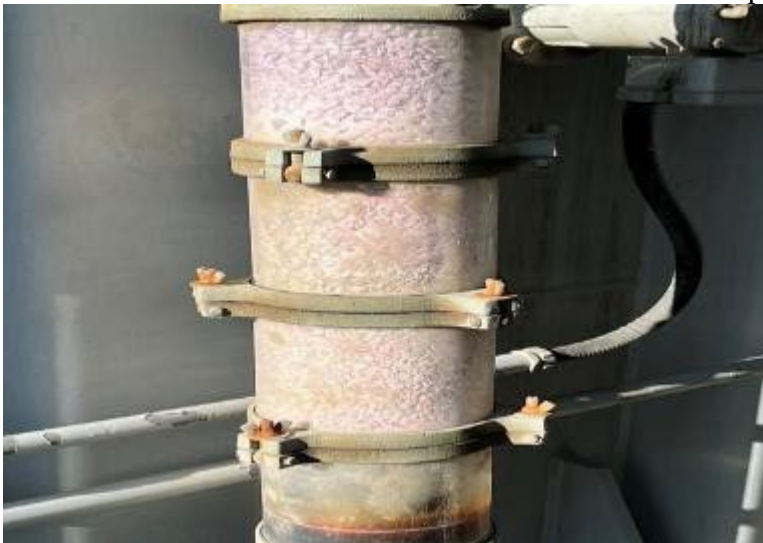
5.13 Transformer Bank 2 Phase C Desiccant Need Replacement.

We agree that Transformer Bank 2 C-Phase had a desiccant that needed replacement at Metcalf Substation. This nonconformance had a pre-existing LC notification, 130535711, that was established in our system of record, SAP, prior to the field audit. We do not agree that this finding qualifies as a violation of GO 174, Rule 12 since this LC notification was being worked in accordance with our maintenance procedures and completed on March 19, 2025.

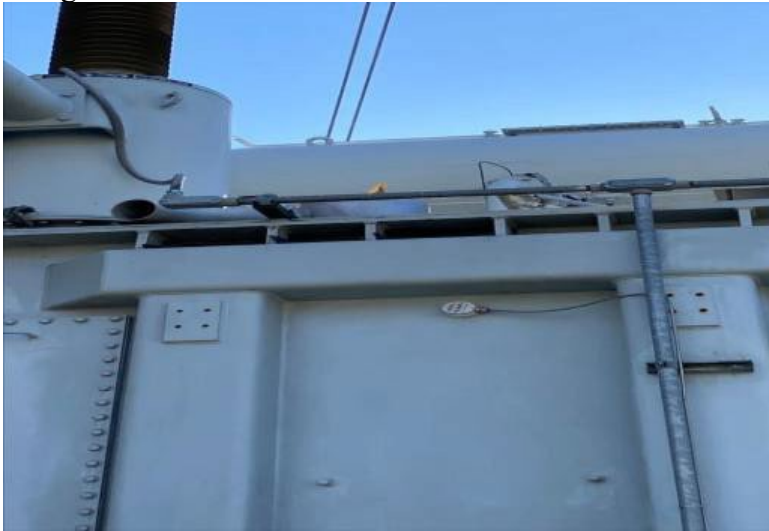
5.14 Transformer Bank 2 Phase C Oil Leak Mitigation at Top Flange Existing LC Tag#130116641.

We agree that Transformer Bank 2 C-Phase has an oil leak mitigation at top flange at Metcalf Substation. This nonconformance has a pre-existing LC notification, 130116641, that was established in our system of record, SAP, prior to the field audit. We do not agree that this finding qualifies as a violation of GO 174, Rule 12 since this LC notification is being worked in accordance with our maintenance procedures and is not past due.

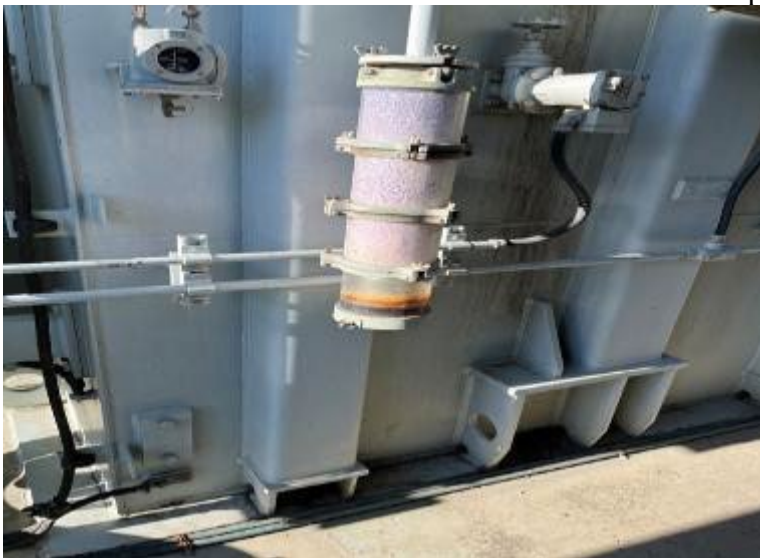
5.15 Transformer Bank 2 Phase B Desiccant Need Replacement.

We agree that Transformer Bank 2 B-Phase had a desiccant that needed replacement at Metcalf Substation. This nonconformance had a pre-existing LC notification, 130535711, that was established in our system of record, SAP, prior to the field audit. We do not agree that this finding qualifies as a violation of GO 174, Rule 12 since this LC notification was worked in accordance with our maintenance procedures and completed on March 19, 2025.

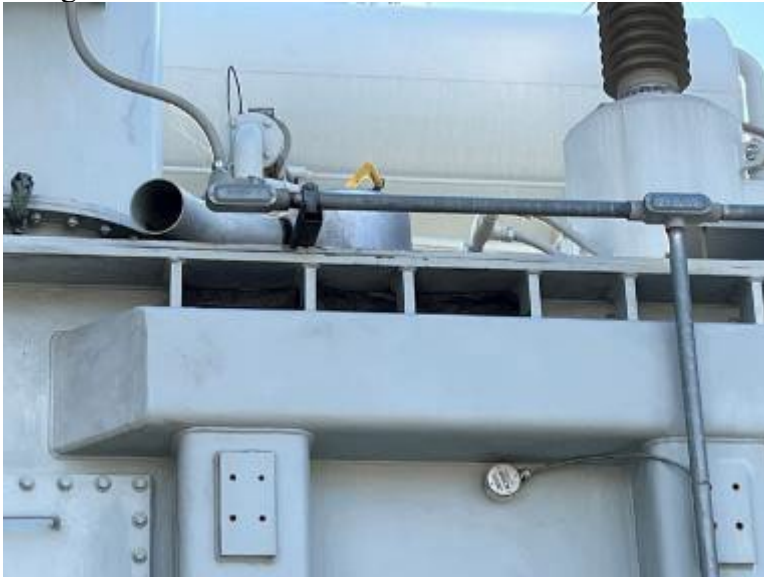
5.16 Transformer Bank 2 Phase B Oil Leak Mitigation at Top Flange Existing LC Tag#130116640.

We agree that Transformer Bank 2 B-Phase has an oil leak at top flange at Metcalf Substation. This nonconformance has a pre-existing LC notification, 130116640, that was established in our system of record, SAP, prior to the field audit. We do not agree that this finding qualifies as a violation of GO 174, Rule 12 since this LC notification is being worked in accordance with our maintenance procedures and is not past due.

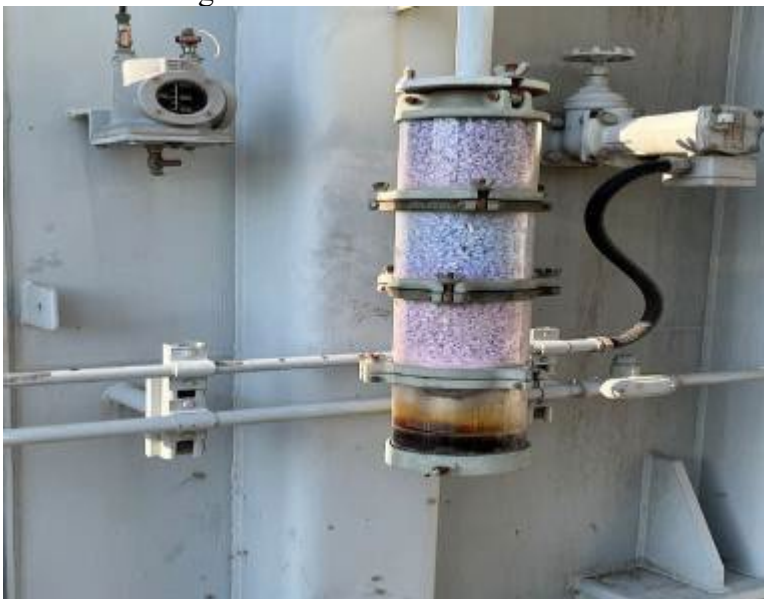
5.17 Transformer Bank 2 Phase A Desiccant Need Replacement. Existing Tag#130535711 Will be Changed to Also Cover Banks 2B and 2C.

We agree that Transformer Bank 2 A-Phase had a desiccant that needed replacement at Metcalf Substation. This nonconformance had a pre-existing LC notification, 130535711, that was established in

our system of record, SAP, prior to the field audit. We do not agree that this finding qualifies as a violation of GO 174, Rule 12 since this LC notification was worked in accordance with our maintenance procedures and the desiccant for all 3 phases was changed out on March 19, 2025.

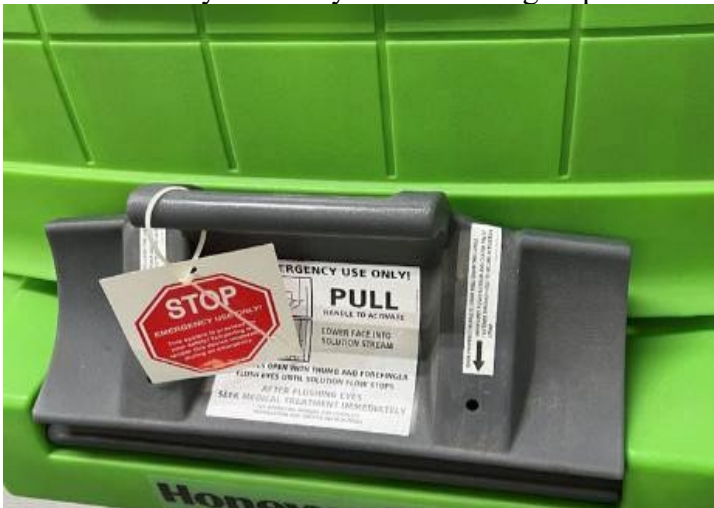
5.19 Battery Room Eyewash Missing Expiration Date Existing LC Tag#129670378.

We agree the battery room eyewash is missing an expiration date at Metcalf Substation. This nonconformance had a pre-existing LC notification, 129670378, that was established in our system of record, SAP, prior to the field audit. We do not agree that this finding qualifies as a violation of GO 174, Rule 12 since this LC notification was worked in accordance with our maintenance procedures and completed on March 6, 2025.

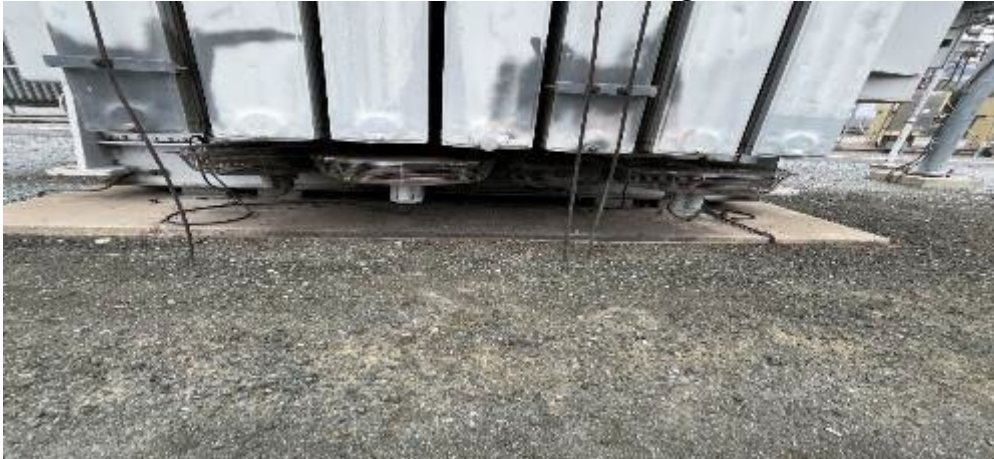
**6.3 Transformer Bank 2 Two Fans Not Working**

We agree with the finding that Transformer Bank 2 has two fans that are not working at El Patio Substation. We created LC notification 130804601, added it to the workplan and will be completed based on current work prioritization and material availability.

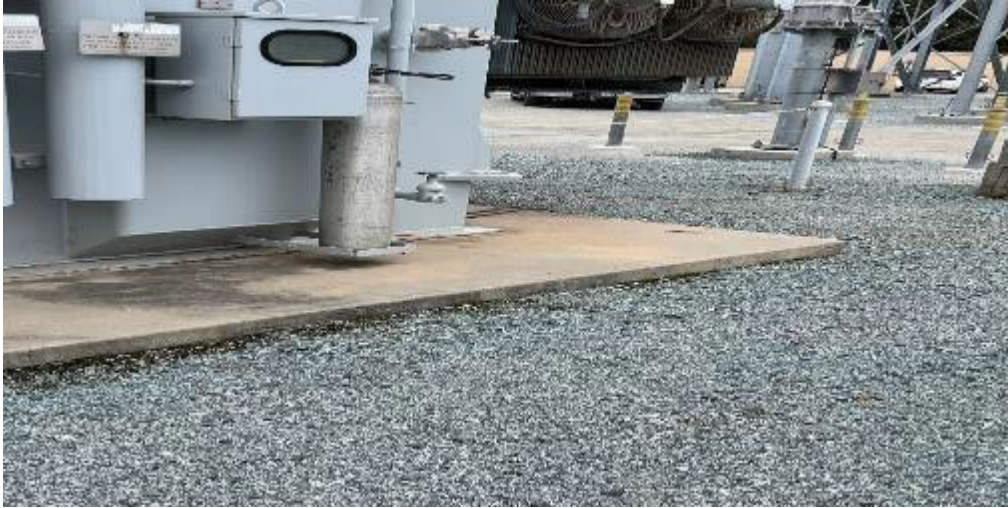
### 7.1 Transformer Bank 5 Nitrogen Bottle Needs 2nd Strap. PG&E Fixed in Field.

We agree with the finding of Transformer Bank 5 Nitrogen Bottle needing a second strap at Hicks Substation. This issue was corrected onsite by PG&E QEW on the day of the field audit.

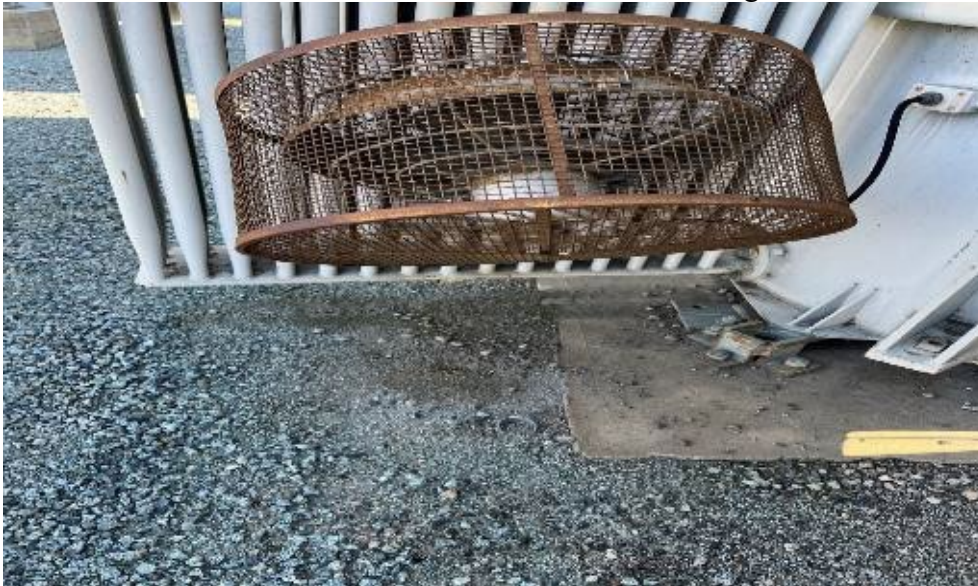
9.2 Transformer Bank 1 Phase B 3 Fans Not Working Left Side

We agree with the finding that 3 fans on the left side of Transformer Bank 1 B-Phase were not working at Evergreen Substation. We created LC notification 130804663, added it to the workplan and it was completed on March 30, 2025.

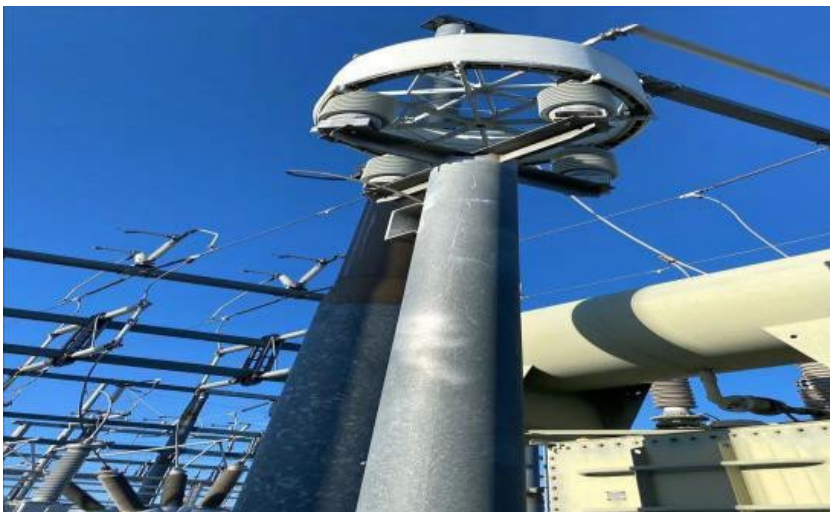
9.10 Transformer Banks 2 and 3 Neutral Reactor Missing Label. As a best practice, it should have labels to be consistent with Edendale Substation which has LC Tag #129619844.

We agree that Transformer Banks 2 and 3 have a neutral reactor label missing at Evergreen Substation. We created LC notifications 130821828 and 130821827, added them to the workplan and will be

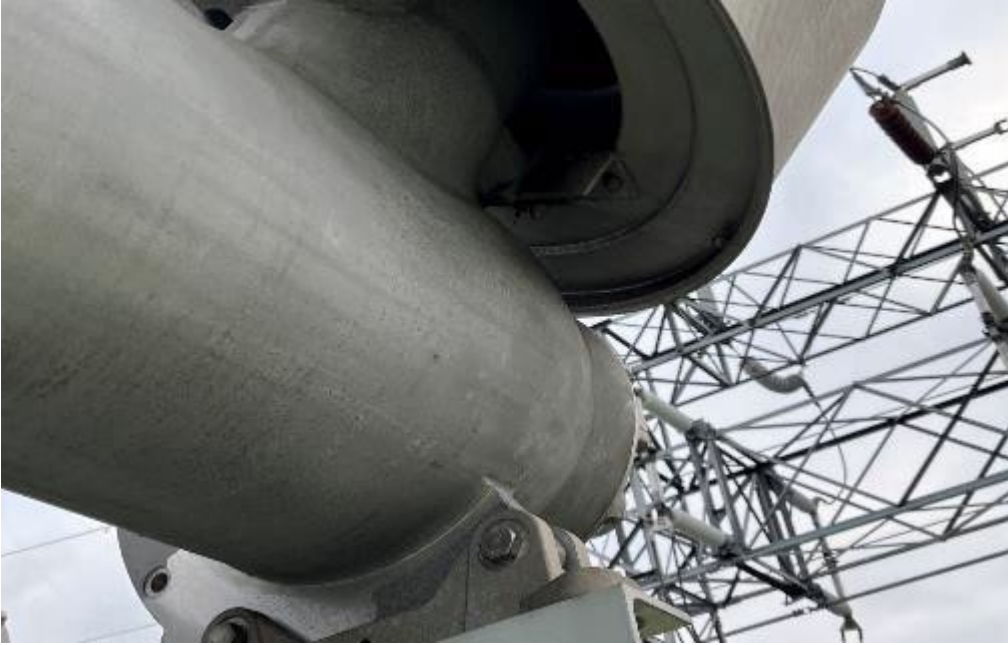
### **10.1 Bird Nest at Circuit Breaker 332. PG&E Fixed in Field.**

We agree with the finding of a bird's nest present on circuit breaker 332 at San Jose A Substation. This issue was corrected onsite by PG&E QEW on the day of the field audit.

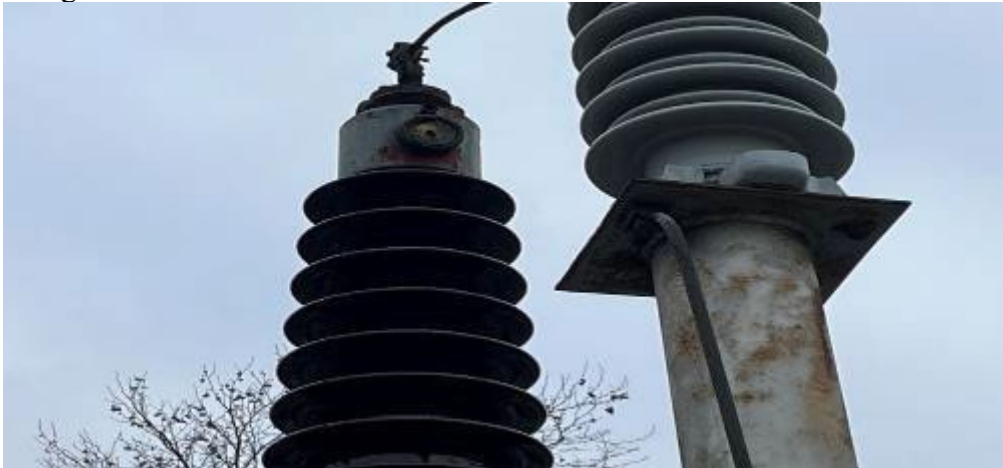
10.5 Transformer Bank 1 Cracked Glass Bushing Oil Level Gauge. Existing LC Tag#129389739.

We agree that Transformer Bank 1 has a cracked glass on the bushing oil level gauge at San Jose A Substation. This nonconformance has a pre-existing LC notification, 129389739, that was established in our system of record, SAP, prior to the field audit. We do not agree that this finding qualifies as a violation of GO 174, Rule 12 since this LC notification is being worked in accordance with our maintenance procedures and is not past due.

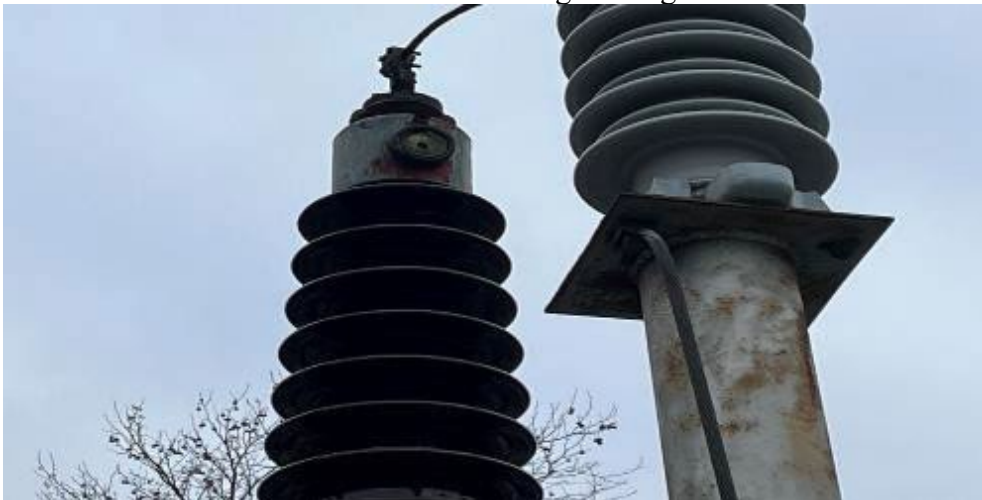
10.6 Transformer Bank 1 Rust. Existing LC Tag#129389229.

We agree that Transformer Bank 1 has rust at San Jose A Substation. This nonconformance has a pre-existing LC notification, 129389229, that was established in our system of record, SAP, prior to the field audit. We do not agree that this finding qualifies as a violation of GO 174, Rule 12 since this LC notification is being worked in accordance with our maintenance procedures and is not past due.
