**CPUC SUBSTATION AUDIT FINDINGS REPORT RESPONSE**  
**PG&E Cupertino Headquarters**  
**January 27 – 31, 2025**

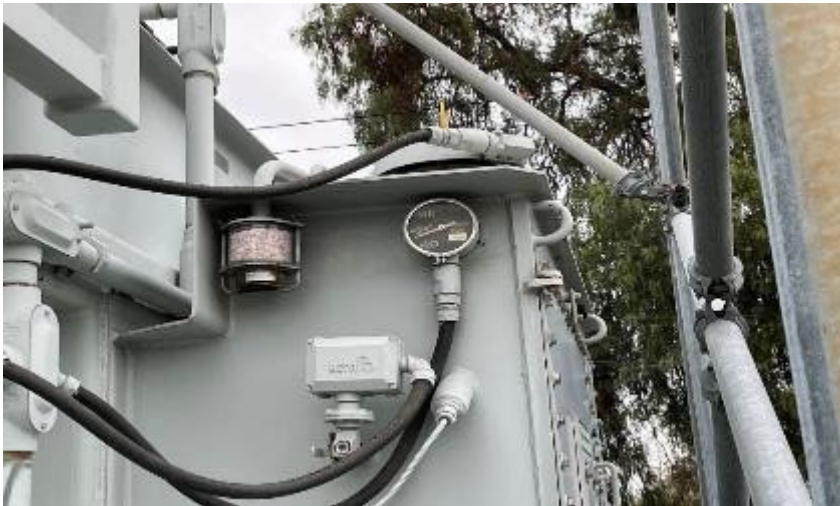
10.8 Transformer Bank 4 Desiccant Near End of Life Need Replacement.

We agree with the finding that Transformer Bank 4 has a desiccant needing replacement at San Jose A Substation. We created notification LC 131181250, added it to the workplan and will be completed based on current work prioritization and material availability.

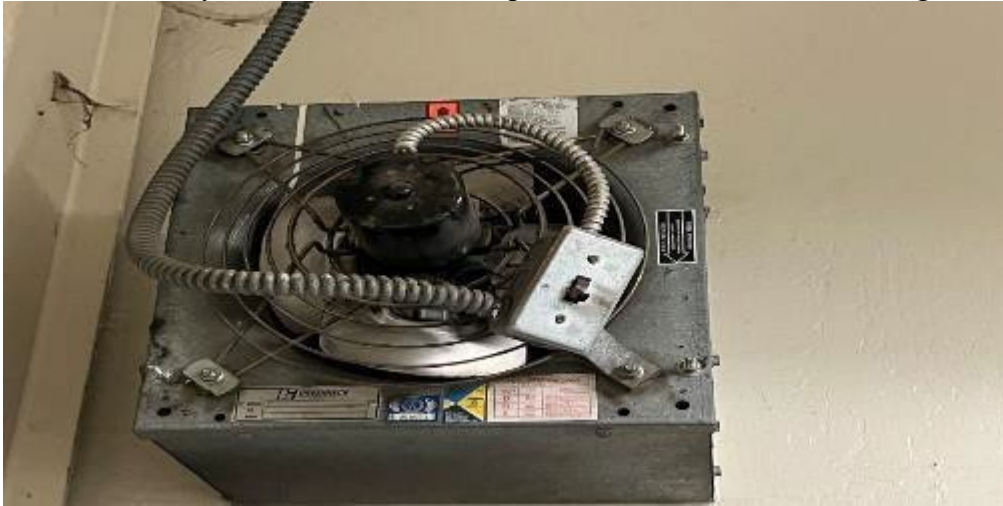
11.4 Battery Room Fan Was Not Operational. Created New LC Tag#130806140.

We agree that the battery room fan was not operational at San Jose B Substation. We created LC notification 130806140, added it to the workplan, and completed it on February 21, 2025.

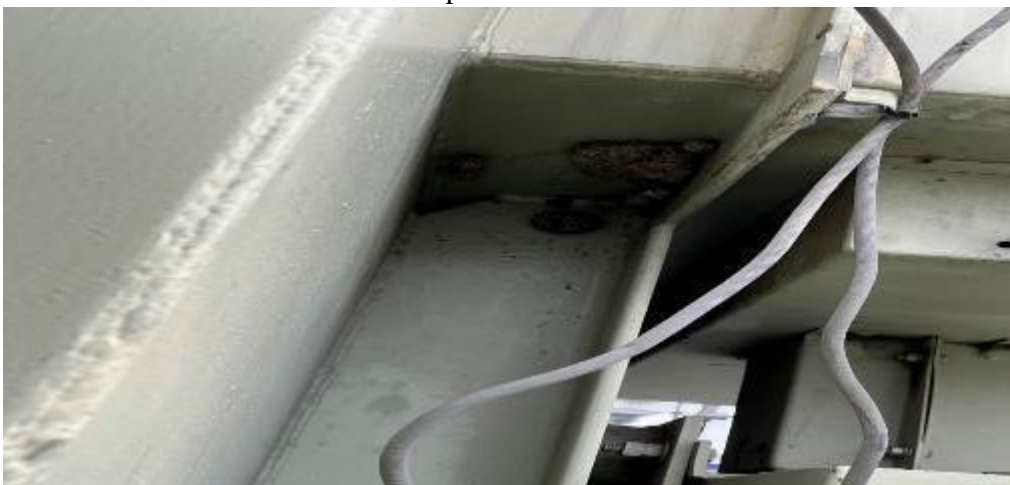
11.5 Transformer Bank 1 Wasp Nest. PG&E Fixed in Field.

We agree with the finding of a wasp nest on Transformer Bank 1 at San Jose B Substation. This issue was corrected onsite by PG&E QEW on the day of the field audit.

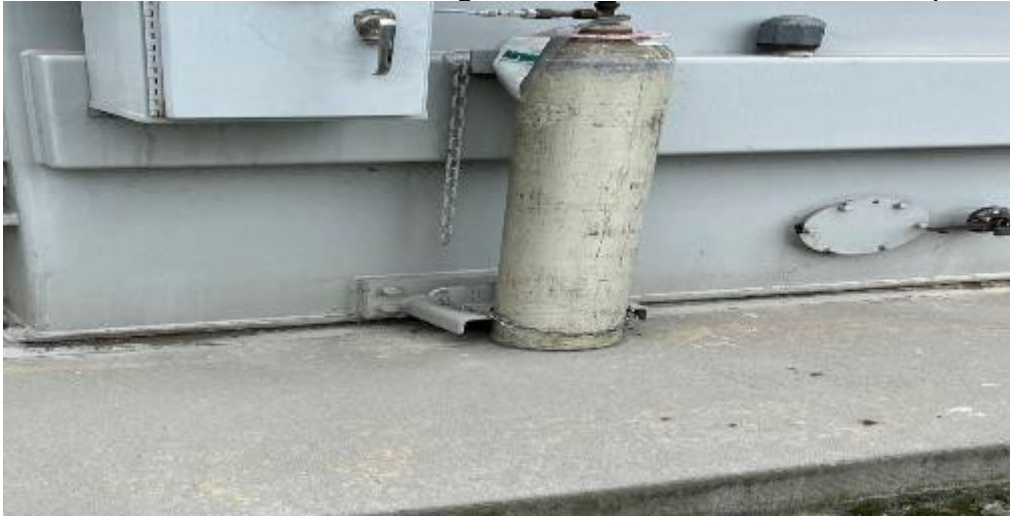
11.6 Transformer Bank 2 Nitrogen Bottle Not Secured With 2<sup>nd</sup> Strap. PG&E Fixed in Field.

We agree with the finding that the nitrogen bottle on Transformer Bank 2 was not secured with a second strap at San Jose B Substation. This issue was corrected onsite by PG&E QEW on the day of the field audit.

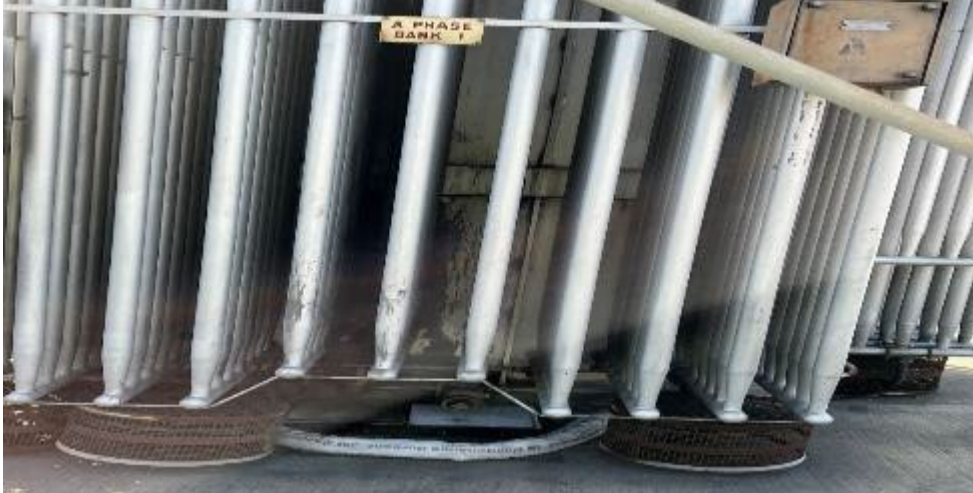
12.5 Transformer Bank 1 Phase A Oil Leak Mitigation. Existing LC Tag#130732657

We agree that Transformer Bank 1 A-Phase has an oil leak at Mabury Substation. This nonconformance has a pre-existing LC notification, 130732657, that was established in our system of record, SAP, prior to the field audit. We do not agree that this finding qualifies as a violation of GO 174, Rule 12 since this LC notification is being worked in accordance with our maintenance procedures and is not past due.

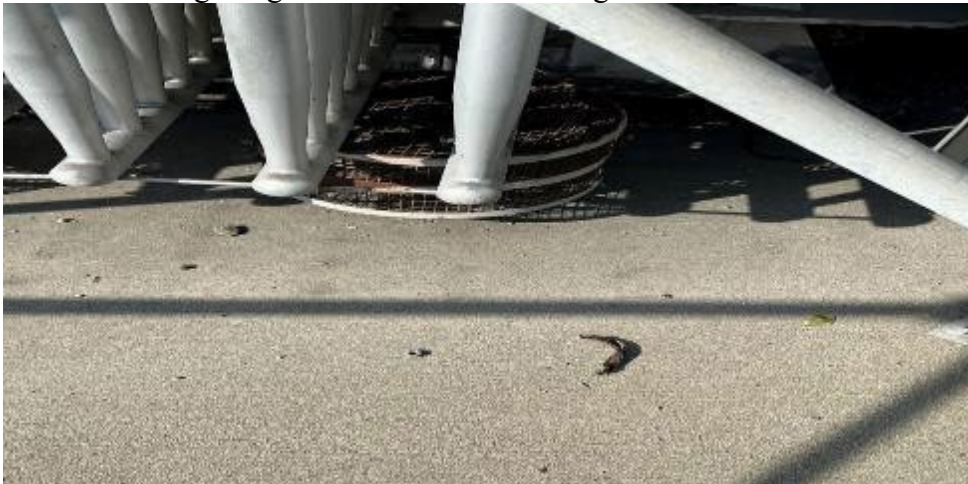
12.6 Voltage Regulator 1 Fan Not Working.

We agree with the finding that the Voltage Regulator 1 Fan was not working at Mabury Substation. We created LC notification 130807635 and, added it to the workplan, and it was completed on April 12, 2025.

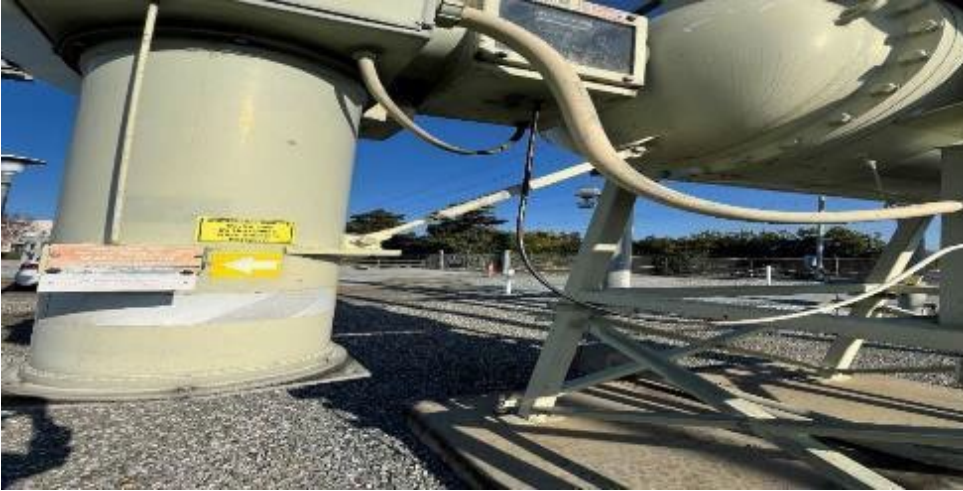
#### 13.1 Circuit Breaker 332 Oil Leak Hydraulic Line to Counter.

We agree that Circuit Breaker 332 has a hydraulic line oil leak at Trimble Substation. We created LC notification 131062030, added it to the workplan, and it will be completed based on current work prioritization and material availability.

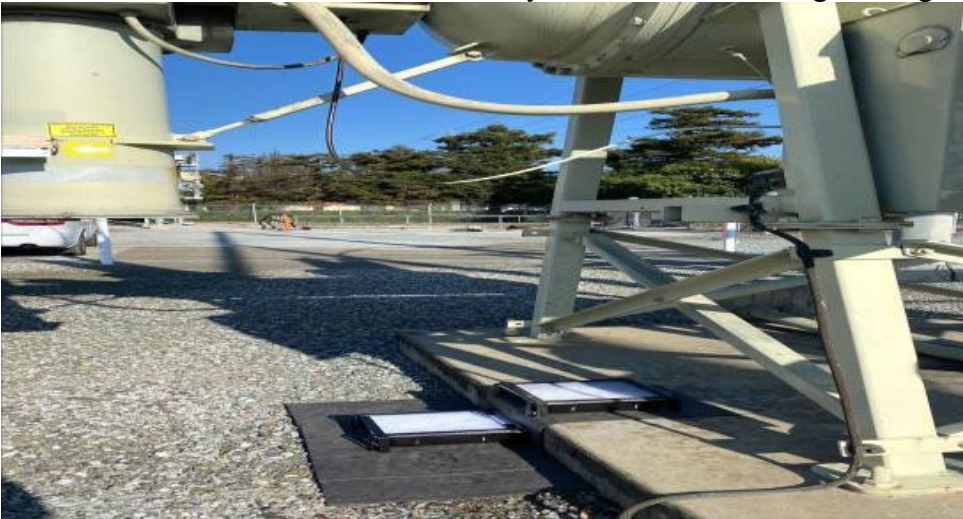
#### 13.2 Circuit Breaker 312 Oil Leak Hydraulic Line. Existing LC Tag#130712304.

The cited violation references Circuit Breaker 312, but the nonconformance was observed at Circuit Breaker 322. Nonetheless, we agree that Circuit Breaker 322 has a hydraulic line oil leak at Trimble Substation. This nonconformance has a pre-existing LC notification, 130712304, that was established in our system of record, SAP, prior to the field audit. We do not agree that this finding qualifies as a violation of GO 174, Rule 12 since this LC notification is being worked in accordance with our maintenance procedures and is not past due.

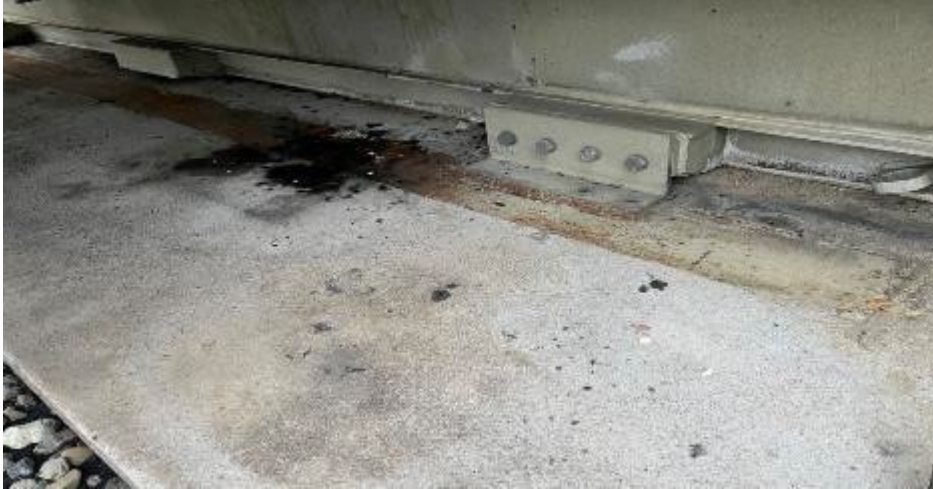
15.2 Transformer Bank 1 Oil Leak Mitigation. Existing LC Tag#124733582.

The initial LC notification that we provided ESRB was incorrect. The correct LC notification is 130864093. We agree that Transformer Bank 1 has an oil leak at Britton Substation. We created LC notification 130864093, added it to the workplan, and it will be completed based on current work prioritization and material availability.

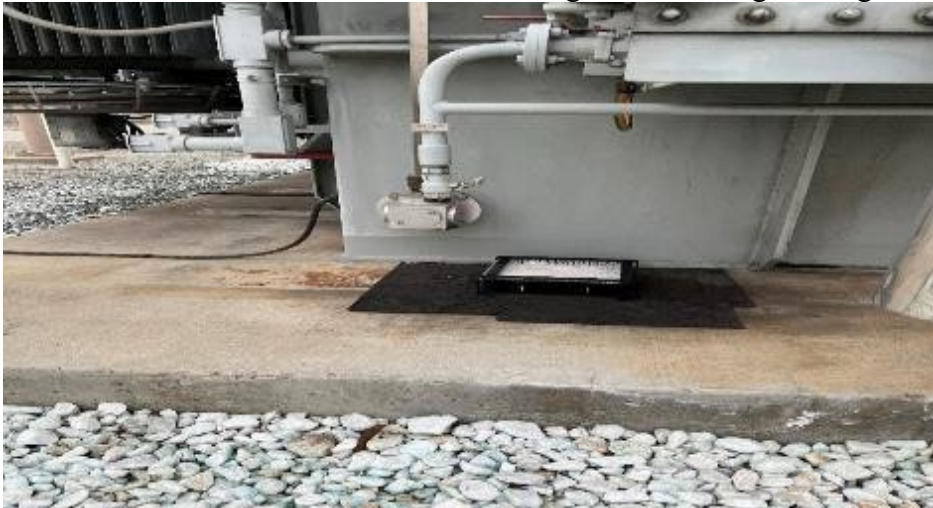
15.3 Transformer Bank 2 Oil Leak Mitigation. Existing LC Tag#130732362.

We agree that Transformer Bank 2 had an oil leak at Britton Substation. This nonconformance had a pre-existing LC notification, 130732362, that was established in our system of record, SAP, prior to the field audit. We do not agree that this finding qualifies as a violation of GO 174, Rule 12 since this LC notification was worked on in accordance with our maintenance procedures and completed on March 10, 2025.

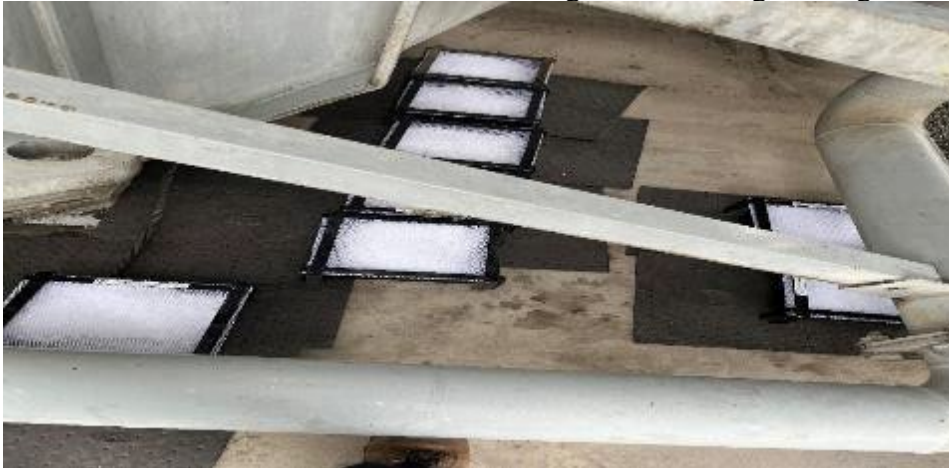
16.4 Transformer Bank 2 Oil Leak Mitigation. Existing LC Tag#130777293.

We agree that Transformer Bank 2 has an oil leak at Monta Vista Substation. This nonconformance has a pre-existing LC notification, 130777293, that was established in our system of record, SAP, prior to the

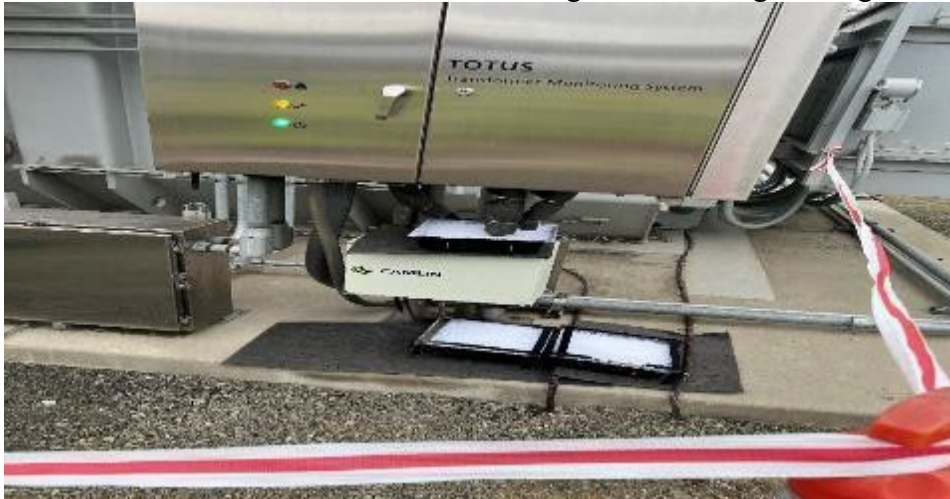
16.5 Transformer Bank 4 Oil Leak Mitigation. Existing LC Tag#130777294.

We agree that Transformer Bank 4 has an oil leak at Monta Vista Substation. This nonconformance has a pre-existing LC notification, 130777294, that was established in our system of record, SAP, prior to the field audit. We do not agree that this finding qualifies as a violation of GO 174, Rule 12 since this LC notification is being worked in accordance with our maintenance procedures and is not past due.
