Incident Investigation Report
Reference Documents
SED Incident E20211223-01
(Brewer Fire)

ELECTRIC INCIDENT REPORT FORM

PG&E Reference Number: EI210707A

Grass Valley – Property Damage

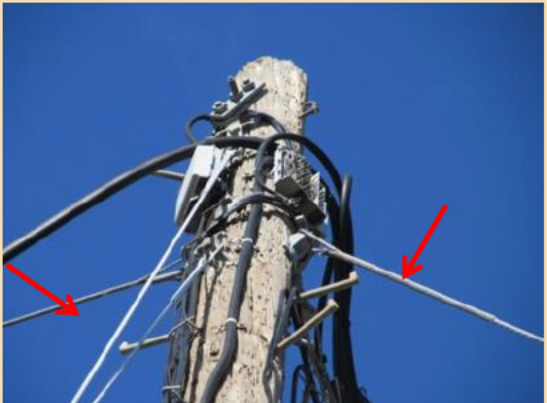
<p>At this Location: Obstructed climbing space, access via bucket truck from street below. Also, look for clearance issues between communications facilities and the PG&E down guys.</p> <hr/> <p>Perform Minor Work: No</p> <hr/> <p>Write Third Party Notification: No</p> <hr/> <p>Write EC Form: No</p>

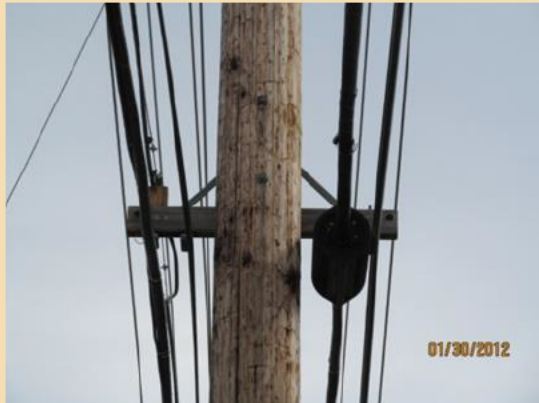
<p>At this Location: Climbing space obstruction by communication facilities on pole with equipment. Communication messengers are too close. No bucket truck access.</p> <hr/> <p>Perform Minor Work: No</p> <hr/> <p>Write Third Party Notification: Yes</p> <hr/> <p>Write EC Form: No</p>

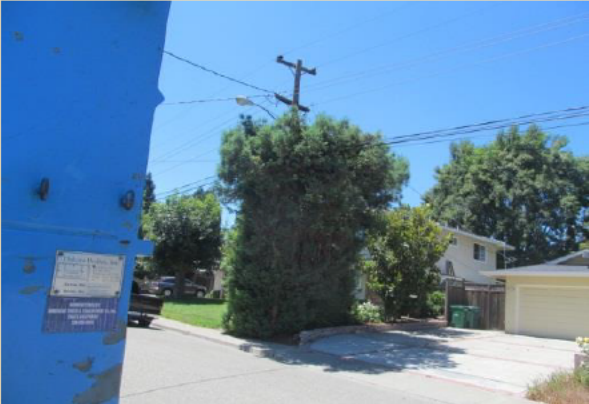
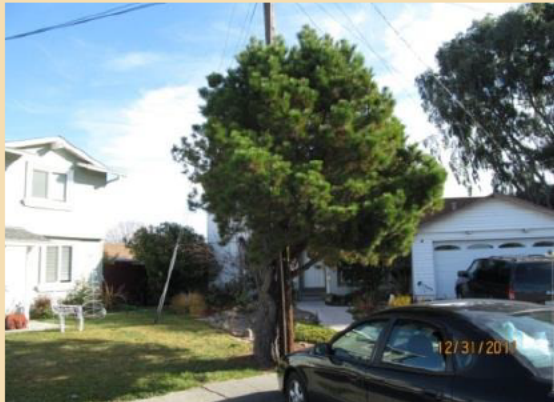
OBSTRUCTED CLIMBING SPACE	CLIMBING SPACE OBSTRUCTED

<p>At this Location: Obstructed climbing space. Inspector cannot see enough of the pole to complete Inspection (heavy vegetation, cannot see through) No equipment on pole. The only reason to address is to complete the inspection.</p>	<p>At this Location: Climbing space obstruction, able to perform inspection, no equipment on pole (able to see guys, able to see up the pole under tree)</p>
<p>Perform Minor Work: No</p>	<p>Perform Minor Work: No</p>
<p>Write Third-Party Notification: No, only need clearing to perform inspection</p>	<p>Write Third Party: No</p>
<p>Write EC Form: Yes</p> <ul style="list-style-type: none"> • FDA=OH Facility / Limited Access/Obstruct / Inspect (Primary) • FDA=OH Facility / Limited Access/Obstruct / Remove • Priority "B", 0-3 months depending upon exposure; must complete before CPUC due date for map 	<p>Write EC: No, not compelling</p>

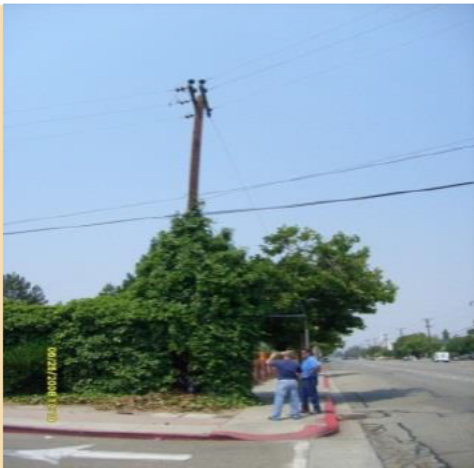
POLE WITH VEGETATION

At this Location: 360° pole inspection not possible

- FDA= OH Facility / Limited Access/Obstruct / Inspect (Primary)
- FDA=OH Facility / Limited Access/Obstruct / Remove
- Priority "B", 0-3 months depending upon exposure; must complete before CPUC due date for map

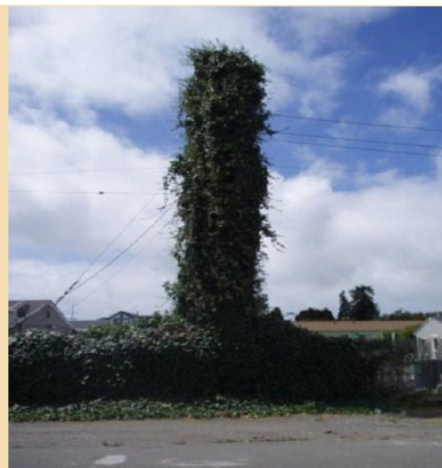
IVY COVERED POLE

At this Location: 360° pole inspection not possible

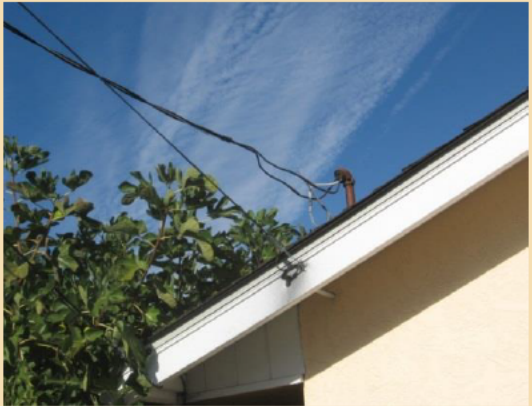
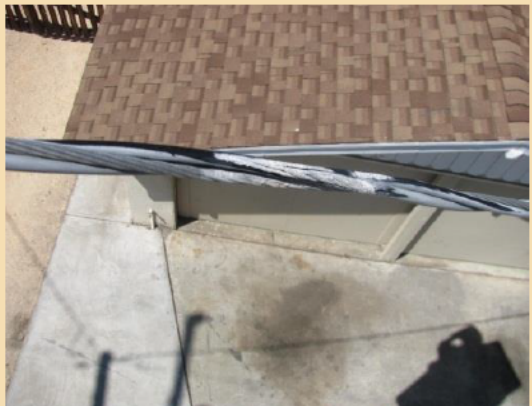
BROKEN SERVICE NEUTRAL	DAMAGED/CRACKED GREY SERVICE

<p>At this Location: Broken service neutral</p>	<p>At this Location: Cracked grey service. Older grey services tend to crack and will appear to have rings around the insulation.</p>
<p>Perform Minor Work: Yes, if safe to do so. If you replace the service conductor, this is capital Minor Work. Fill out EC Form to account for this minor work; charge time to your Division standing order</p>	<p>Perform Minor Work: Yes, if safe to do so. If you replace the service conductor, this is capital Minor Work. Fill out EC Form to account for this minor work; charge time to your Division standing order</p>
<p>Write Third Party Notification: No</p>	<p>Write Third Party Notification: No</p>
<p>Write EC Form: Yes, if minor work is not possible, or to document completed capital minor work</p> <ul style="list-style-type: none"> • FDA=Conductor / Broken/Damage / Repair or Replace • Priority "A", follow Emergency Process 	<p>Write EC Form: Yes, if minor work is not possible, or to document completed capital minor work</p> <ul style="list-style-type: none"> • FDA=Conductor / Broken / Replace - OR • FDA=Conductor / Damaged / Replace - OR • FDA=Conductor / Burnt / Replace • Priority "A", emergency, due to exposed hotleg.

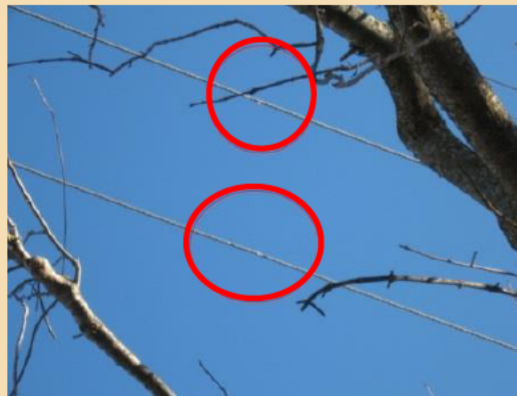
DAMAGED SECONDARY

At this Location: Damaged strands

- FDA= Conductor / Damage / Repair
- Priority "E", 3-12 months depending upon exposure

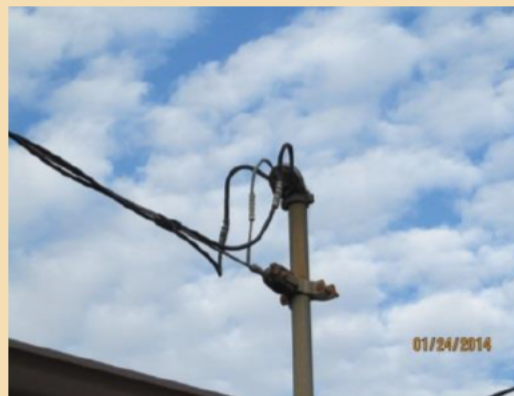
EXPOSED SERVICE CONNECTOR

At this Location: Exposed conductors

- FDA= Conductor / Broken/Damage / Repair
- Priority "E", 3-12 months depending upon exposure

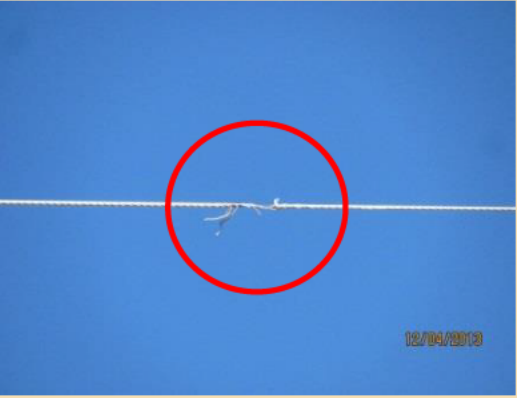
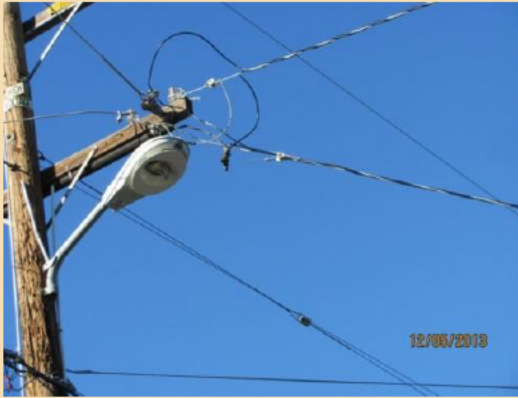
CONDUCTOR TEARING APART	HARDWARE BROKEN

<p>At this Location: Primary conductor damage (possibly shotgun)</p>	<p>At this Location: The #6 solid copper is broken causing strain on the conductor. Unsecured service.</p>
<p>Perform Minor Work: No</p>	<p>Perform Minor Work: Yes, if safe to do so</p>
<p>Third-Party Notification: No</p>	<p>Write Third-Party Notification: No</p>
<p>Write EC Form: Yes</p> <ul style="list-style-type: none"> • FDA= Conductor / Broken/Damage / Repair • Priority "B", 0-3 months depending upon exposure 	<p>Write EC Form: Yes, if minor work is not possible</p> <ul style="list-style-type: none"> • FDA= Hardware/Framing / Broken/Damaged / Repair • Priority "E", 3-12 months depending upon exposure

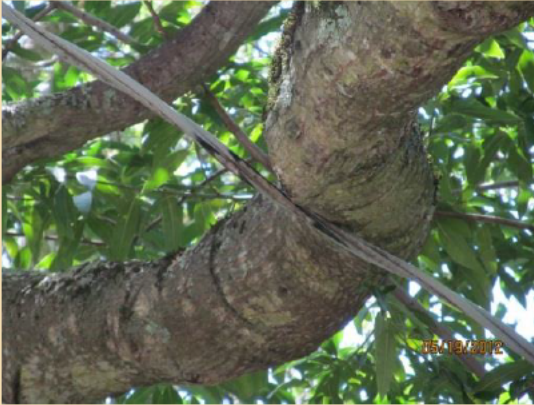
OVERHEAD SERVICE STRAIN ABRASION

At this Location: Service strain abrasion, with possible burning at some sections. Damaged insulation.

Perform Minor Work: Yes, if safe to do so. If you replace the service conductor, this is capital Minor Work.

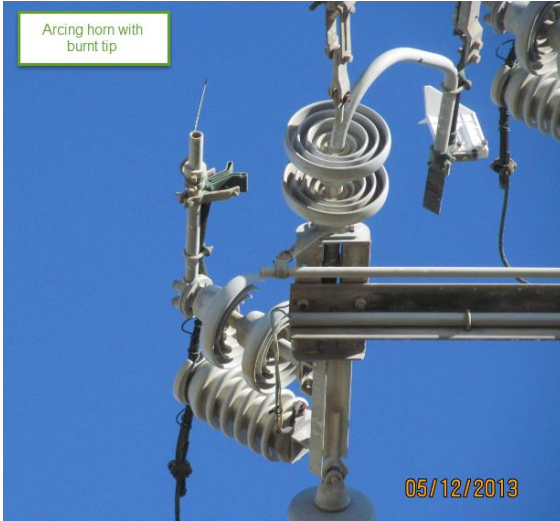
Example: Arcing horn with burnt tip

General Guidance: Call Restoration Dispatch to get a T-Man dispatched to the location to create a COE (CE) notification. Consider installing a warning tag on the pole.

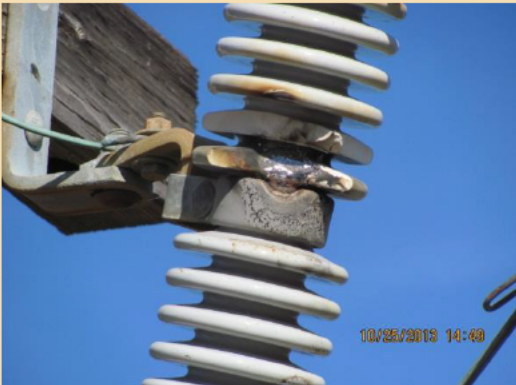
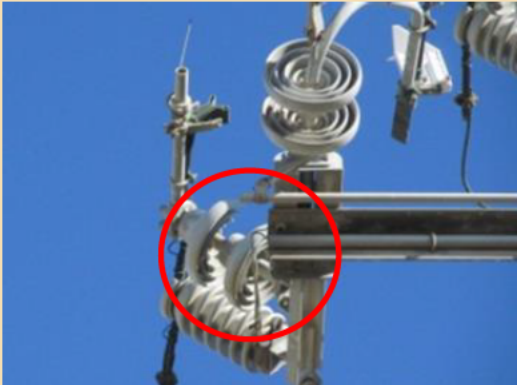
BROKEN DAMAGED CROSSARM MOUNTED CUTOUT	BROKEN INSULATOR ON AIR SWITCH

<p>At this Location: Broken/Flashed cutout</p>	<p>At this Location: Broken insulator on air switch</p>
<p>Perform Minor Work: No</p>	<p>Perform Minor Work: No</p>
<p>Write Third-Party Notification: No</p>	<p>Write Third-Party Notification: No</p>
<p>Write EC Form: Yes</p> <ul style="list-style-type: none"> • FDA=Cutout / Broken/Damaged / Replace • Priority "E", 3-12 months depending upon exposure • COE = No 	<p>Write EC Form: Yes</p> <ul style="list-style-type: none"> • FDA=Cutout / Broken/Damaged / Replace • FDA Switch / Broken/Damaged / Replace • Priority "E", 3-12 months depending upon exposure • COE = Depending on voltage & Insulation value remaining if not operable

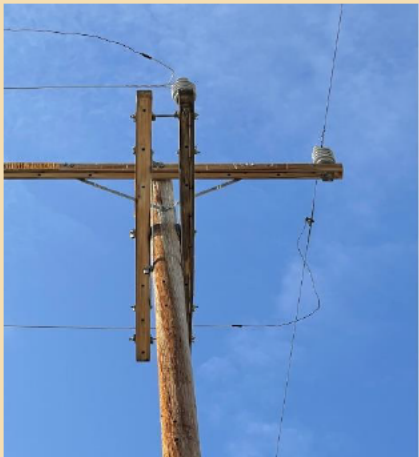
BRIDGING

<p>At this Location: Pole, burnt, pole failed</p> <hr/> <p>Perform Minor Work: No</p> <hr/> <p>Write Third-Party Notification: No</p> <hr/> <p>Write EC Form:</p> <ul style="list-style-type: none"> • FDA = Hardware/Framing / Broken/Damaged / Replace • Priority "E", 3-12 months depending upon exposure

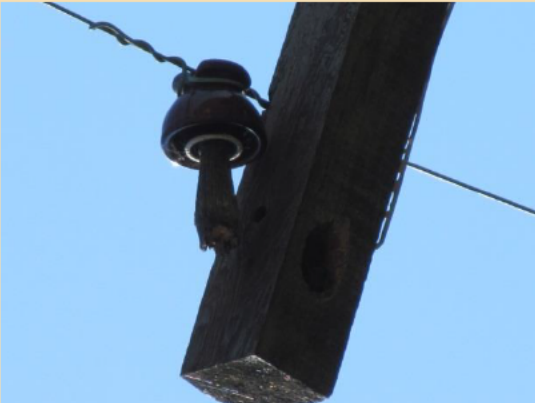
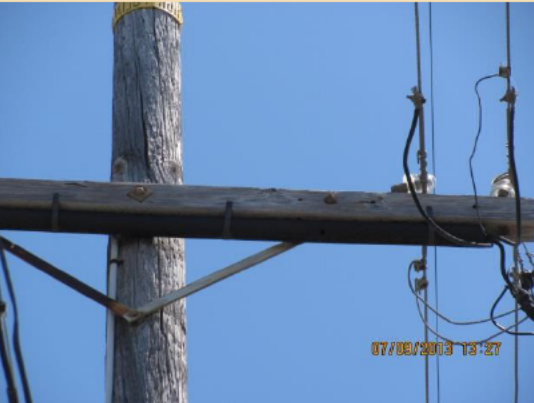
PIN BROKEN	PIN BROKEN (FLOATER)

<p>At this Location: Primary wood pin is broken, and the conductor is laying on the crossarm. Wood pin arm replace with Composite arm</p>	<p>At this Location: Secondary wood pin is broken, and the conductor is laying on the crossarm. Woodpin arm. Replace arm.</p>
<p>Perform Minor Work: No</p>	<p>Perform Minor Work: Yes, replace wooden pin with steel pin.</p>
<p>Write Third-Party Notification: No</p>	<p>Write Third-Party Notification: No</p>
<p>Write EC Form: Yes</p> <ul style="list-style-type: none"> • FDA=Hardware/Framing / Broken/Damage / Replace • FDA= Crossarm/Broken Damaged/Replace • Priority "A", follow Emergency Process 	<p>Write EC Form: Yes</p> <ul style="list-style-type: none"> • FDA= Conductor / Floating / Repair • FDA= Crossarm/Broken Damaged/Replace • Priority "A", follow Emergency Process

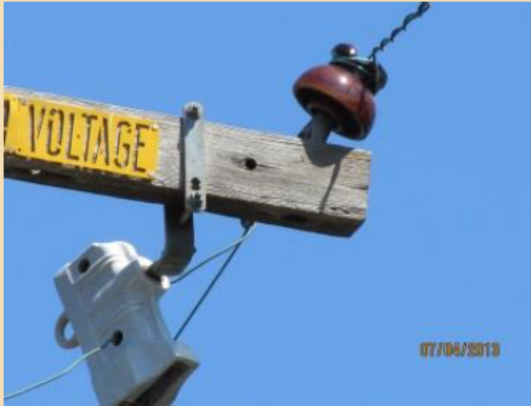
PRIMARY WOOD PIN AT ANGLE

At this Location: Deteriorated primary wood pin at angle. All insulators need to be replaced. Replace the crossarm with a composite arm.

- FDA= Crossarm/Broken Damaged/Replace
- FDA=Hardware/Framing / /Broken/Damaged / Replace
- Priority "B", 0-3 Months depending on exposure.

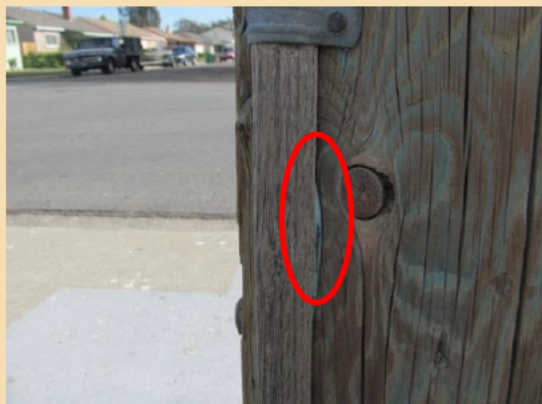
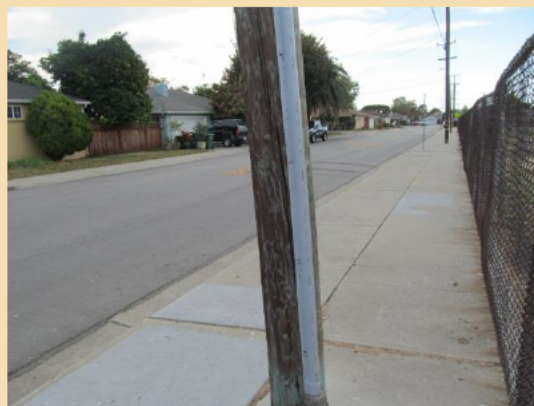
REPAIR WITH 1.5" MOLDING

Before: Copper Wire sticking out from under the wood molding

After: 1.5 inch u-shaped molding installed over existing wood molding

At this Location: Wood molding with ground exposed

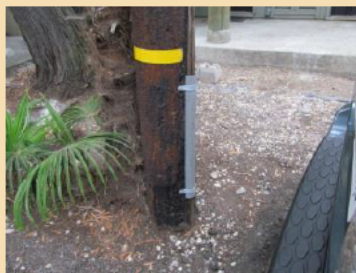
REPAIR WITH 2" PLASTIC

At this Location: Condition acceptable after repair of exposed ground

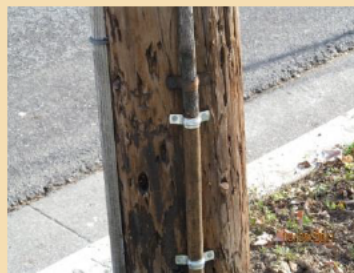
REPAIR WITH WOOD MOLDING

At this Location: Condition acceptable after repair with wood molding

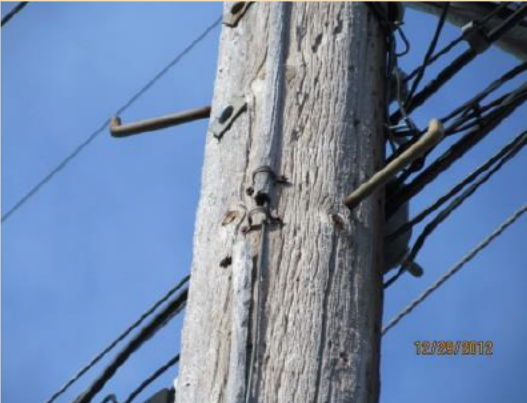
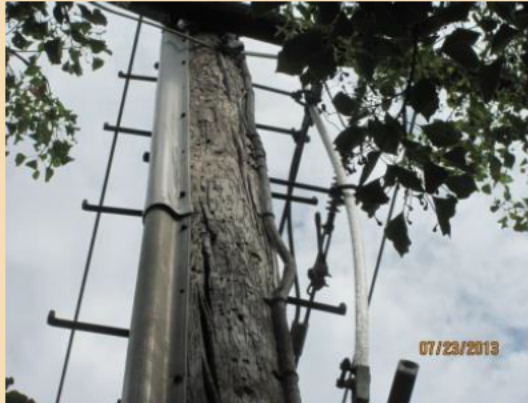
EXPOSED GROUND AT COMMUNICATION LEVEL	EXPOSED GROUND DUE TO TWISTED MOLDING

<p>At this Location: Exposed ground at communications level. Wood molding broken in climbing space.</p>	<p>At this Location: Exposed ground in wood molding.</p>
<p>Perform Minor Work: Yes, if safe to do so.</p>	<p>Perform Minor Work: Yes, when safe to do so.</p>
<p>Write Third-Party Notification: No</p>	<p>Write Third-Party Notification: No</p>
<p>Write EC Form: Only if unable to perform minor work.</p> <ul style="list-style-type: none"> • FDA=Ground / Exposed / Repair • At minimum – must write up as Priority "F-R", next inspection cycle; based on field condition and exposure, corrosion, etc.; prioritize as needed (A, B, E, or F) 	<p>Write EC Form: Only if unable to perform minor work.</p> <ul style="list-style-type: none"> • FDA=Ground / Exposed / Repair • FDA=Molding / Broken/Damaged / Repair • At minimum – must write up as Priority "F-R", next inspection cycle; based on field condition and exposure, corrosion, etc.; prioritize as needed (A, B, E, or F)

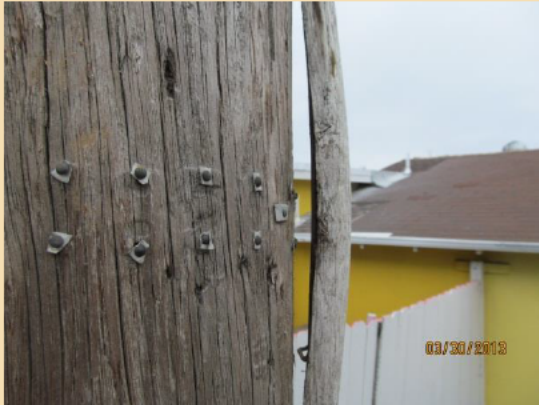
**WOOD MOLDING NOT SECURE
EXPOSING GROUND**

At this Location: Wood molding not secure, allowing human contact.

- FDA=Ground / Exposed / Repair
- At minimum – must write up as Priority "F-R", next inspection cycle; based on field condition and exposure, corrosion, etc.; prioritize as needed (A, B, E, or F)

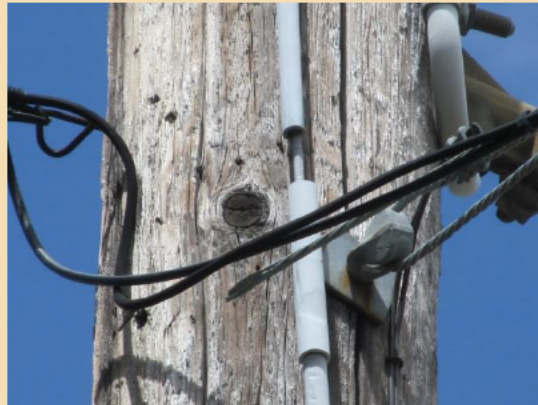
**PVC MOLDING NOT SECURE EXPOSING
GROUND**

At this Location: PVC molding not secure, due to failure of previous repairs, allowing human contact.

- FDA=Ground / Exposed / Repair
- At minimum – must write up as Priority "F-R", next inspection cycle; based on field condition and exposure, corrosion, etc.; prioritize as needed (A, B, E, or F)

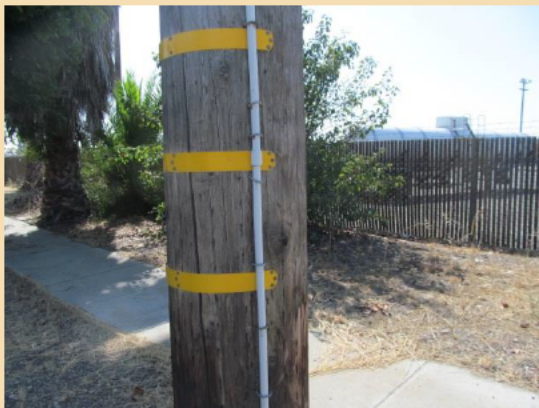
PVC MOLDING SECURED

At this Location: PVC molding adequately secured with staples upon arrival. No action is required.

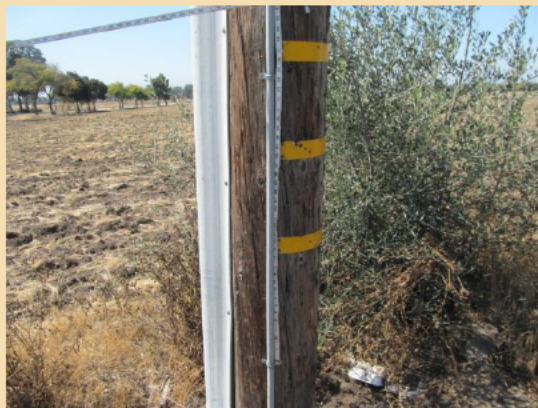
WOOD MOLDING SECURED

At this Location: Wood molding adequately secured with straps spacing 36 inches or less upon arrival. No action required.

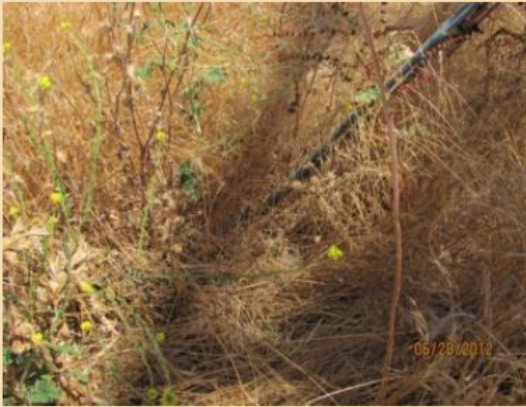
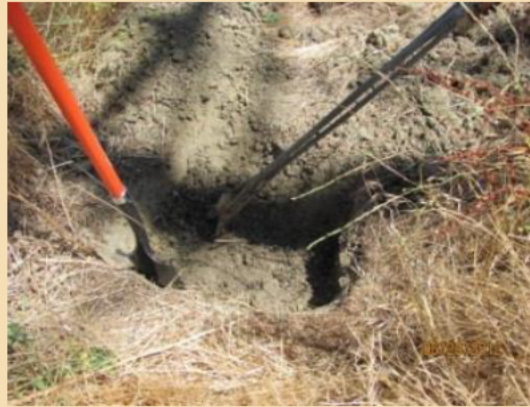
BURIED ANCHOR

Before: Vegetation covers anchor

After: Vegetation cleared from anchor

At this Location: Anchor below grade overgrown with vegetation. After minor work inspector decides if the anchor can be adjusted or needs replaced.

Perform Minor Work: Yes, remove the vegetation
Yes, expose anchor and evaluate condition/corrosion
Yes, preferred method is to adjust anchor by adding extension

- FDA=Anchor / Soil/Eroded/Graded / Replace (if the anchor cannot be adjusted)
- At minimum – must write up as Priority "F-R", next inspection cycle; based on field condition and exposure, corrosion, etc.; prioritize as needed (A, B, E, or F)

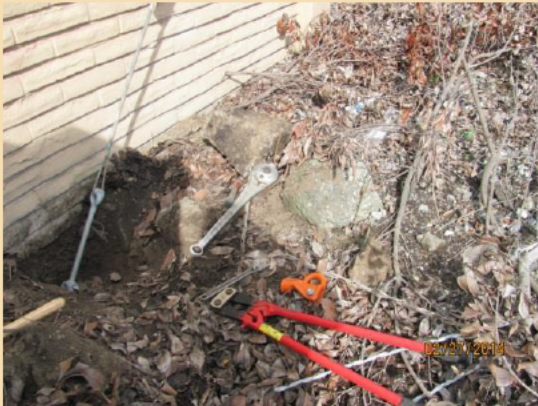
ANCHOR EXTENSION

At this Location: Inspector performed minor work, exposed anchor, evaluated anchor to be in good condition so that extension could be installed, then installed extension. (Back fill not shown)

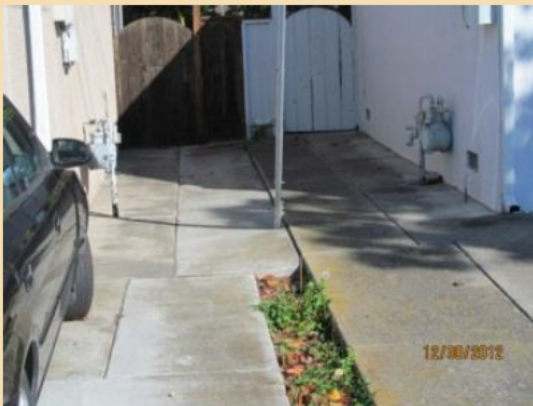
ANCHOR COVERED BY CONCRETE

At this Location: Anchor covered by concrete

FDA=Anchor /Soil/Eroded/Graded / Replace
At minimum – must write up as Priority "F-R", next inspection cycle; based on field condition and exposure, corrosion, etc.; prioritize as needed (A, B, E, or F)

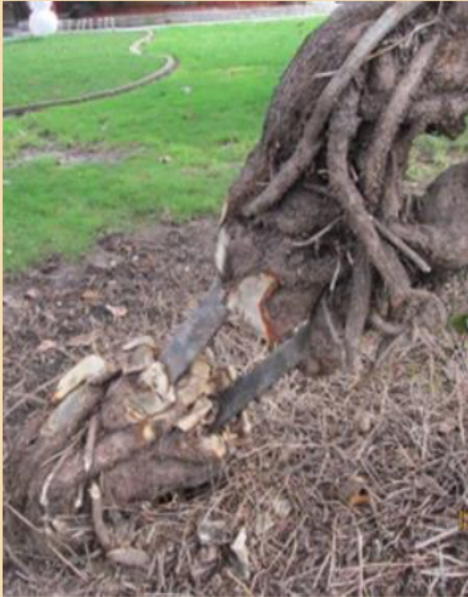
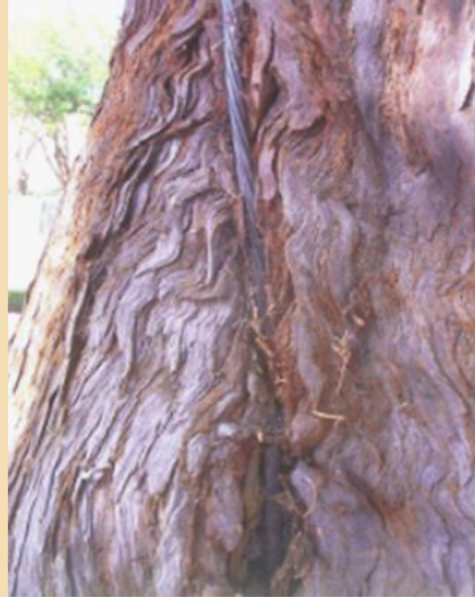
ANCHOR BURIED BY VEGETATION

Anchor buried by roots

Anchor buried by tree

At this Location: Anchor buried by ivy roots / tree

- FDA=Anchor / Soil/Eroded/Graded / Replace
- At minimum – must write up as Priority "F-R", next inspection cycle; based on field condition and exposure, corrosion, etc.; prioritize as needed (A, B, E, or F)

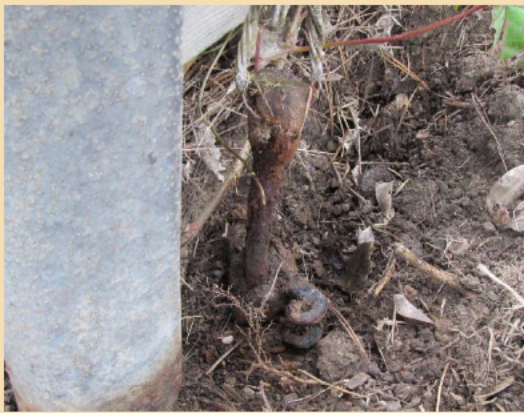
ANCHOR ROD WITH SIGNIFICANT CORROSION

At this Location: Corroded Anchor

- FDA=Anchor / Corroded / Replace
- Priority "E", 3-12 months depending upon exposure

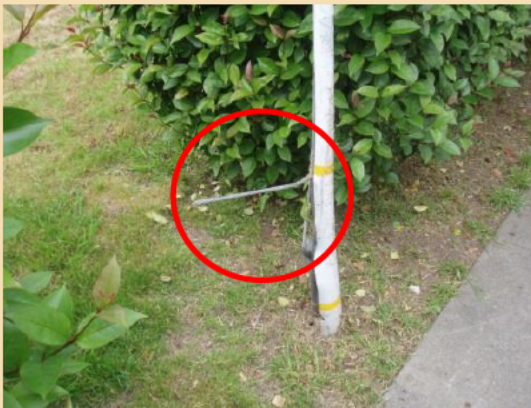
<p>At this Location: Guy tail extends beyond the preform <u>near sidewalk</u>, safety hazard.</p> <hr/> <p>Perform Minor Work: Yes</p> <hr/> <p>Write Third-Party Notification: No</p> <hr/> <p>Write EC Form: Only if minor work cannot be performed.</p> <ul style="list-style-type: none"> • FDA Guy / Broken/Damaged/ Repair • Priority "E", 3-12 months depending upon exposure

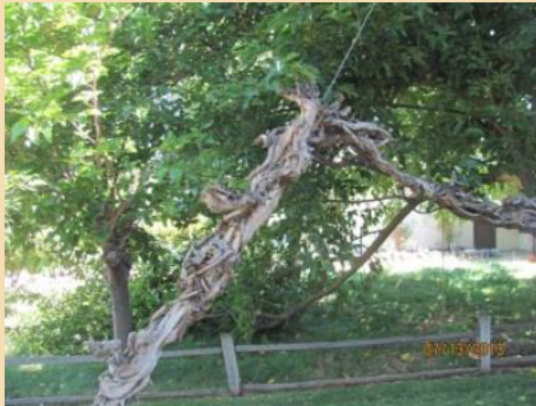
OVERGROWN GUY

At this Location: Extensive dead ivy covering half of length of guy.

- FDA=Guy / Broken/Damaged / Replace
- Priority "E", 3-12 months depending upon exposure

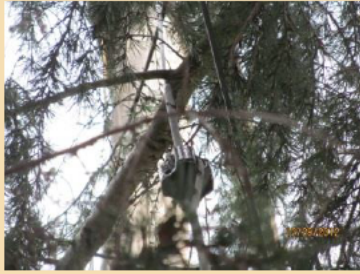
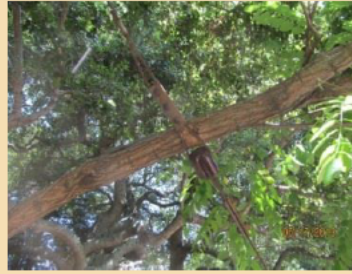
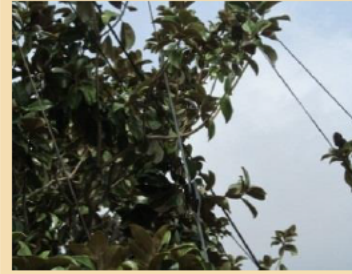
GUY GROUNDED BY VEGETATION

Guy grounded by vegetation

Guy overgrown by vegetation

At this Location: Guy grounded by vegetation, above the bob.

- FDA=Guy / Overgrown / Trim
- Priority "E", 3-12 months depending upon exposure

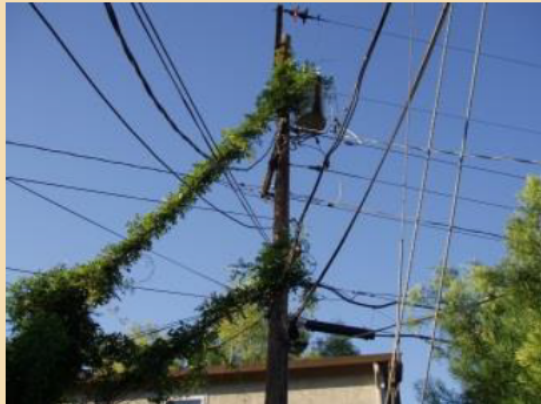
IVY ON GUY AND PRIMARY

At this Location: Ivy on guy and on primary. Safety issues, possible energized guy and pole, transformer weeping – no oil on ground, evaluate per oil spill matrix.

- FDA=Transformer / Leaks/Seeps/Weeps / Replace (primary)
- FDA=Guy / Overgrown / Trim
- Priority "B", 3 months or less depending upon exposure

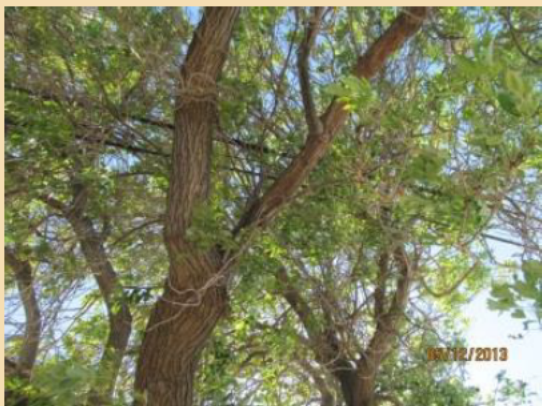
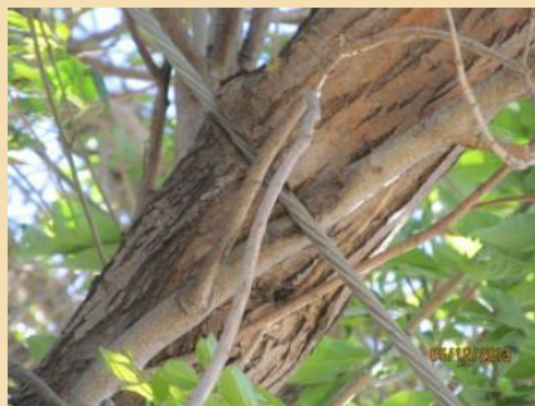
TREE LIMB GROWING AROUND GUY

Guy through tree

At this Location: Tree limb growing around guy, below the bob.

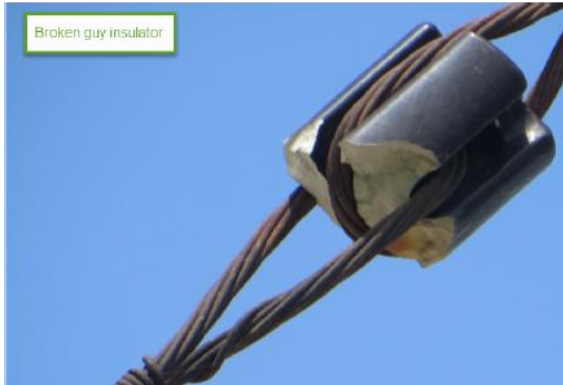
Example: Broken guy insulator

Must be sectionalized and ungrounded. Ensure there is an intact guy insulator.

- FDA: Guy / Broken/Damaged / Replace or Guy / Missing / Install
- Select the Priority and Due Date based upon compelling abnormal condition that may adversely impact public safety and/or service reliability in the next five (5) years

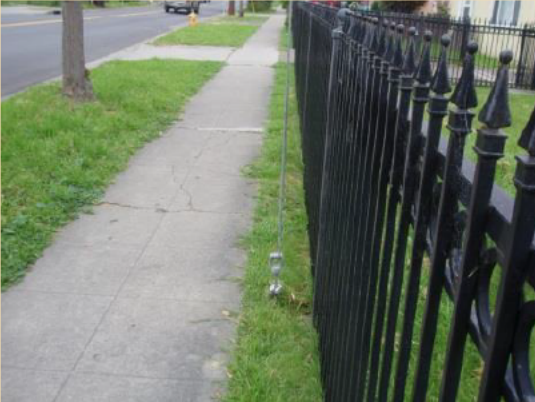
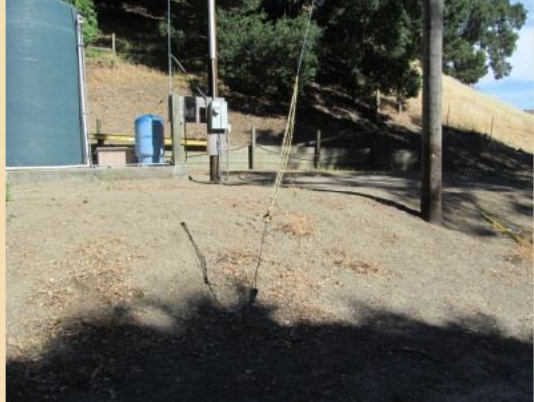
GUY MARKER MISSING	CATTLE GUARD LESS THAN 8 FT

<p>At this Location: Guy marker missing</p>	<p>At this Location: Cattle guard is less than 8 feet in length</p>
<p>Perform Minor Work: Yes, install new guy marker</p>	<p>Perform Minor Work: Yes, lower cattle guard and add guy marker to meet 8 feet requirement.</p>
<p>Write Third-Party Notification: No</p>	<p>Write Third-Party Notification: No</p>
<p>Write EC Form: No, perform minor work</p>	<p>Write EC Form: No, perform minor work</p>

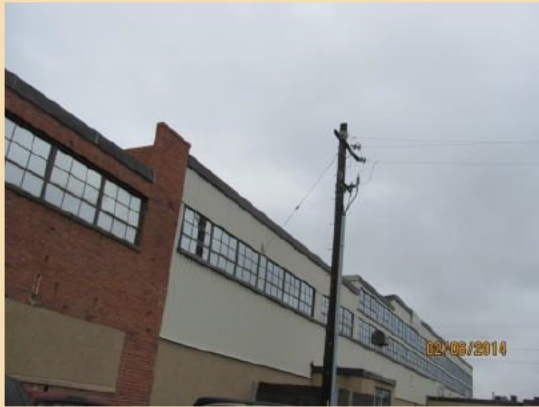
DOWN GUY: MARKER NOT REQUIRED

At this Location: Acceptable down guy attached to building, no marker required.

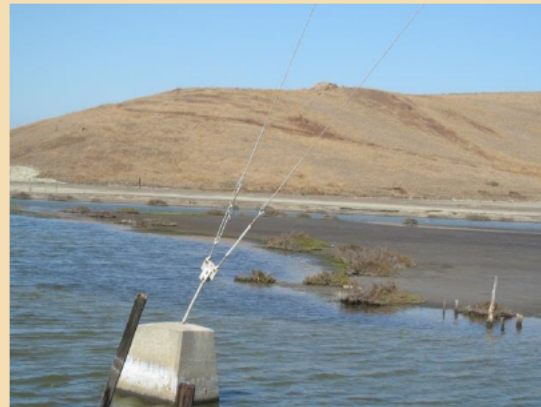
At this Location: Acceptable down guy in marsh, no marker required.

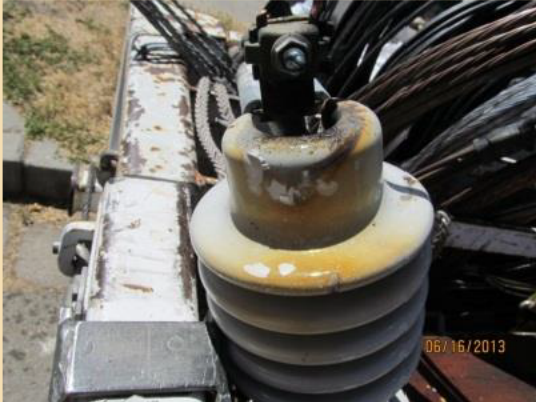
FLASHED INSULATOR POTHEAD

At this Location: Flashed pothead

- FDA=Riser/Pothead / Flashed / Replace
- At minimum – must write up as Priority "F-R", next inspection cycle; based on field condition and exposure, corrosion, etc.; prioritize as needed (A, B, E, or F)

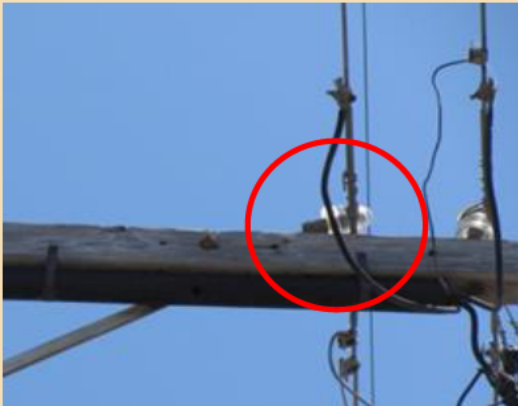
BROKEN WOOD PIN ON SECONDARY

At this Location: Broken secondary wood pin. Conductor lying on the arm, tangent pole. (excluding urban wildfire areas, use risk priority matrix). Wood pin arm at end of life replace arm with composite arm

- FDA= Crossarm / Decayed/Rotten / Replace
- FDA= Insulator / Squatter (Secondary) / Replace
- Priority "B", 0-3 months depending upon exposure

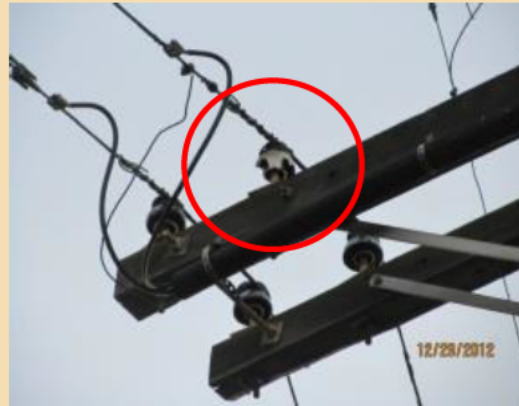
BROKEN SECONDARY INSULATOR

At this Location: Broken secondary insulator

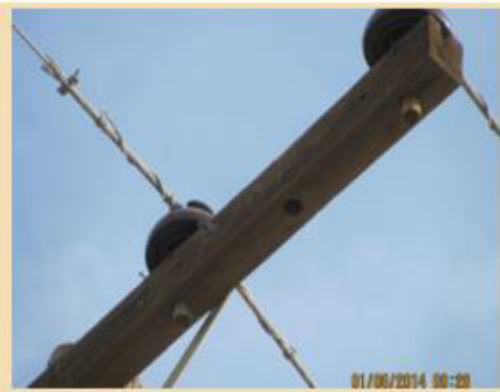
PRIMARY SQUATTER

At this Location: 2 Primary Wood Pin Squatters; replace wood crossarm with composite crossarm.

- FDA = Crossarm Decayed/Rotten / Replace
- FDA = Insulator / Primary Squatter / Replace
- At minimum – must write up as Priority "E", based on field condition and exposure, corrosion, etc.; prioritize as needed (A, B, or E)

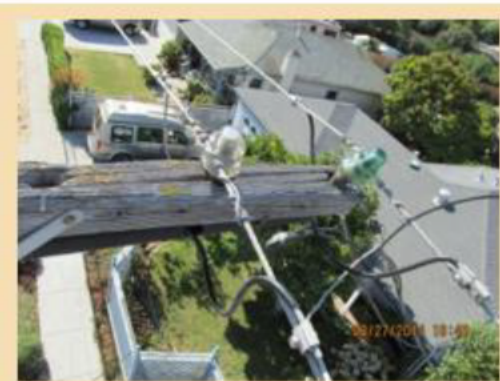
SECONDARY SQUATTER AND DECAYED CROSSARM

At this Location: Secondary Squatter and decayed crossarm.

- FDA= Crossarm / Decayed/Rotten / Replace
- Priority "E", 3-12 months depending upon exposure
- Note: When replacing insulators, do NOT mismatch insulators.

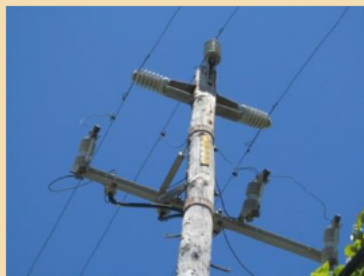
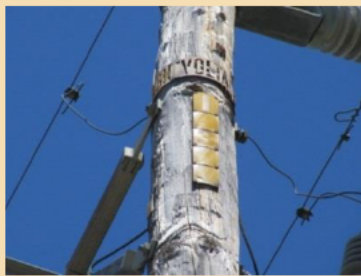
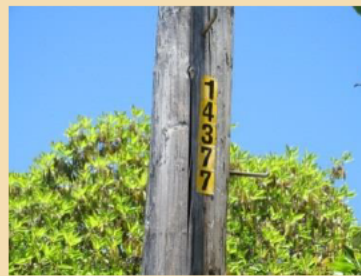
FADED OPERATING NUMBER

Before: Faded operating number

At this Location: Operating number is faded

After: Minor work completed, operating number applied below operating position.

- FDA=Marking / Broken/Damaged / Replace
- At minimum – must write up as Priority "F-R", next inspection cycle; based on field condition and exposure, corrosion, etc.; prioritize as needed (A, B, E, or F)

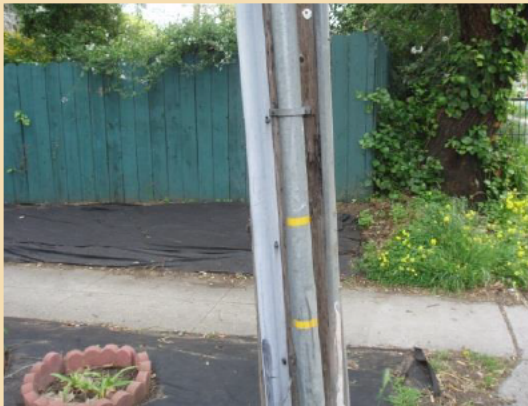
INADEQUATE VISIBILITY STRIPS

At this Location: Pole with vehicular exposure. Two small sections of yellow adhesive visibility strips.

Write EC Form: No, perform minor work

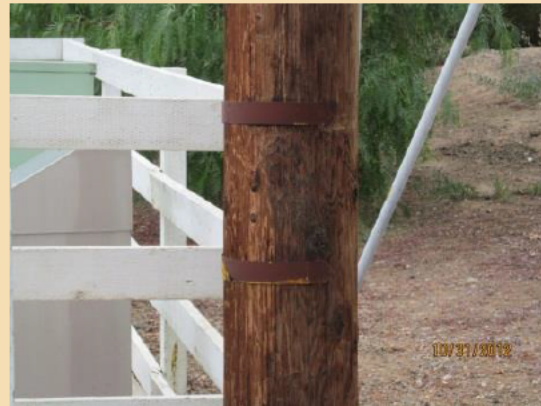
VISIBILITY STRIPS PAINTED OVER NO LONGER REFLECTIVE

At this Location: Visibility strips painted brown (3rd visibility strip located above not shown in picture)

Perform Minor Work: Yes, remove old visibility strips and install new.

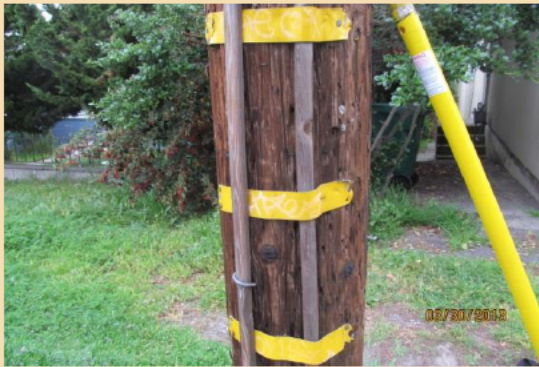
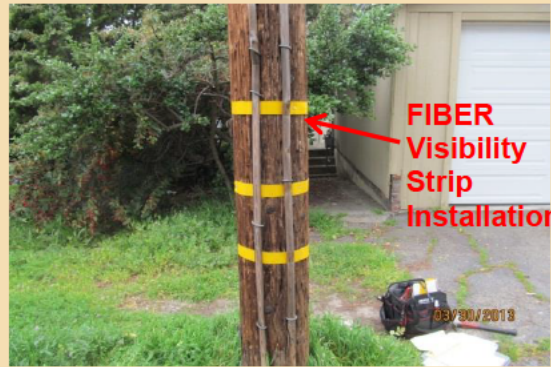
METAL OVER MOLDING

At this Location: Metal visibility strips under wood molding and over wood molding with protruding edge.

Write EC Form: No, perform minor work

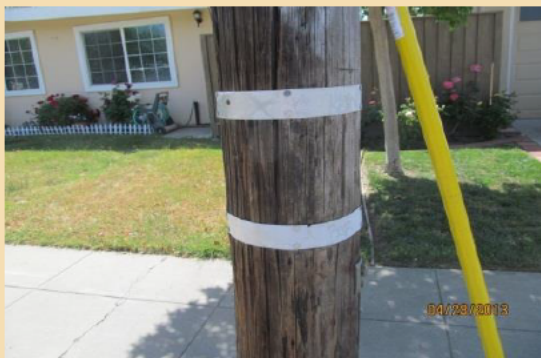
OLD METHOD VISIBILITY STRIPS

At this Location: Aged visibility strips have lost reflectivity.

Perform Minor Work: Yes, replace with 3 yellow visibility strips

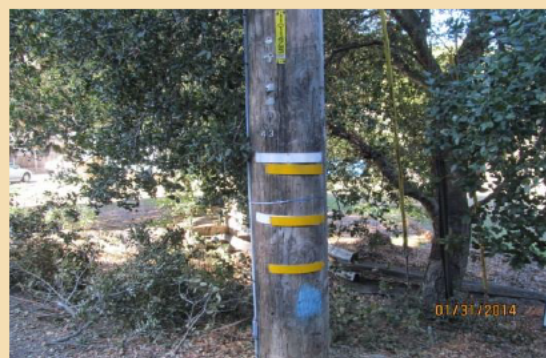
OLD AND NEW VISIBILITY STRIPS

At this Location: Yellow visibility strips mounted over old white visibility strips.

Perform Minor Work: Yes, remove old visibility strips

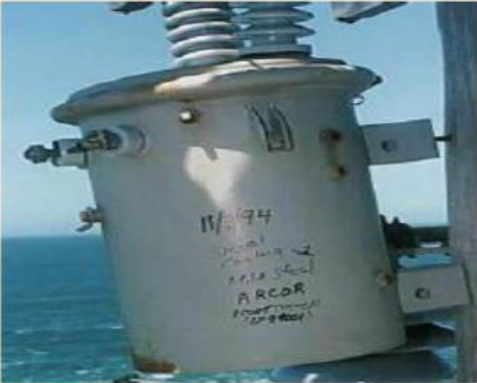
At this Location: Transformer with moderate/heavy corrosion

Metal structure still sound (rust staining from attachments)

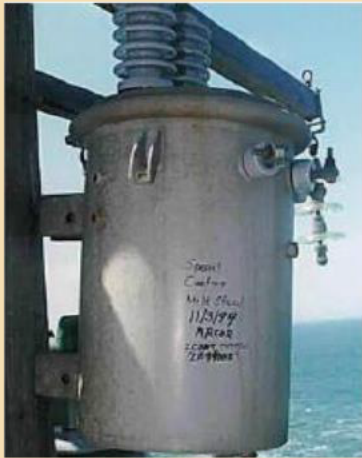
TRANSFORMER WITH STAINING, NO CORROSION

At this Location: Transformer with dirt and salt spray staining, no metal damage

Write EC Form: No

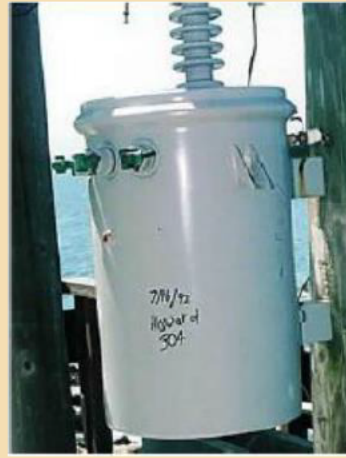
TRANSFORMER CASE WITH LITTLE OR NO CORROSION

At this Location: Transformer with little to no corrosion, no metal damage

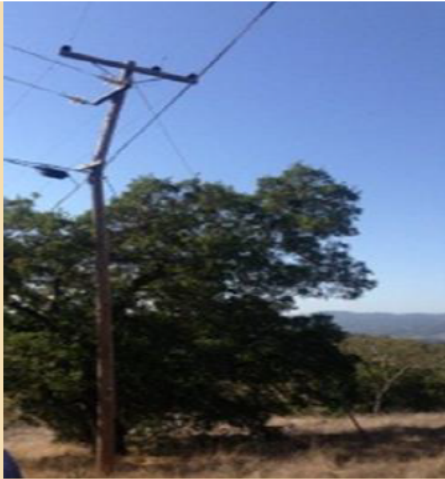
POLE BROKEN AT THE COMMUNICATION LEVEL

At this Location: Pole broken at the communication level in HFTD area.
Complete Pole Inspection Test Report

- FDA=Pole / Broken/Damaged / Replace
- Priority "A" address immediately

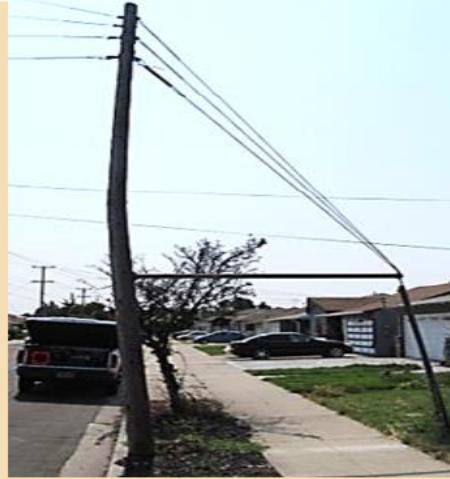
POLE BROKEN AT MIDDLE SECTION

At this Location: Broken pole. Complete Pole Inspection Test Report

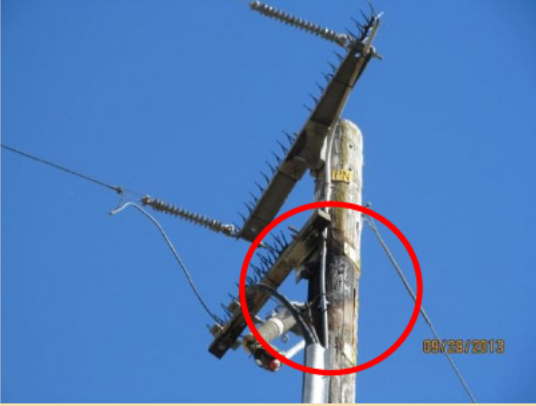
DAMAGE TO POLE FROM SPECIFIC EVENT	DECAY OF POLE OVER TIME

<p>At this Location: Pole burnt</p> <p>If pole has reduced circumference. Write EC notification for estimating to confirm pole loading.</p>	<p>At this Location: Pole top decayed. Entire pole failed pole test. Complete the Pole Inspection Test Report.</p>
<p>Perform Minor Work: No</p>	<p>Perform Minor Work: No</p>
<p>Write Third-Party Notification: No</p>	<p>Write Third-Party Notification: No</p>
<p>Write EC Form: Yes, Write EC notification for estimating to confirm pole loading.</p> <ul style="list-style-type: none"> • FDA=Pole/Overloaded/Test • Priority "E", 3-12 months depending on exposure. 	<p>Write EC Form: Yes</p> <ul style="list-style-type: none"> • FDA=Pole Decayed/Rotten/Replace • Priority "E", 3-12 months depending upon exposure

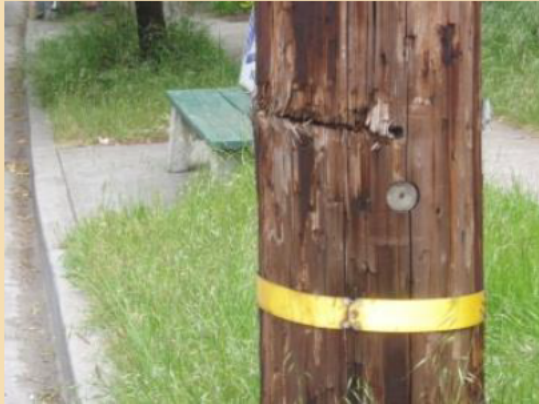
SAW CUT INTO POLE

At this Location: Vandalized pole. Chain saw cut into lower portion of pole. Half of pole circumference cut into.
Notify supervisor of possible vandalism. Supervisor will have to communicate to damage claims. Complete Poles Inspection Test Report.

- FDA=Pole / Broken/Damaged/ Replace
- Priority "A" or "B", 0-3 months depending upon exposure

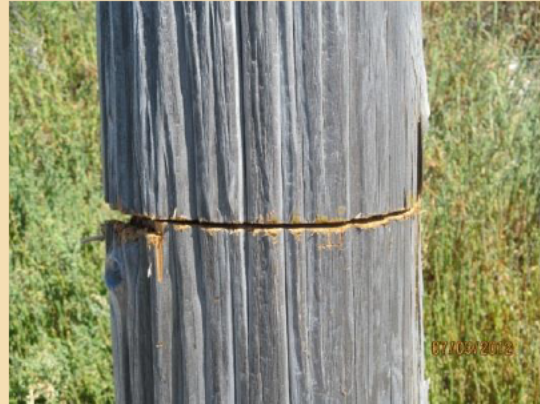
At this Location: Vandalized pole. Chain saw cut into lower portion of pole. More than half of pole circumference cut into.
Notify supervisor of possible vandalism. Supervisor will have to communicate to damage claims. Complete Poles Inspection Test Report.

- FDA=Pole / Broken/Damaged / Replace
- Priority "A" or "B", 0-3 months depending upon exposure

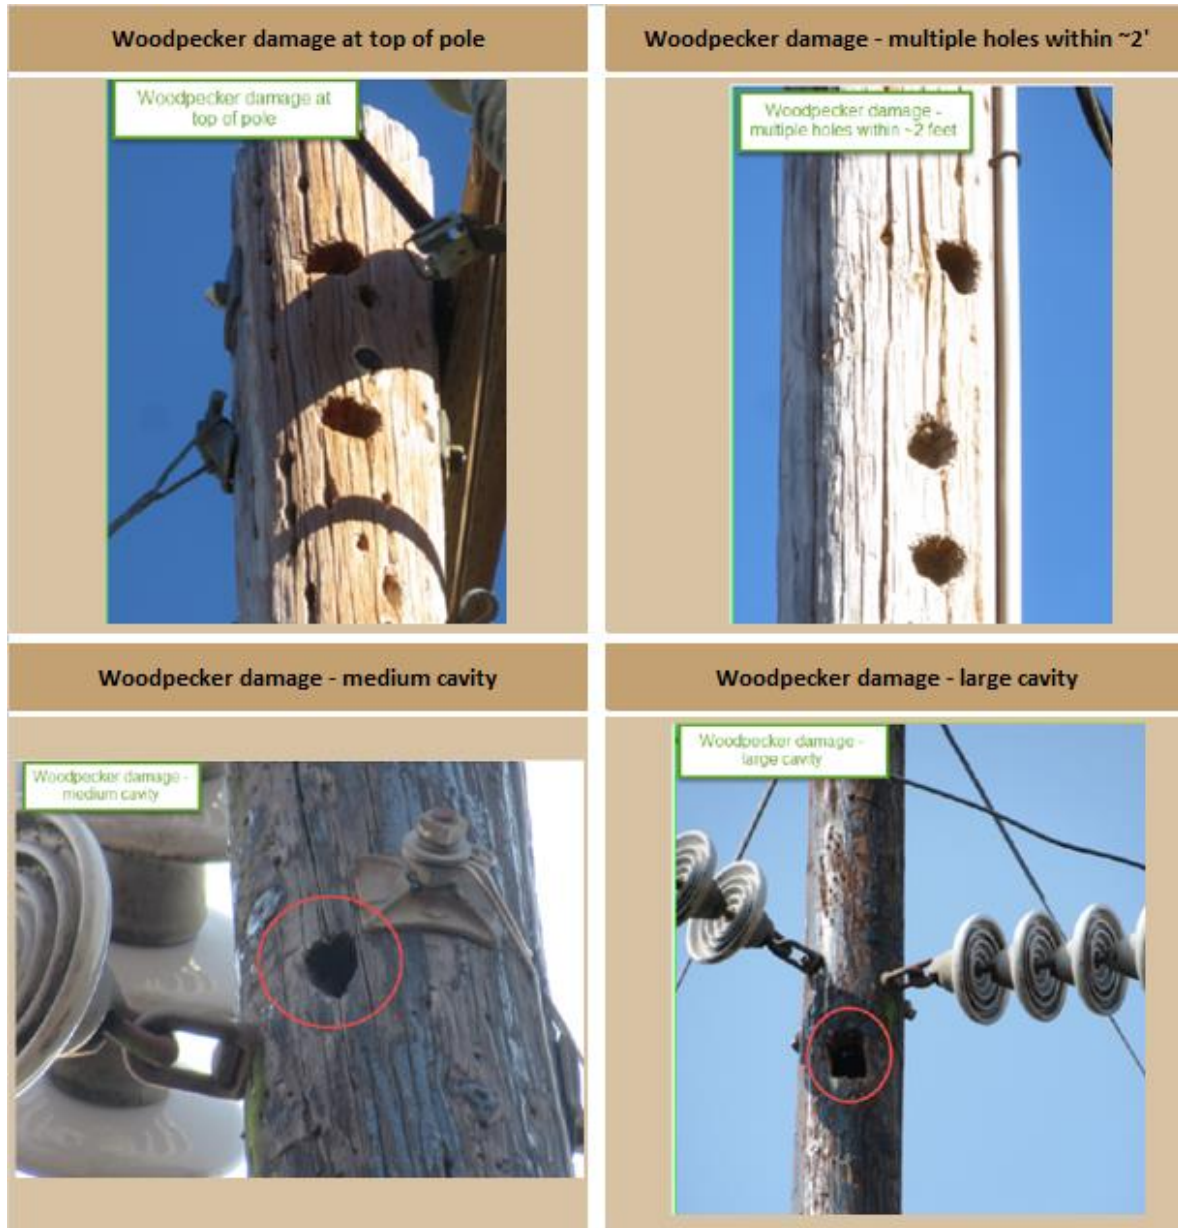
Examples: Poles with woodpecker damage – assess using woodpecker assessment guidelines.

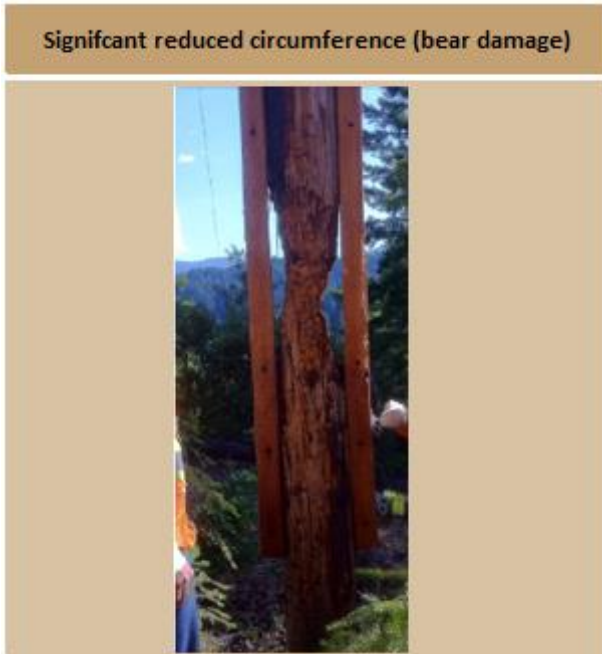
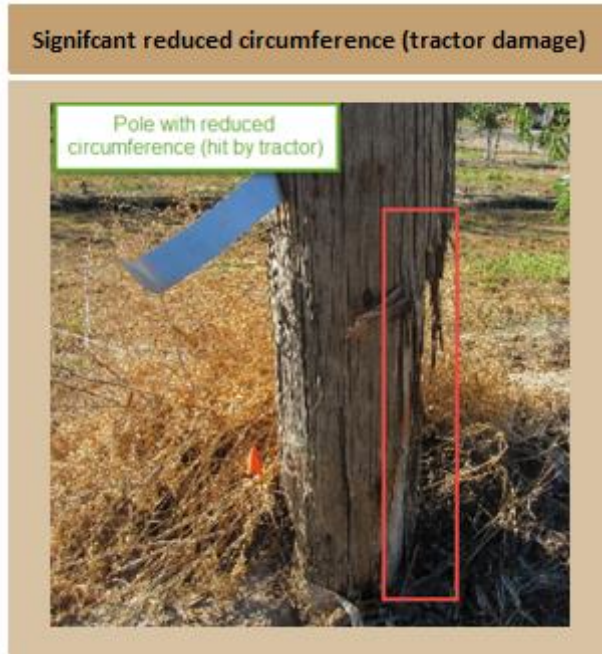
Examples: Significant reduced circumference

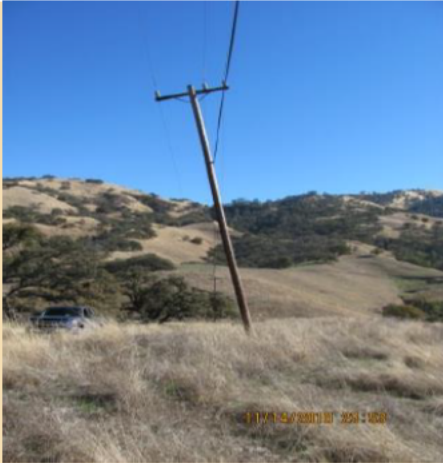
LEANING POLE

At this Location: Leaning pole greater than 10% out of plumb. Pole is stable. No equipment in rural area. Causing reduced clearance.

- FDA=Pole / Leaning / Replace
- Priority "E", 3-12 months depending upon exposure

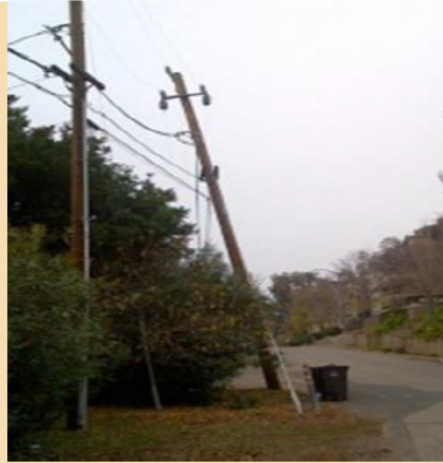
LEANING SLACK SPAN

At this Location: Leaning pole more than 10% out of plumb. Pole test indicates that pole is solid below ground and can be straightened. Probability of equipment failure is moderate.

- FDA=Pole / Leaning / Adjust
- Priority "E", 3-12 months depending upon exposure

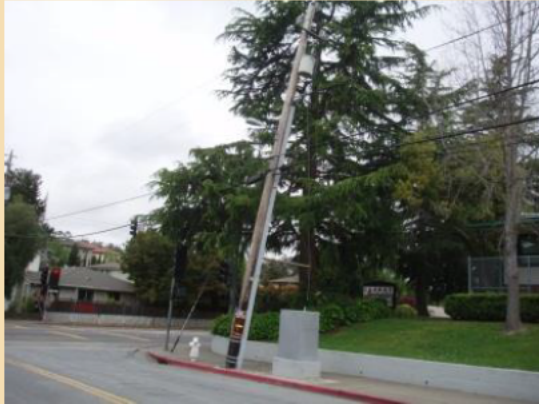
STUBBED POLE LEANING TOWARDS SCHOOL

At this Location: Stubbed pole leaning towards school, supported by down guy. Pole Bands are loose due to additional deterioration of the pole. Pole test data sheet indicates that pole no longer meets stubbing criteria causing reduced clearance issues

- FDA=Pole / Decay/Rotten / Replace
- Priority "E", 3-12 months depending upon exposure
