Incident Investigation Report
Reference Documents
SED Incident E20211223-01
(Brewer Fire)

ELECTRIC INCIDENT REPORT FORM

PG&E Reference Number: EI210707A

Grass Valley – Property Damage

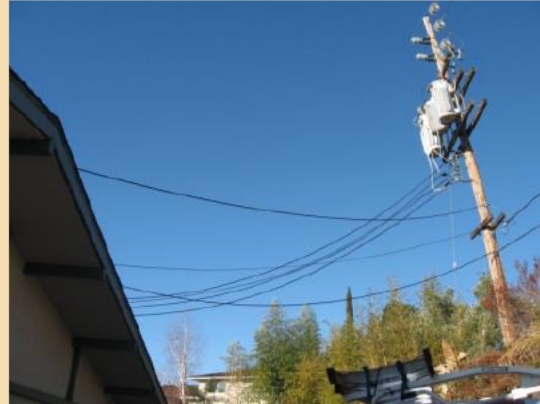
POLE LEANING 3 POT TRANSFORMER IN BUCK POSITION

At this Location: Pole is leaning less than 10% out of plumb, leaning in direction of offset equipment. Pole inspection found pole stable.

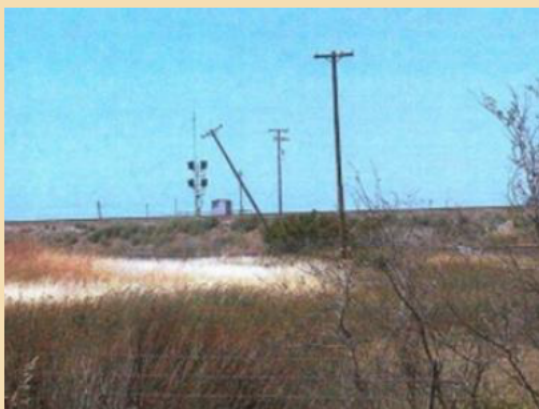
POLE LEANING NEAR RAILROAD TRACKS

At this Location: Severe lean being held up by the primary conductors. Low clearance over active railroad tracks. Pole located in a swamp area with standing water.

- FDA=Pole / Decayed/Rotten/ Replace
- Priority "A", follow Emergency Process

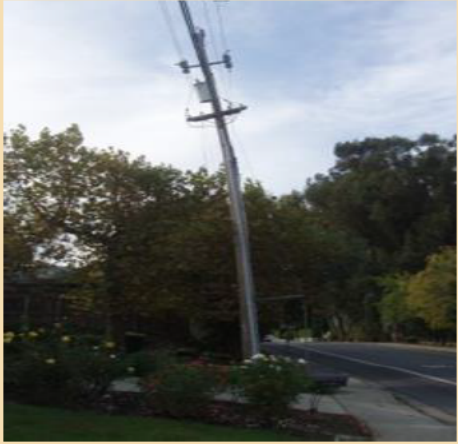
POLE BENT 4 FEET OUT OF LINE

<p>At this Location: Pole bent 4 feet out of line, less than 10% lean</p>
	<p>Perform Minor Work: No</p>
	<p>Write Third-Party Notification: No</p>
	<p>Write EC Form: Yes, only when the inspector decides that further assessment is required.</p> <ul style="list-style-type: none"> • FDA=Pole / Overloaded / Test • Priority "E", 3-12 months depending upon exposure

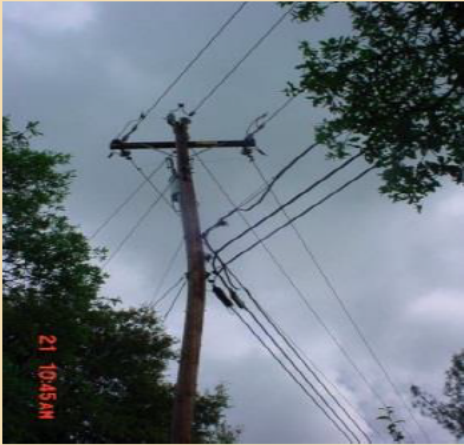
INADEQUATE SUPPORT AT COMMUNICATIONS LEVEL

At this Location: Two guys stabilizing communication level.

- FDA=Pole / Overloaded / Test
- Priority "E", 3-12 months depending upon exposure

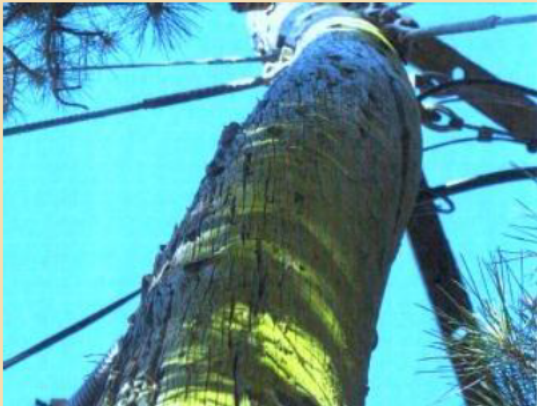
OVER STRESSED POLE

At this Location: Pole is twisted, cracked, due to communication.

- FDA=Pole / Overloaded / Replace Pole Test Data Sheet is Required
- Priority "E", 3-12 months depending upon exposure; add in field comments "overloaded by communications."

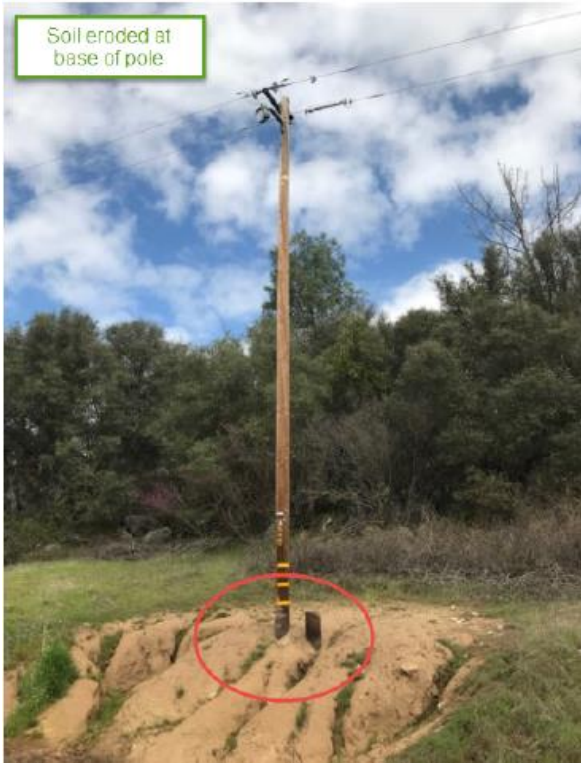
Example: Soil eroded at base of pole

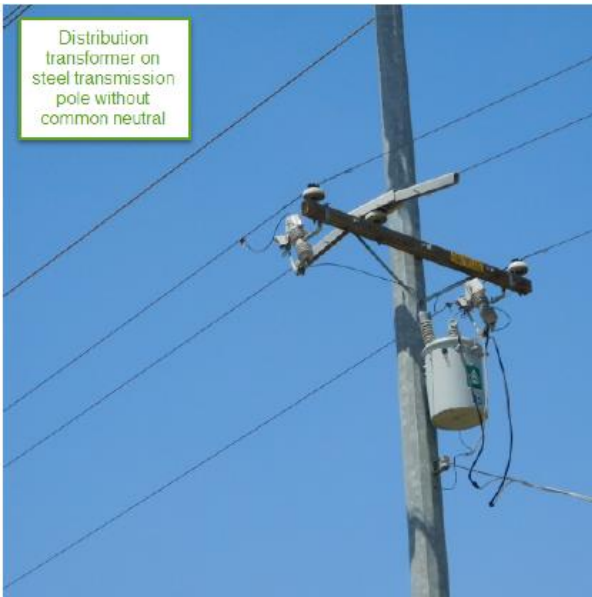
Example: Distribution transformer on steel transmission pole without common neutral.

Guidance: If observed, yes, create EC notification to relocate the transformer.

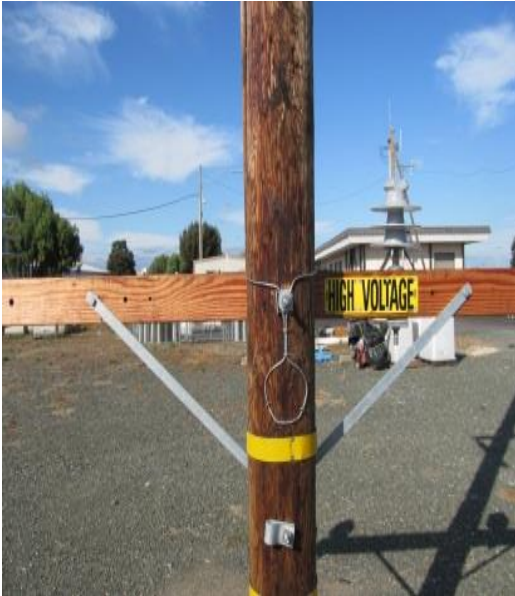
Example: Wood Crossarm on Transmission with Distribution Underbuild that requires bridging

Guidance: If observed, yes, create EC notification to repair or install missing bridging.

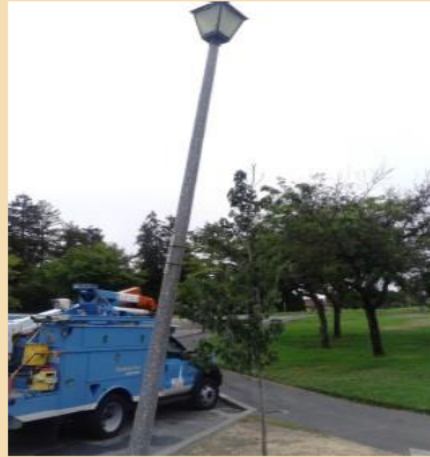
LEANING AGGREGATE POLE

At this Location: Leaning aggregate pole more than 10% out of plumb. Pole is broken at base and not stable. Light still working.

- FDA=Pole / Broken/Damaged / Replace
- Priority "B", 0-3 months depending upon exposure

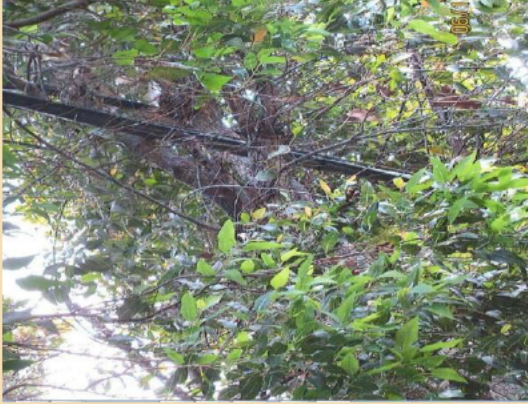
PHONE TREE CONDITION

At this Location: Tree putting strain on the pole, due to communication line

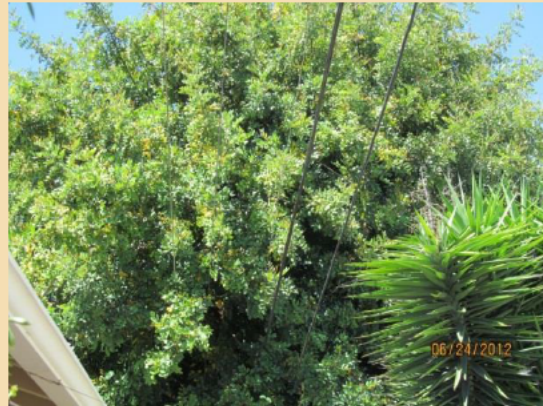
SECONDARY OVERGROWN REDUCING CONDUCTOR CLEARANCES

At this Location: Secondary conductor resting on tree/vegetation

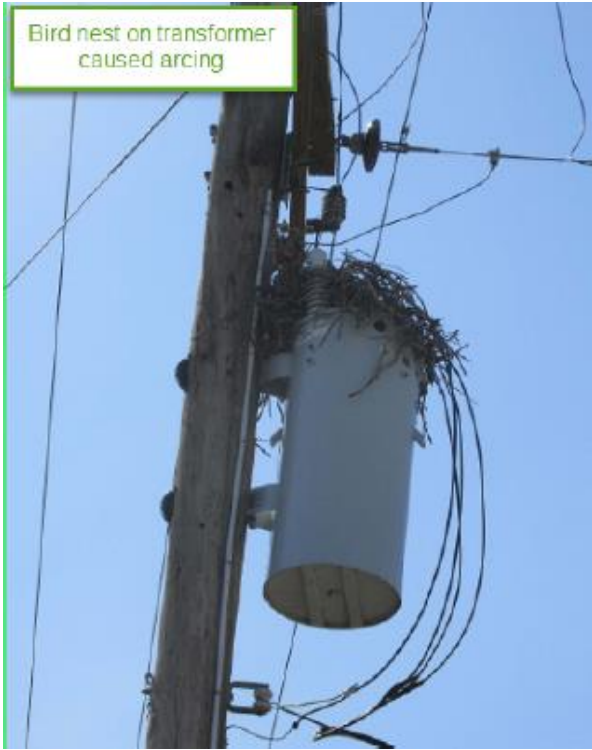
Example: Bird nest on transformer

General Guidance: Evaluate locations where animal mitigation has previously been installed to assess if it is sufficient or is missing or broken. If not sufficient or needs repair, create EC notification to replace.

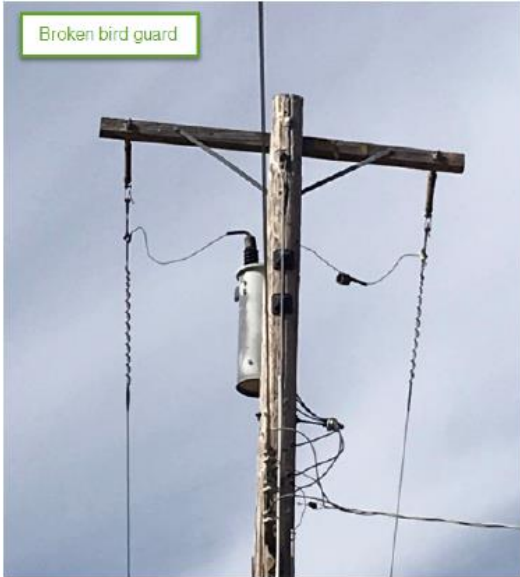
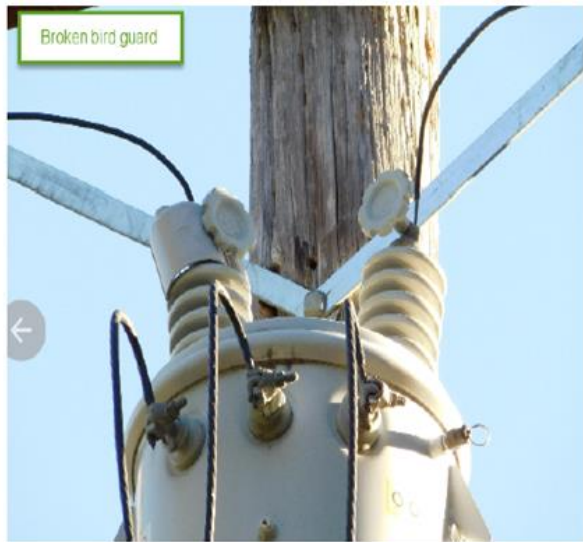
Examples: Broken bird guard

General Guidance: Inspector should create EC notification to repair/replace existing wildlife protection installed in the field (cow guards, etc.)

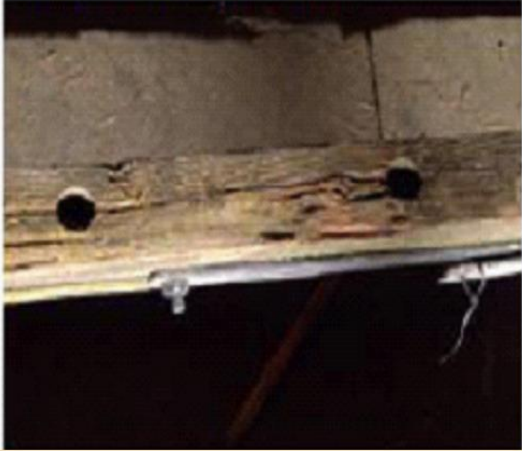
Table 2 – Crossarm Grading Aid	
BOTTOM VIEW	TOP VIEW
<p>Evidence of decay near hole</p>

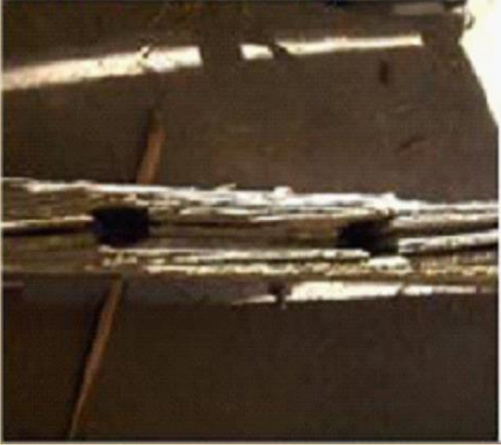
<p>Evidence of Significant Decay</p>

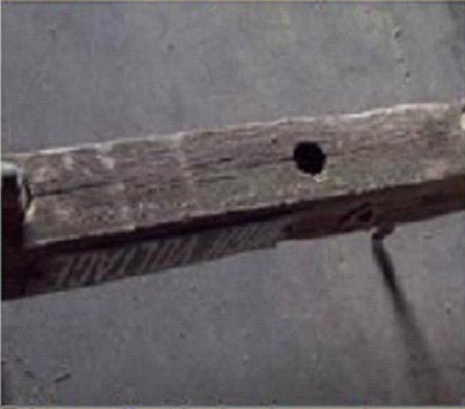
<p>Enlarged hole, minor moss/discoloration/splits near pin hole</p>

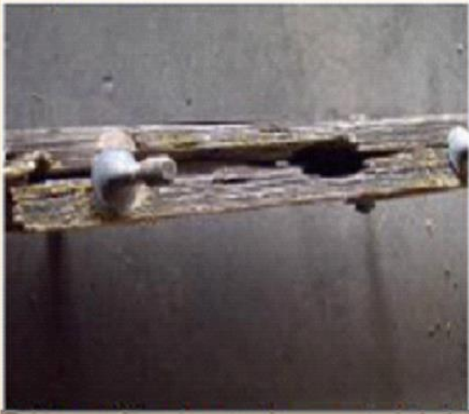
<p>Enlarged hole, minor moss/discoloration/splits near pin hole</p>

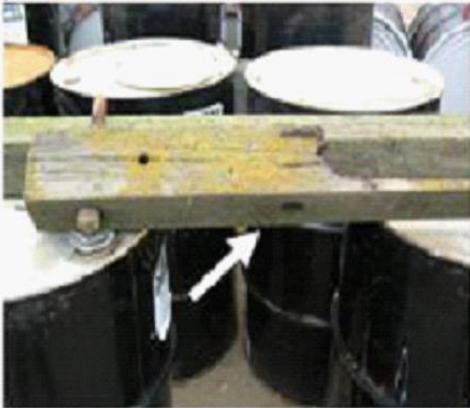
<p>Evidence of tracking/burning near brace and pin holes</p>

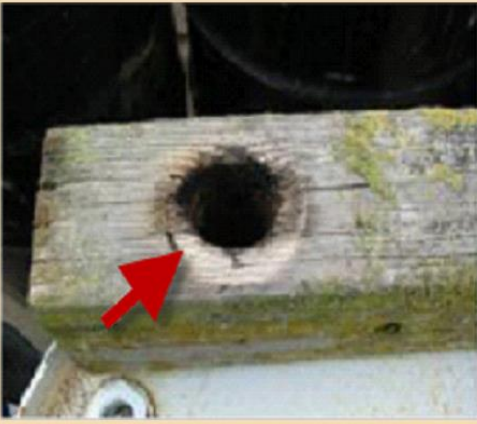
<p>Evidence of burning near brace and pin holes</p>

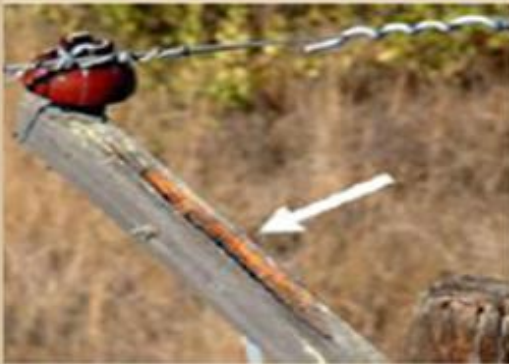
TOP OF CROSSARM DECAYED

Evidence of pole top decay and face of crossarm decay; may need additional assessment of crossarm.

Replace 3-12 months

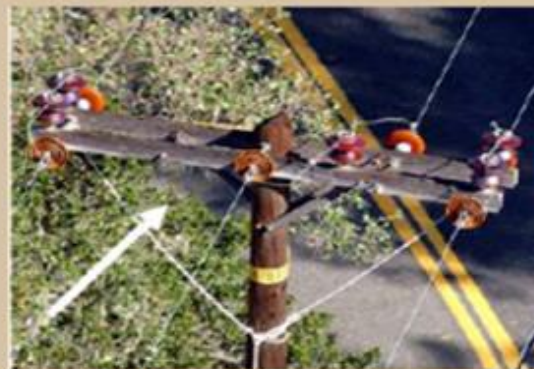
DETERIORATED CROSSARM

Significant deterioration, both arms are broken/split. Evidence of previous temporary repair.

Replace 3-12 months

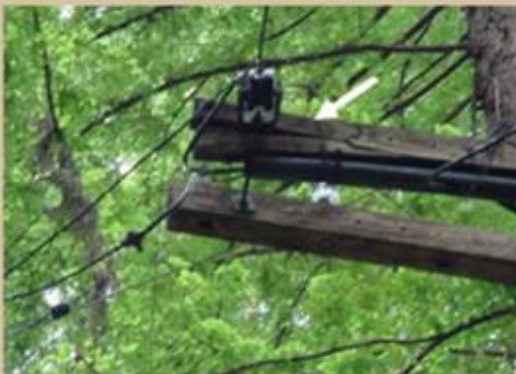
BROKEN SECONDARY CROSSARM

Secondary arm broken; split/fractured within 2" of bolt holes in heavy tree area.

Replace 3-12 months
