# GO Kettleman Compressor Station Ignition RCE Evaluation Report

**Cause Evaluation Report Type:** RCE

CAP Title: Gas Operations Kettleman Compressor Station Ignition RCE

CAP # 129207510

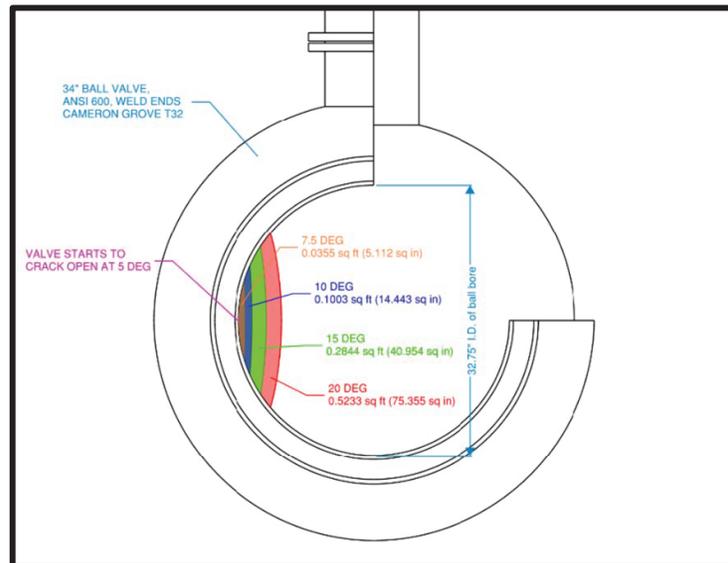
**Figure 16:** Cut away of V-90 showing opening by degrees

This rapid increase in flow is due to the increase in cross sectional area of the flow path as the valve travels open as illustrated below (figures 16,17).

*Note: Per HYSYS model results, the flow velocity leaving V-78 based on all modeled scenarios for V-90 degree of opening, were found to be excessive under all modeled conditions.*

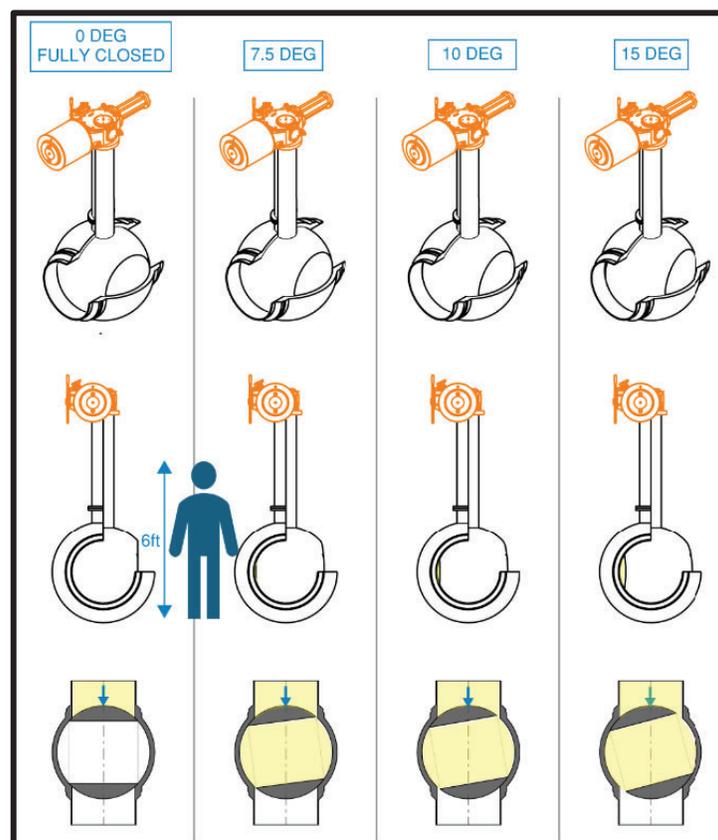
**Figure 17:** V-90 Open Area at Various Valve Positions

Per the manufacturer the valve will not begin to flow until 4°-5° of rotation. Flow data for valve positions lower than 10% open is not available from the manufacturer due to the high velocities in this range resulting in potential damage to the valve seats. To help visualize this relationship, at 2.5° beyond the cracking point the opening is larger than a 2-inch pipe and at 10° beyond cracking the opening is larger than a six-inch pipe. This non-linear relationship to position and cross-sectional area combined with the large size of the valve further complicates achieving fine control for purging operations, especially with a relatively small volume of piping to be purged.
