**CALIFORNIA PUBLIC UTILITIES COMMISSION  
Safety and Enforcement Division  
Electric Safety and Reliability Branch**

**Incident Investigation Report**

**Incident Number:** E20200614-01

**Utility:** Pacific Gas and Electric Company (PG&E)

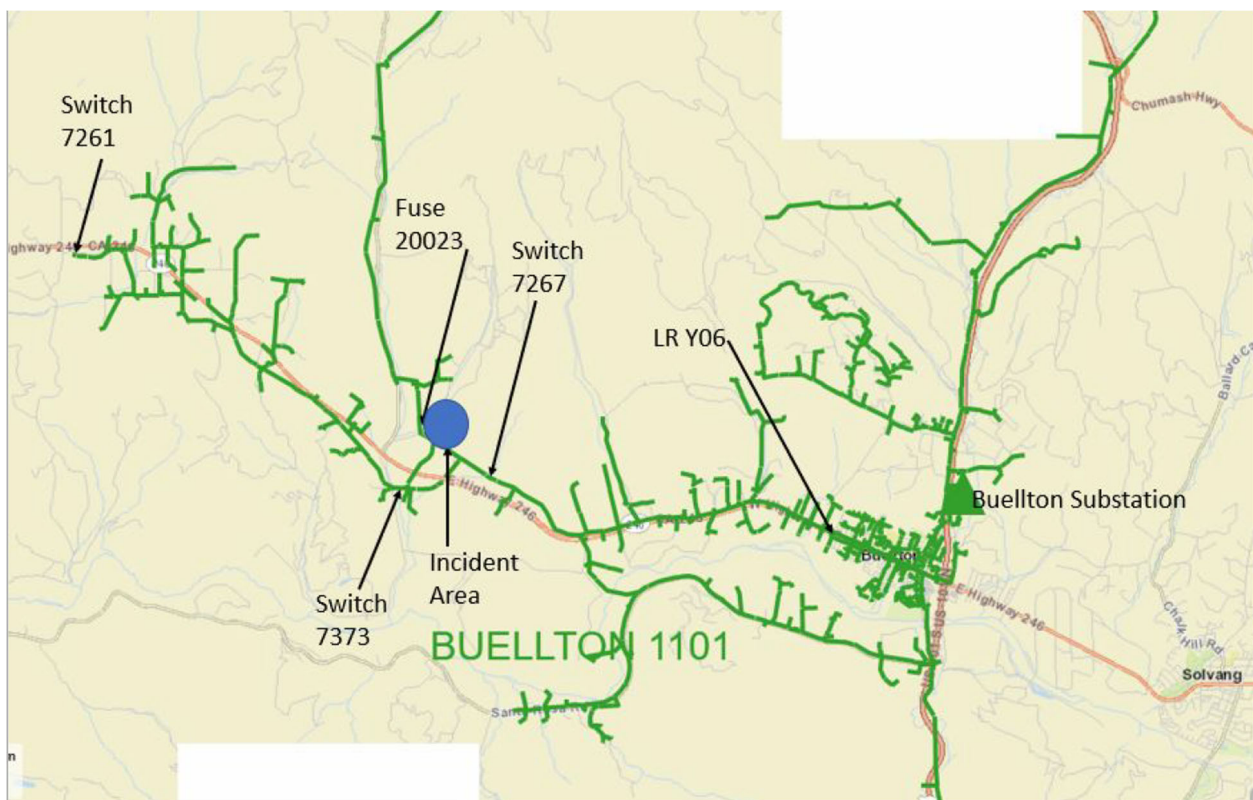
**Figure 5:** Partial Buellton 1101 Circuit Map<sup>15</sup>

Figure 5, below, shows a circuit map of the equipment and incident area.
