CALIFORNIA PUBLIC UTILITIES COMMISSION

Incident Investigation Report

Incident Number: E20191028-01

Utility: Pacific Gas and Electric Company (PG&E)

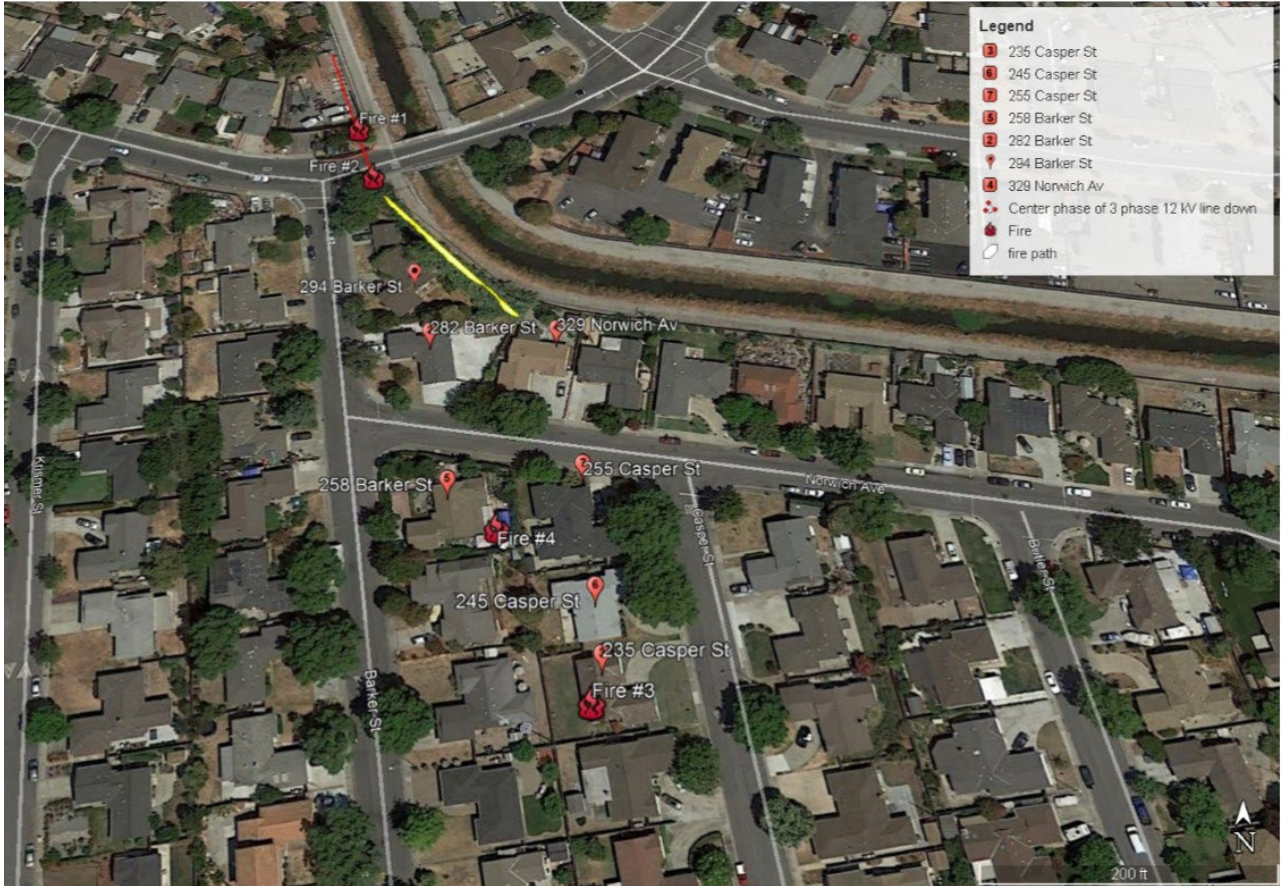
Figure 5: Fire Map

Overall, the incident caused four fires in the neighborhood. Please see Figure 5 for the locations of the above four fire sites.
