SUBJECT: Generation Audit of Aquamarine Solar – Audit Number GA2023-06AMS

**CPUC AUDIT FINDINGS OF
AQUAMARINE SOLAR PARK
MAY 01 – MAY 05, 2023**

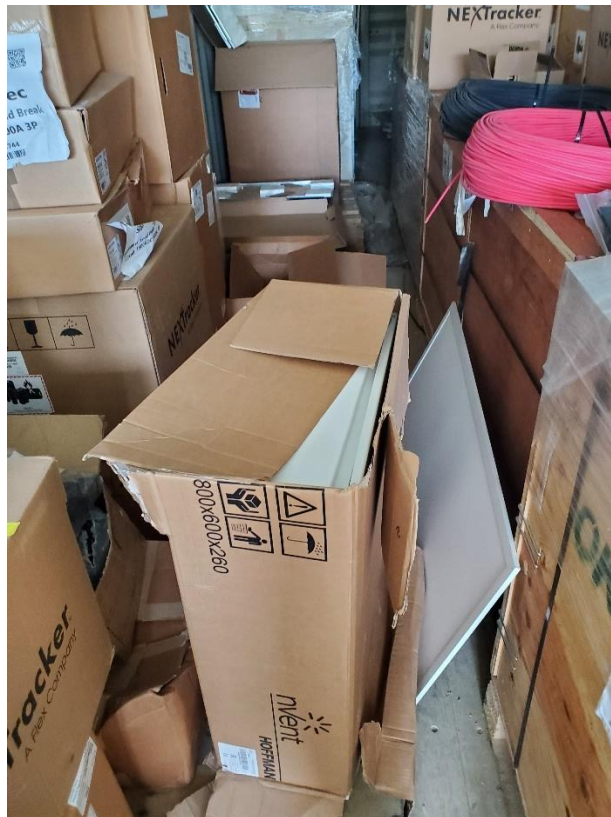
Finding 1: The Plant fails to maintain good housekeeping practices in its storage containers.

ESRB staff observed inconsistent storage practices where items are being allowed to accumulate on the floor in walkways, making portions of the storage facility inaccessible.

Figure 1: Poor housekeeping practices in storage container.

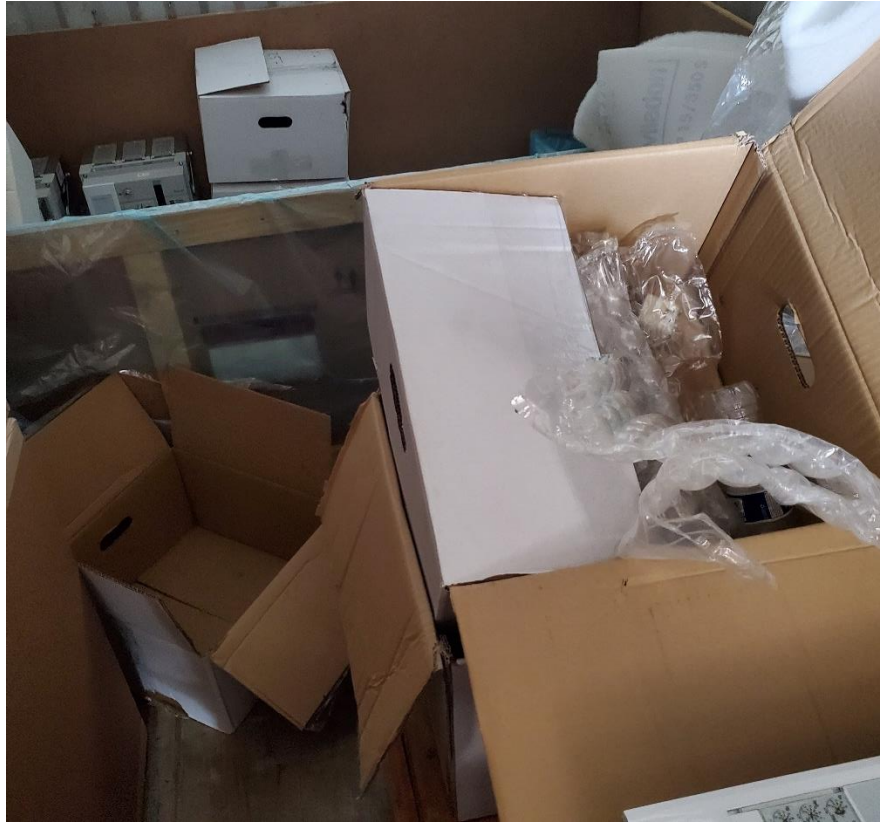
Figure 2: Empty packaging and left in storage container.

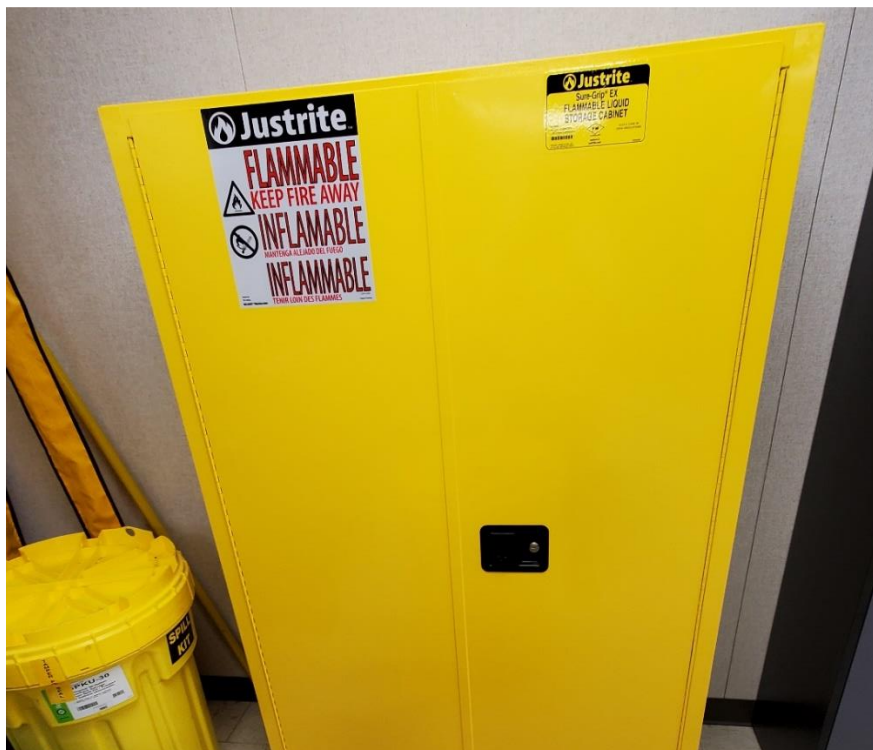
Finding 2: ESRB staff observed missing National Fire Protection Association (NFPA) Fire diamond signs on the exterior of the Operations Building and Flammable Materials Cabinet. The Cabinet also lacks self-closing ability.

ESRB staff observed a missing NFPA sign (the fire diamond) on the Operations Building, where the flammable material cabinet is stored. The cabinet itself is also missing the fire diamond and is not

self-closing. This sign is important to provide information related to hazards that emergency services would need to effectively deal with the emergency.

Figure 3: Missing NFPA sign (fire diamond) on Flammable Material Cabinet.

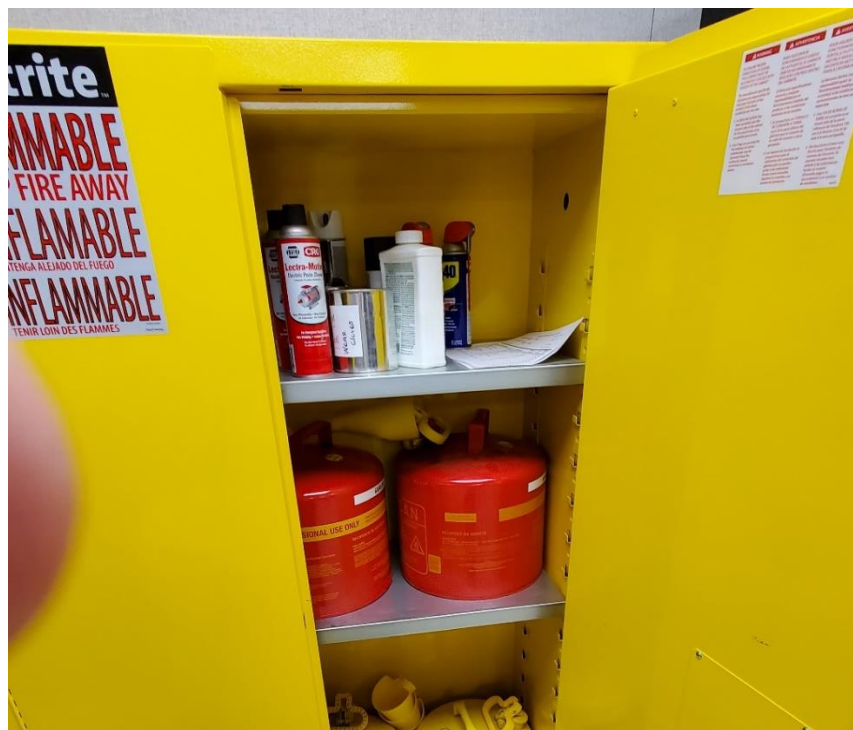
Figure 4: No self-closing on the Flammable Material Cabinet.

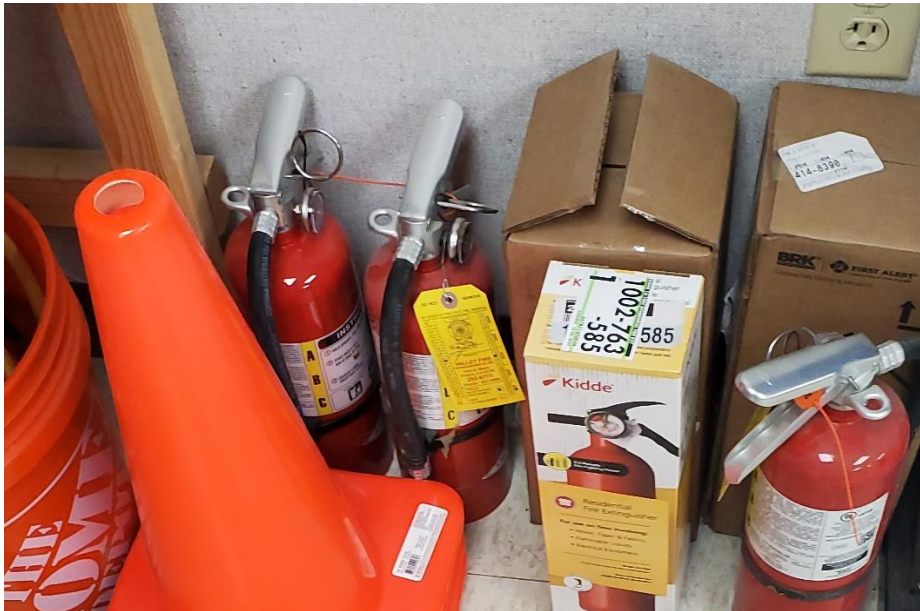
Finding 3: The Plant did not inspect the spare fire extinguishers.

The Plant does not perform monthly inspections on the spare fire extinguishers kept in storage. The fire extinguishers need to be included in the monthly inspections to ensure that they are in proper working condition.

Figure 5: Spare fire extinguishers not being inspected.

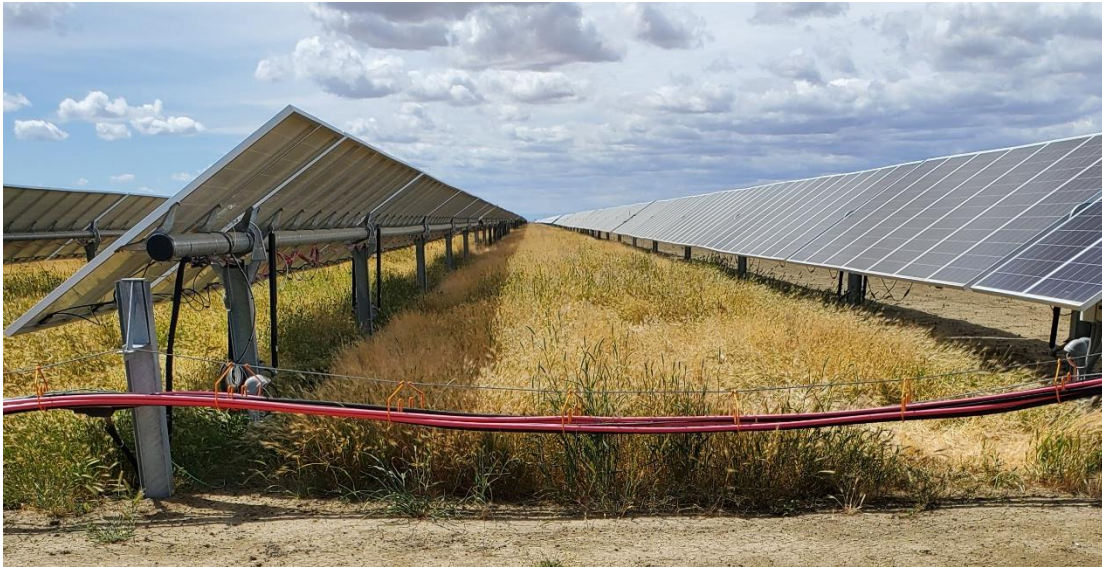
Finding 5: ESRB staff observed overgrown vegetation in The Plant.

ESRB staff observed overgrown vegetation in blocks 5.11 and 4.7 of the Plant. The vegetation was also in a dry and highly flammable state. Proper vegetation management is necessary to mitigate fire risk to ensure safety and maintain service.

Figure 6: Overgrown Vegetation in Block 5.11

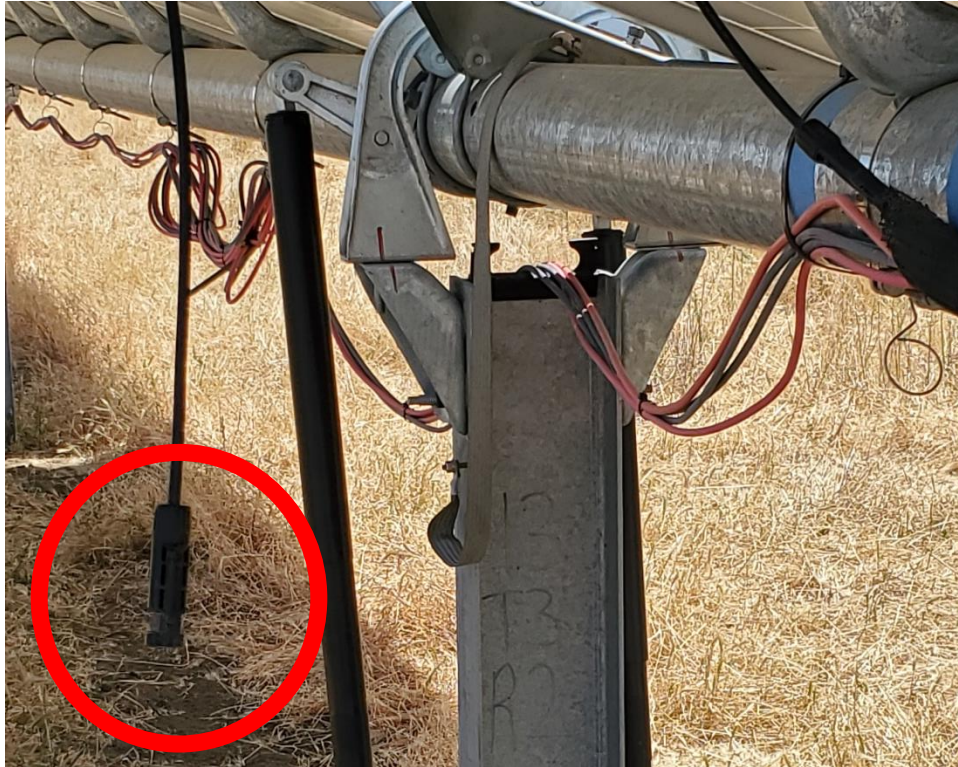
Finding 6: ESRB Staff observed broken solar panel connectors.

In Block 1.3 there were multiple rows of solar panels with broken connectors. The broken connectors are a safety hazard since the panels are electrified when the sun is shining.

Figure 7: Broken connector hanging off solar panel.

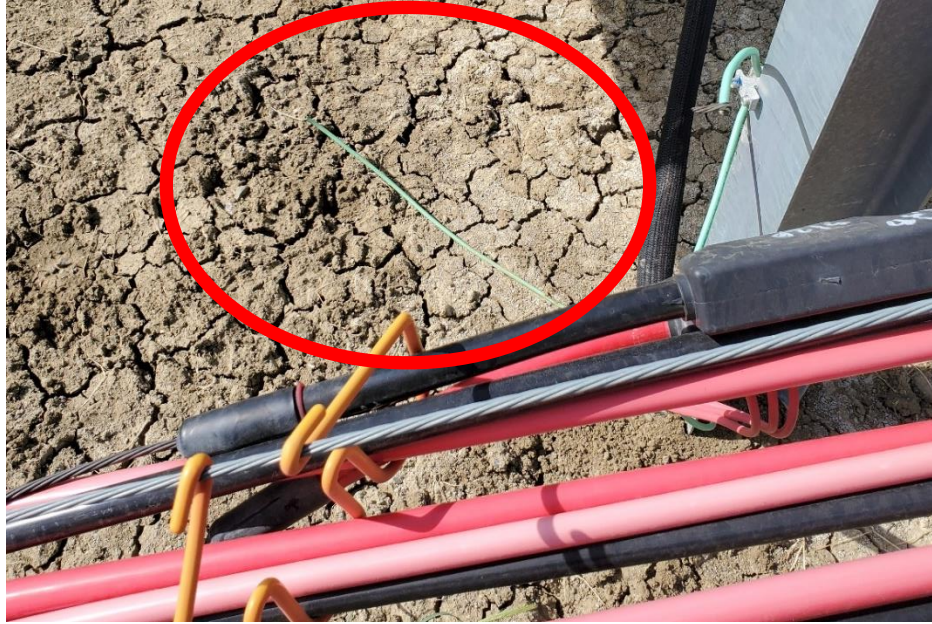
Finding 8: ESRB Staff observed broken ground wires throughout the Plant.

Throughout the Plant the ground wires connecting the array trackers to the cable hangers are broken. The broken ground wires create an electrical safety hazard in the Plant and need to be addressed.

Figure 8: Example of broken ground observed throughout the Plant.
